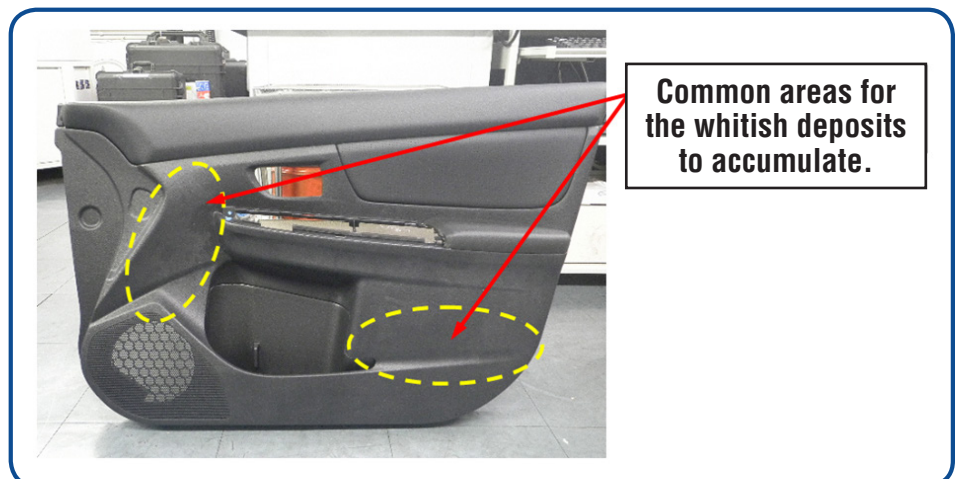
If you receive a customer concern of a whitish discoloration found on the front interior door trim panels, it is most likely a by-product of the scratch prevention agent used in the front door trim material. If the vehicle has been in storage for a period of time or unused with all the windows closed, a lack of air circulation in the cabin can cause deposits to form on the front door trim panel surfaces in the areas shown in the photo below.

Use a clean detailing cloth wet with plain water to remove the deposits. After the surface dries, confirm all the deposits have been removed. Should any deposits remain, repeat the process again. Make sure the cloth is wet as using a dry cloth can damage the surface of the trim panel.

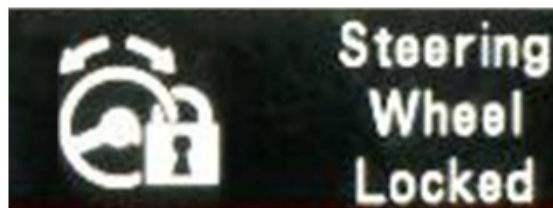
Should you receive a customer concern of no crank or no response from the push-button start button, make sure the steering column is not locked. The information display on the combination meter may also show the warning indicator shown. For example: on a key-start vehicle, the key may not turn in the ignition if there is excess pressure being placed on the steering lock. In those cases, the steering wheel needs to be turned side to side to release the ignition lock and start the car (see Section 3: "Instruments & Controls" of the applicable Owner's Manual). The same holds true for push-button start vehicles except, since there is no key to turn, if the steering lock has excess pressure placed on it, there will be no starter response when pressing the start button. In addition, the operation indicator on the button itself will flash green (for a maximum of 15 seconds). Just as on a key-start vehicle, the steering wheel must be turned side to side to release the pressure on the ignition lock allowing the starter motor to operate. The steps to take should this occur on a push-button start equipped vehicle are: press the brake pedal down firmly, verify the green operation indicator on the start button is flashing then rock the steering wheel side to side while pressing the start button. This condition is a normal operating characteristic and no attempt should be made to repair it. If the customer reports the indicator on the start button is a color other than green when the condition occurs, diagnose the concern following the troubleshooting section of the applicable Service Manual.

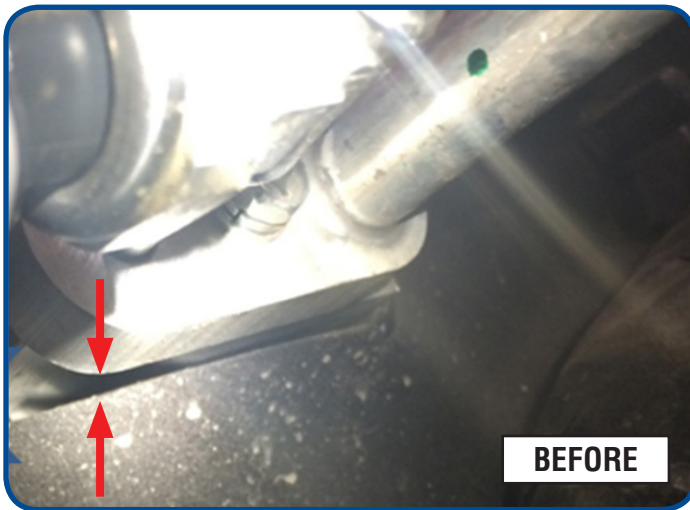
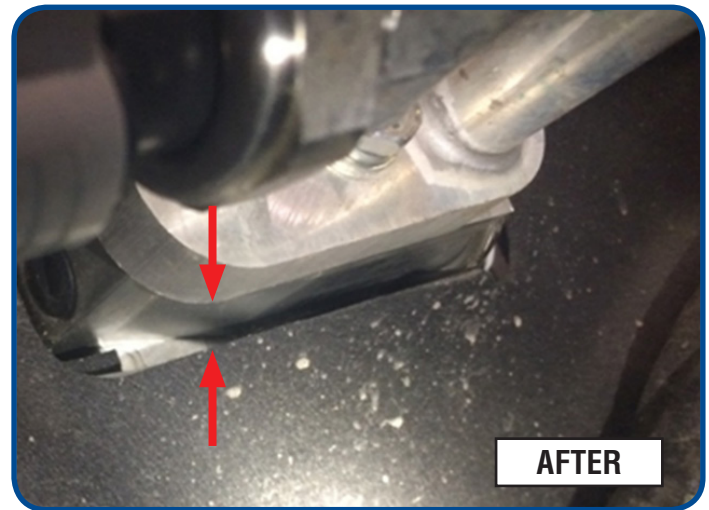
The Techline has received a small number of concerns regarding a rattling sound which seems to be coming from the right side of the dash / behind the glove box area. This information is not model / model year specific. In some cases, the sound is easily duplicated with the engine at idle, transmission in gear and under high a electrical load condition (A/C on, headlights and other accessories on, etc.). Confirmed cases have shown contact between the expansion (TXV) valve assembly and the bulkhead at the pass-through area as shown in the “before” and “after” photos below. The A/C system piping is aluminum and can easily become bent or displaced if precautions are not taken when working in this area of the engine bay. Take care to not lean on / against or otherwise move this piping when working on or trying to gain access to other components in the immediate area. Otherwise, the expansion valve assembly may end up out of position resulting in a rattling sound and potential customer comeback situation. In this case, a careful “repositioning” was all that was required to provide the additional clearance needed to eliminate the sound.
