## ARTICLES CONTAINED IN THIS ISSUE

CODE	ARTICLE.....	PAGE
(00)	March STIS New Releases .....	9
(01)	QMR of the Month.....	1
(01)	QMR of the Month Award Presentations.....	2
(01)	Calling the Techline Revisited ..	3
(02)	FA and FB Engine Crank Sprocket Timing Mark - Important Reminder .....	4
(07)	Identifying Electrical Harness Connectors .....	5
(07)	Electrical Diagnosis and Aftermarket Equipment .....	7
(12)	Fuel Door Freeze-Up .....	8

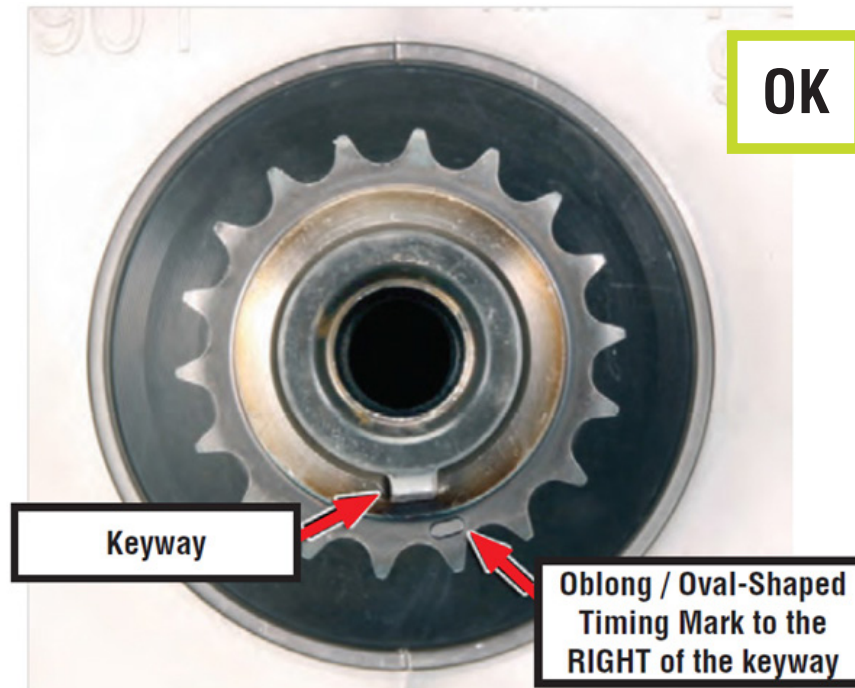
As a reminder, to avoid unnecessary DTCs setting after engine reassembly, when aligning timing components on the FA and FB engines, the crankshaft timing chain sprocket **MUST** be installed with the **OVAL-SHAPED (oblong) timing mark facing front** as shown below.

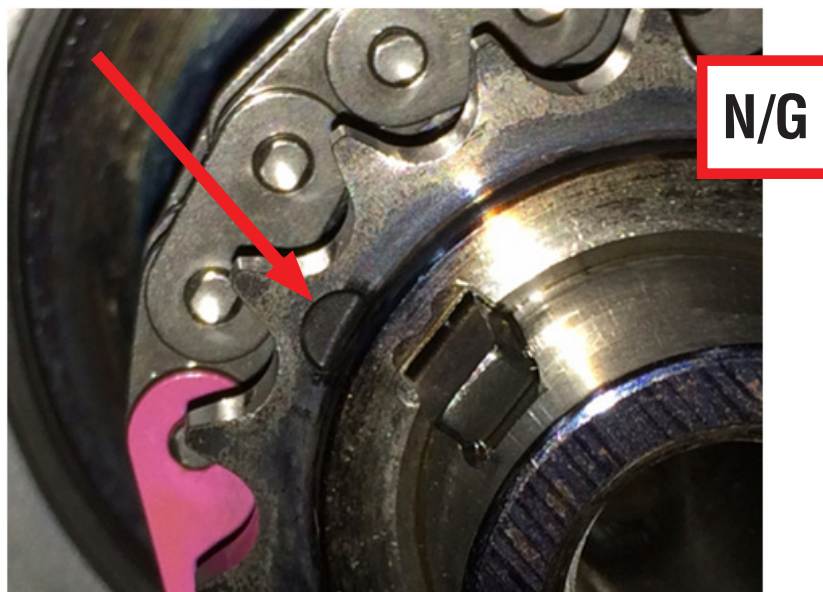
Be advised, there is also a half-moon shaped mark found on the back-side of the crank sprocket. This mark can be easily mistaken for a timing mark like in the example photo below which clearly shows the crank sprocket installed backwards. Use this mark to help identify the back-side of the crank sprocket **ONLY**.

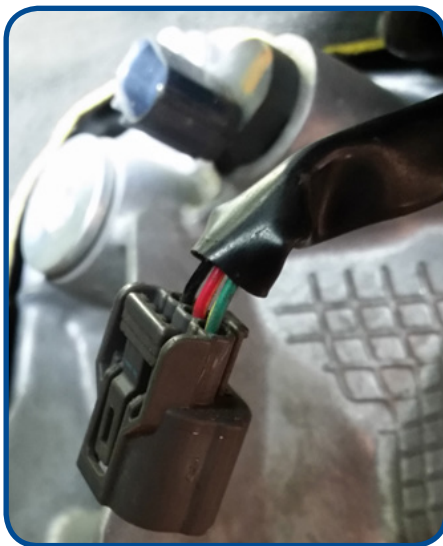
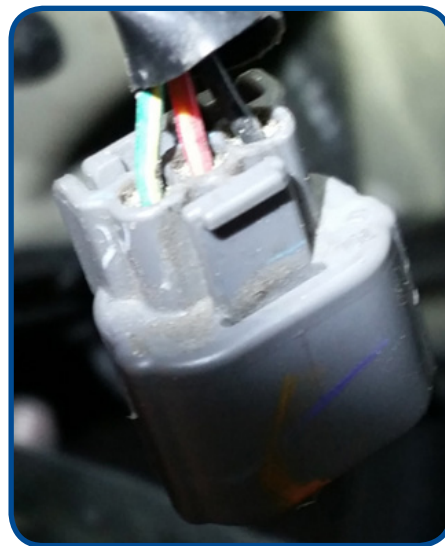
**Example:** DTC P0716 on a 2013 Outback with CVT transmission. The photos below show 2 very similar connectors (AT4 and AT5), both with the same wire colors and located very close to each other on the transmission. The difference is, one connector is dark gray in color while the other is light gray. In this case, doing the pin tests on the wrong connector resulted in both an incorrect repair diagnosis and unnecessary part replacement.

**Remedy:** Refer to the end of the Wiring System section of the Service Manual where you will find the handy harness connector chart shown below.

The diagnosis chart for the DTC references connector AT5 (light gray as shown in the chart).

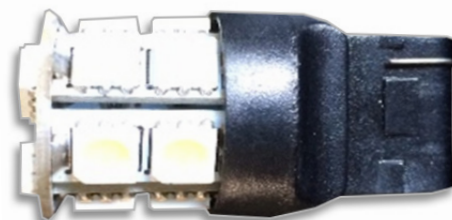
This replacement LED bulb which came from a 2010 Outback, had no resistor and was determined to be causing the shift lock solenoid to turn on/off randomly. In addition, the solenoid would occasionally stick “on” enabling the transmission to be taken out of Park without stepping on the brake pedal. Voltage at the BIU, ECM, TCM, and VDC control modules from the brake light circuit measured 2.83V with the brake pedal not depressed (specification is less than 1.5V). The result was a damaged BIU which caused the 2.83V output voltage to the shift lock solenoid.

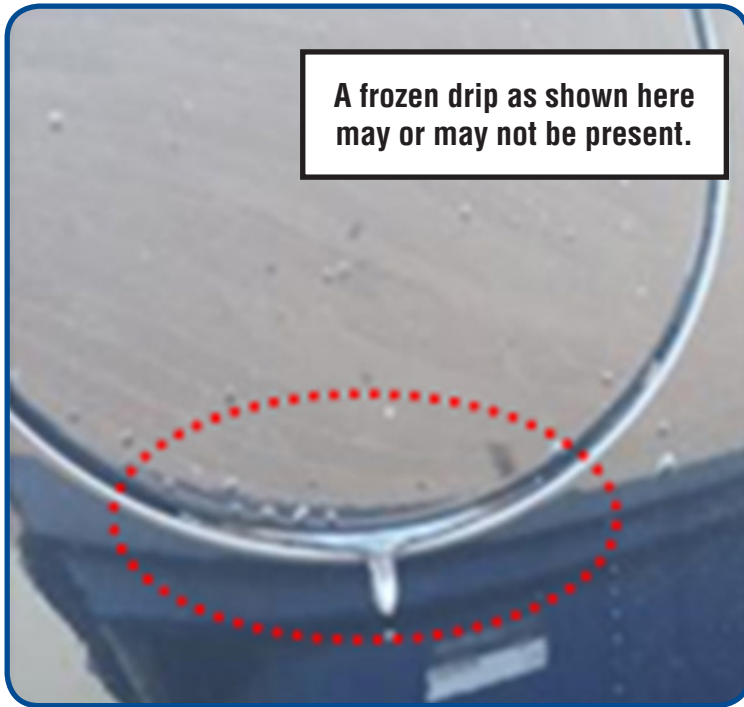
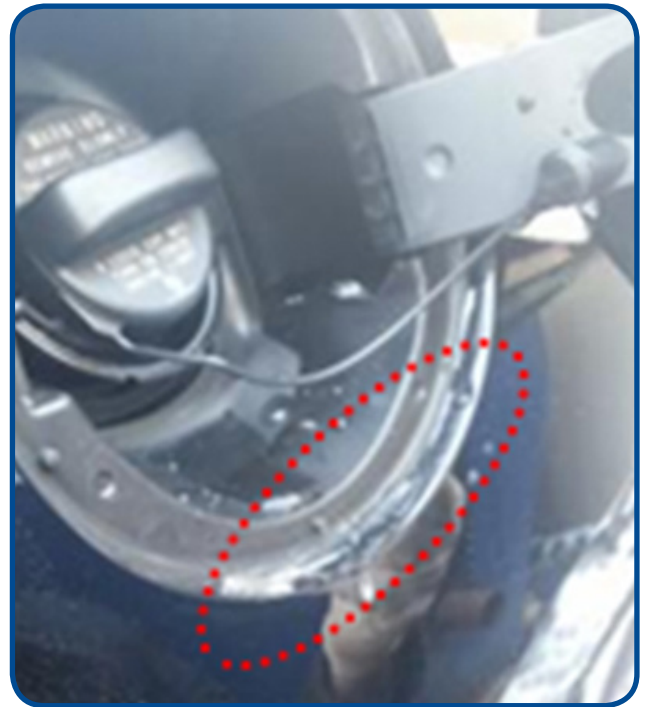
We have received a limited number of reports regarding fuel doors freezing shut and / or inoperative inside release mechanisms, especially in cold weather. The cause is water droplets accumulating at the bottom of the saucer portion and freezing to the filler door flap as shown in the photos below.

Either a CAREFUL “tap” with the side of your closed hand to break the ice or application of a spray de-icer product directly onto the indicated area of fuel door has provided good results in restoring normal operation. Spray de-icer products like those shown in the example photos below are readily available at major retail outlets and are all specifically described as being safe for application directly onto the vehicle finish.
