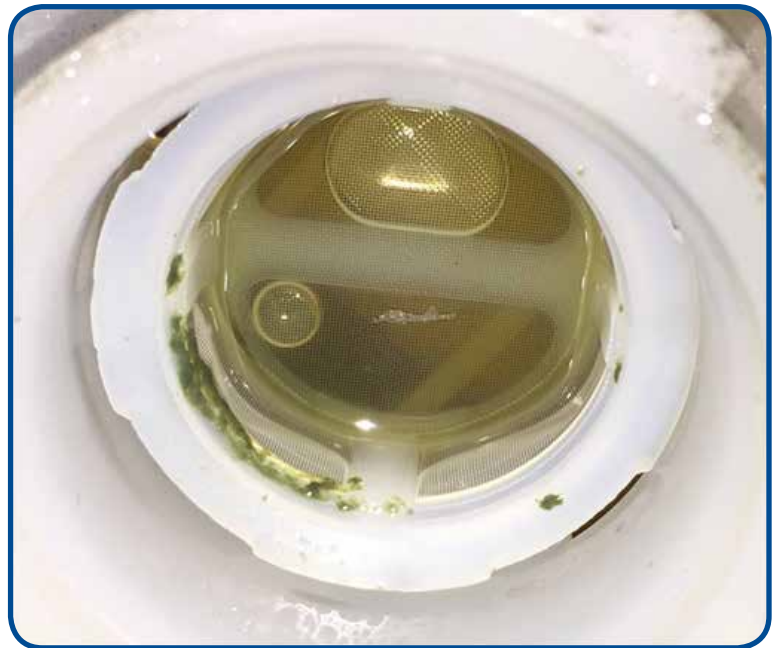
We have received a small number of inquiries regarding a greenish substance found when removing the brake master cylinder fluid reservoir cap. This substance results from a natural reaction between the copper coating applied to the inside of the brake lines during manufacturing and a chemical compound called Triazole ($C_2H_3N_3$) which exists naturally in brake fluid. When these two substances contact each other, Cupric Benzotriazol ($C_6H_4N_{32}Cu$) results which is greenish in color. The actual particles of this substance are very small and have no impact on brake system performance or durability.
