ARTICLES CONTAINED IN THIS ISSUE

QUALITY DRIVEN® SERVICE

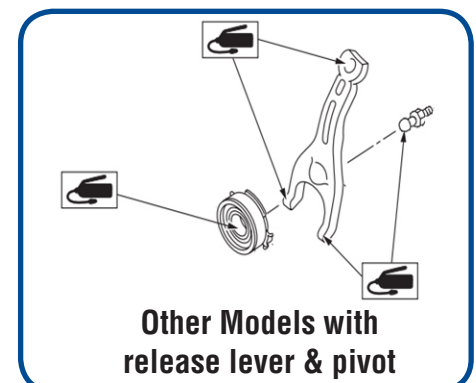
To avoid customer concerns of a creaking, squeaking or clicking sound possibly accompanied by increased pedal effort (stiffness) when operating the clutch pedal after performing a clutch-related repair, it is important to remember to always thoroughly clean and re-lubricate the clutch release components. Where applicable, the release lever, shaft, pivot, release bearing contact points on both the release lever and pressure plate along with the input shaft splines should all be properly lubricated and checked for smooth operation before re-installing the transmission assembly. It is also important to apply the grease sparingly, especially on the input shaft splines to avoid any grease contamination of the clutch disc friction material.

In addition, if you receive a customer concern of a squeaking or creaking sound when operating the clutch pedal, review TSB 12-190-15 to make sure the source of the sound is properly identified and addressed on the first repair visit. As always, when attempting to identify the location of an unusual sound, chassis ears or a similar tool can be helpful in isolating the source.

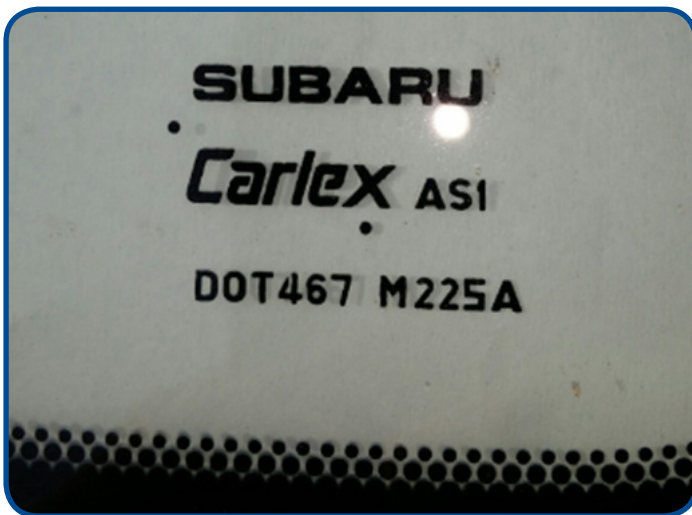
When completing a Glass Authorization Request going forward, you will notice there is an additional required photo that must be submitted with the Authorization Request. The new Required File Type is named, "Glass Identification Marking", see Illustration 1 .

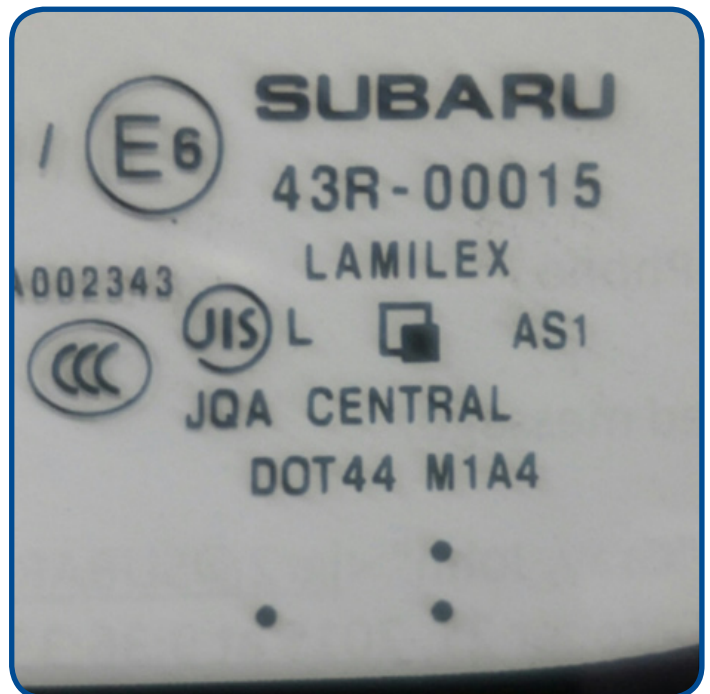
The Glass Identification Marking is located in the lower left corner of the windshield. See Illustration 2 for examples of what is required.
