ARTICLES CONTAINED IN THIS ISSUE

CODE	ARTICLE.....	PAGE
(00)	January STIS New Releases ...	7
(01)	QMR of the Month	1
(01)	QMR of the Month Award Presentation	2
(02)	Addressing Accessory Drive Belt Noise.....	5
(07)	2016 Impreza / Crosstrek Telematics and "D-Check" Fuse Clarification	6
(15)	Auto Dimming and Home Link Accessory Mirror Wiring Harness Troubleshooting.....	3
(18)	WVX-34 (Lower Control Arm Corrosion) REMINDER	2

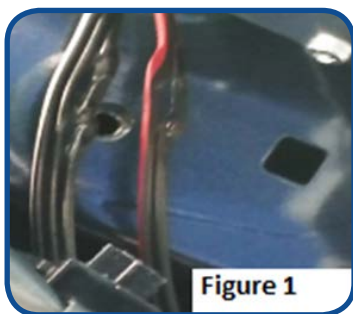
Figure 1

Example of damaged harness

If you are diagnosing an electrical fault on a vehicle, do not forget to check all of the associated systems involved with the circuit in question. One example would be inoperative back-up lights on a 2016 Forester with a short to ground in power supply circuit FB-35. If the vehicle is equipped with the Auto Dimming and Home Link accessory mirror, there is a possibility when the map light or Eye Sight® panel was reinstalled, the wiring harness could have been damaged when inserting the retaining fasteners if not routed correctly as shown in Figure 1. Outlined below is the wiring diagram, connector identification, and associated circuits involved with this particular scenario.

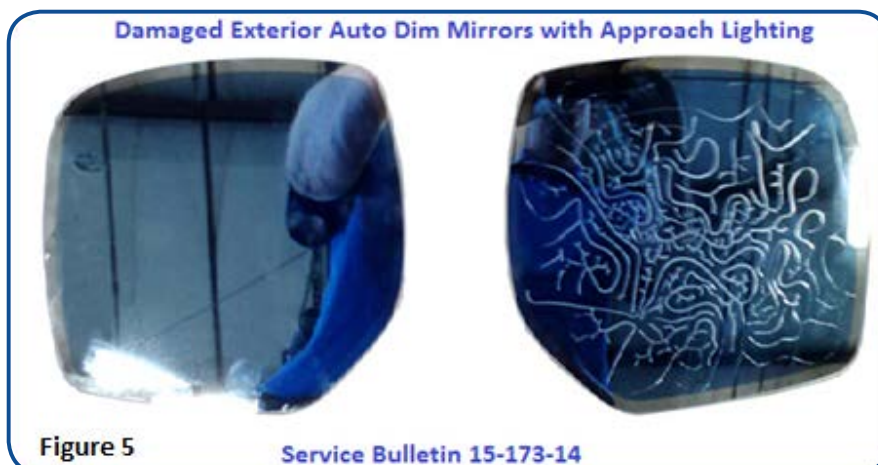
As you can see, there are multiple components that can be affected on this 2016 Forester if the roof harness or Auto Dimming and Home Link accessory mirror harness is damaged. Another symptom of this damage, shown in figure 5, can be found in Service Bulletin 15-173-14 which is applicable to the 2014-2015 Forester models. Information found in this bulletin includes excellent material pertaining to damaged exterior auto dimming mirrors with approach lighting caused by a short to ground in the interior auto dimming mirror harness.

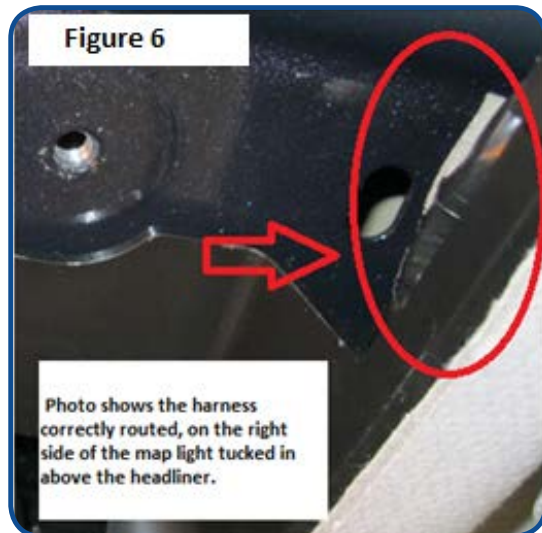
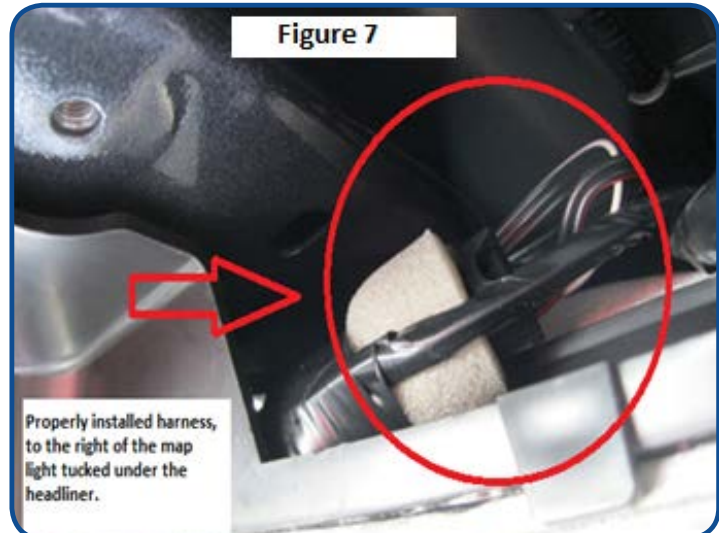
Service bulletin 15-173-14 also includes detailed images of the harness damage, along with auto dimming mirror circuit testing when applicable. If inspecting this harness for damage, or replacement of the harness is necessary, it is required that the harness be routed correctly. Figures 6 and 7 show the proper routing and placement of the roof harness and accessory mirror harness.

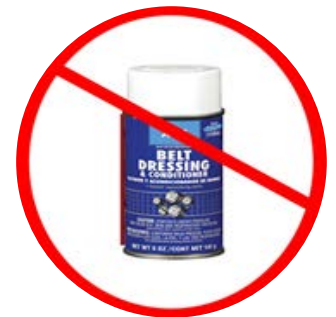
Whenever addressing a squealing or chirping-type sound from the engine compartment isolated as coming from an accessory drive belt, it is important to determine the root cause of the condition. In the past, especially when “V” belts were common, unless an obvious cause was identified, often times a belt dressing or other form of cleaner / lubricant was applied to the belt which TEMPORARILY eliminated the noise addressing the customer concern. Now that ribbed or serpentine belts are the standard, lubricants or conditioners like these should never be used. The Service Manual even indicates “Do not use the V-belt (sic) if there is any oil, grease or coolant on the belt.” If the belt needs to be tested, FHI recommends that only a light spray of pure water be applied to the belt in order to see if the characteristics of the sound changes or not. The belt itself, in addition to items such as the tensioner, accessories, idlers, and even simple adjustment make up the list of items which may cause belt noise conditions. This makes the need to identify the root cause extremely important to help avoid repeat repair attempts and most importantly, dissatisfied customers.

To summarize, although these types of products (belt dressings, cleaners, and lubricants) are readily available and in some cases commonly used, it is **NOT RECOMMENDED** to use any kind of belt dressing product or lubricant on a Subaru accessory drive belt. In the event the belt becomes contaminated, it should always be replaced. Cleaning and re-use is not recommended. Always keep the best interests of your customers in mind by identifying the root cause of the condition and repairing it properly the first time.

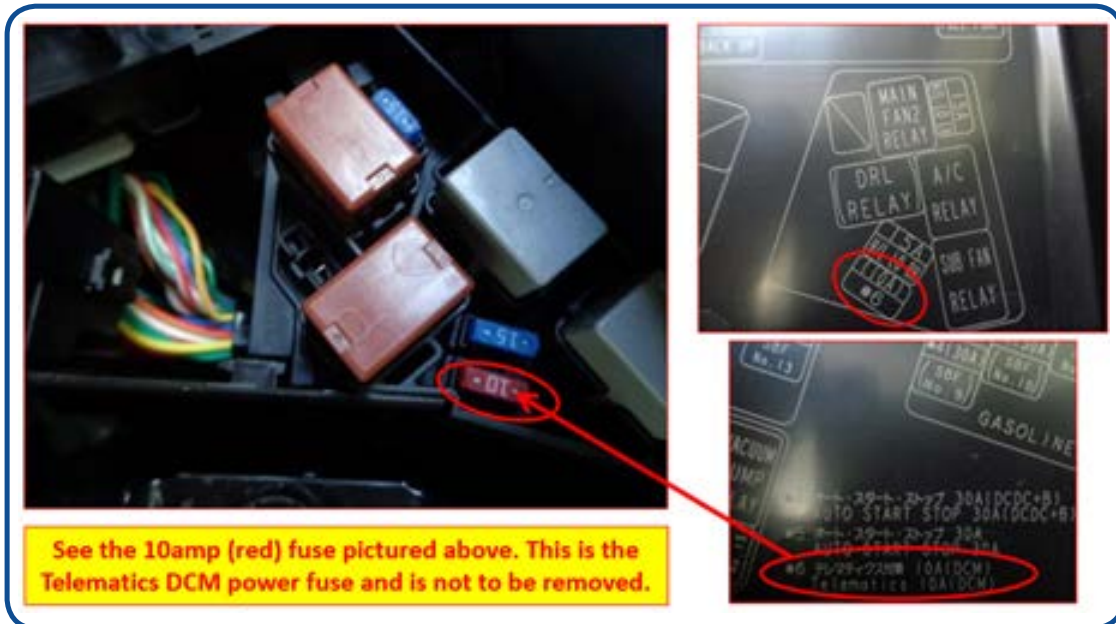
Some 2016MY Crosstrek and Impreza models are now available with the optional Telematics system. We have received a number of reports from the field describing what seems to be some confusion between the 10-amp fuse for the Telematics system and the 10-amp "D-Check" (Transit or "PDI") fuse. First and foremost, there is NO need to do anything at all with the 10-amp Telematics fuse. Although the 2 fuses are the same red color, amperage rating and located relatively close to each other in the under-hood (M/B) fuse box as shown in the bottom photo below, the Telematics fuse should be left alone.

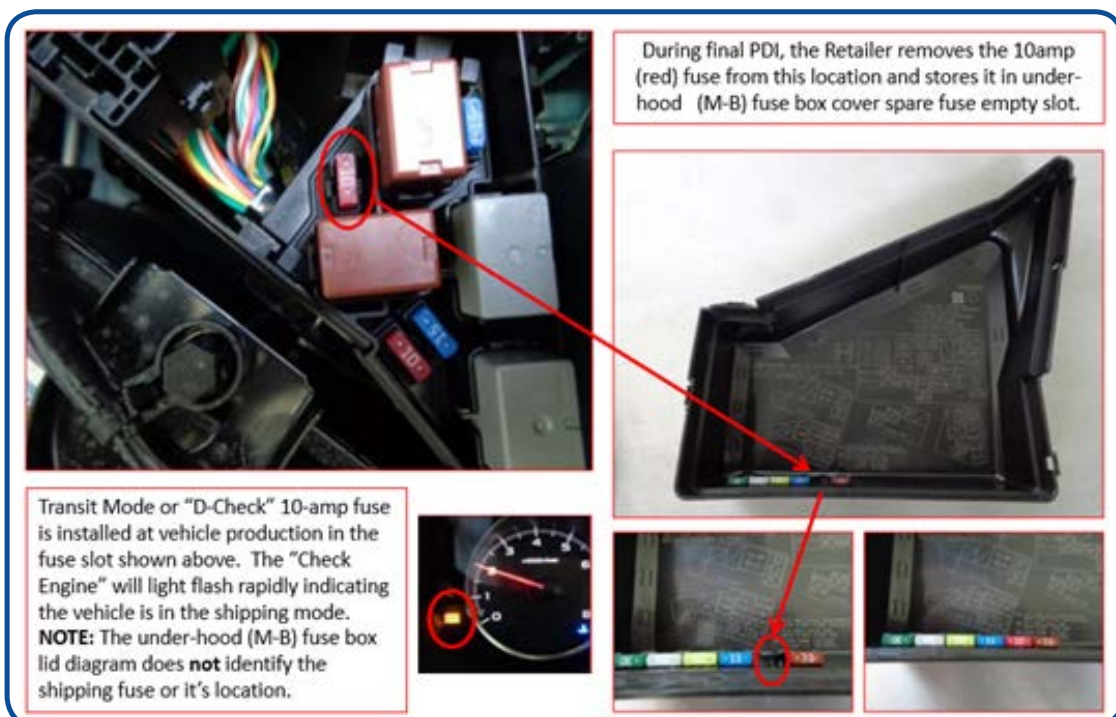
The second photo shows the location of the 10-amp "D-Check" (Transit or "PDI") fuse. During Retailer PDI, this fuse must be removed from the M/B and stored in the empty slot in the fuse box cover. Prior to removing this fuse, when the ignition is "ON", the Check Engine light will flash rapidly. Photo (1) below shows the fuse in the "transit" position and (2) the location where it belongs after removal during PDI.
