ARTICLES CONTAINED IN THIS ISSUE

07 SPARK PLUG INFORMATION & A REMINDER

07 BATTERY SERVICING PRECAUTIONS

15 ACCESSORY DOOR EDGE GUARD REMOVAL PROCESS

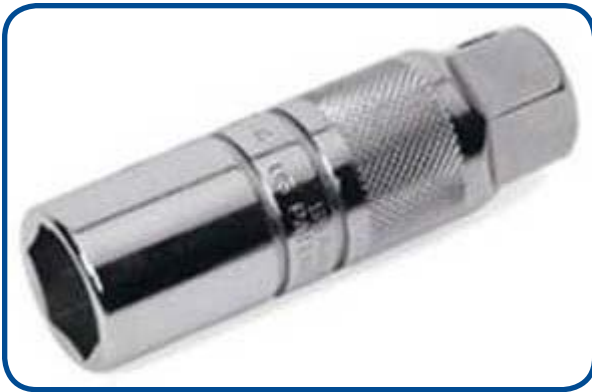
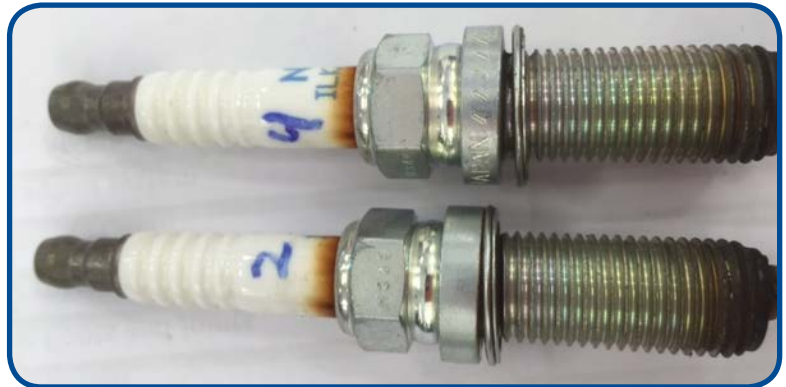
Both the Techline and Claims Group have been receiving a number of calls recently asking about spark plug coverage when performing engine repairs, especially since release of the WQW-58R Service Program Bulletin. When removing the spark plugs, and to avoid damaging the porcelain insulator, it is imperative to ALWAYS use the right tool for the job (e.g. a Snap-On S9714MKR or equivalent dedicated spark plug socket) and NOT a regular 14mm deep-well socket. Use of a standard socket or a spark plug socket that has a missing or loose rubber insert can result in plug damage.

There have also been inquiries about a brownish-colored ring or stain which develops on the insulator between the top of the steel body (hex portion) of the plug and the bottom of the silicone coil or plug wire boot. This discoloration is called a “Corona Stain” and is NOT an indicator of compression leakage. It is often seen on spark plugs which are installed deep into the engine such as on many four valves per cylinder engine applications where oil particles do not get blown away by air circulating around the engine compartment. When coupled with the high voltage pulsing inside the spark plug insulator, the particles will often adhere to the insulator surface and develop the stain as shown in these photo above. This phenomenon is normal and does not compromise function of the spark plug in any way.

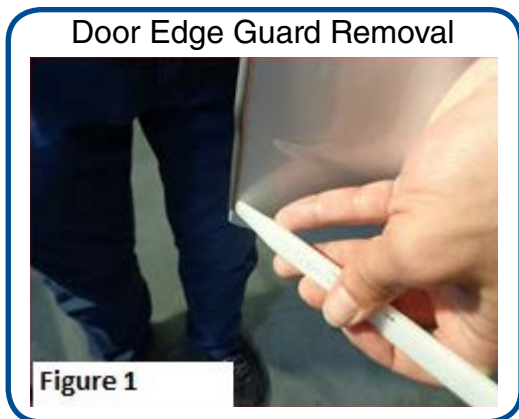
Caution: Do not pull on the Door Edge Guard as this can damage the finished paint quality.

Start by positioning the tip of a plastic trim tool as shown in figure 1, against the leading edge of the Door Edge Guard on the exterior door surface. Begin tapping the tool gently, starting from the top of the Door Edge Guard to separate the accessory from the door. Continue to tap and separate the Door Edge Guard from the door itself until about 3” above the bottom of the accessory. Once at this point, place the tip of the tool at the bottom of the Door Edge Guard and begin tapping while working your way upward until the accessory is removed. If the Door Edge Guard requires removal for any reason, reuse is not recommended as the fitment is not guaranteed once removed.
