### ARTICLES CONTAINED IN THIS ISSUE

CODE	ARTICLE.....	PAGE
(00)	STIS New Releases .....	11
(01)	QMR of the Month .....	1
(01)	QMR of the Month Award Presentation .....	2
(01)	QMR of the Month Program Update .....	2
(01)	Subaru University .....	3
(05)	Abnormal Noise Diagnosis .....	4
(07)	Bluetooth Pre-Call Worksheet .	5
(11)	DTC P0171 Diagnostics .....	5
(12)	Interior Rear View Mirror Separation Reminder .....	6
(15)	Auto Dimming and Home Link Accessory Mirror Wiring Harness Troubleshooting – A Reminder .	7
(15)	Microphone Not Working? Check the Telematics System .	11

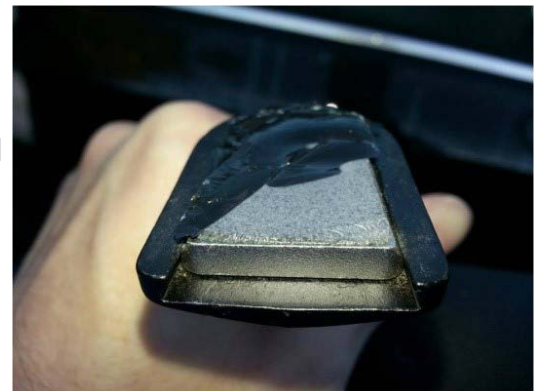
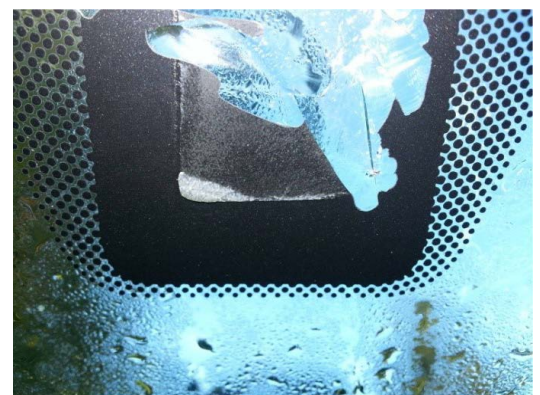
Techline has received several glass repair authorization requests where the interior rear view mirror has separated from the windshield and in the process pulled some glass from the windshield. This type of failure is a result of abnormal (high shear force) being applied to the mirror. The mirror mounting is designed to meet the FMVSS (Federal Motor Vehicle Safety Standard) for required separation in the event of specified impact forces being applied to it during a collision to reduce bodily injury. These forces exceed the normally applied forces found during standard mirror adjustment. The application of high shear force to the mirror through sudden, forceful movements or an unusual level of force being applied against the mirror when it reaches or has reached the end limit of its range of travel, may duplicate the forces required to cause the mirror to shear from the windshield. This type of separation is not a result of any defect in the windshield glass and not eligible for authorization through the Techline glass authorization process. If you believe some unusual circumstances occurred beyond the control of the customer resulting in this condition, those facts should be reviewed with your DPSM.

Photo examples are shown to the right of mirror base and windshield glass following the application of high (unusual) shear force and the expected results. This will not occur during normal mirror adjustment.

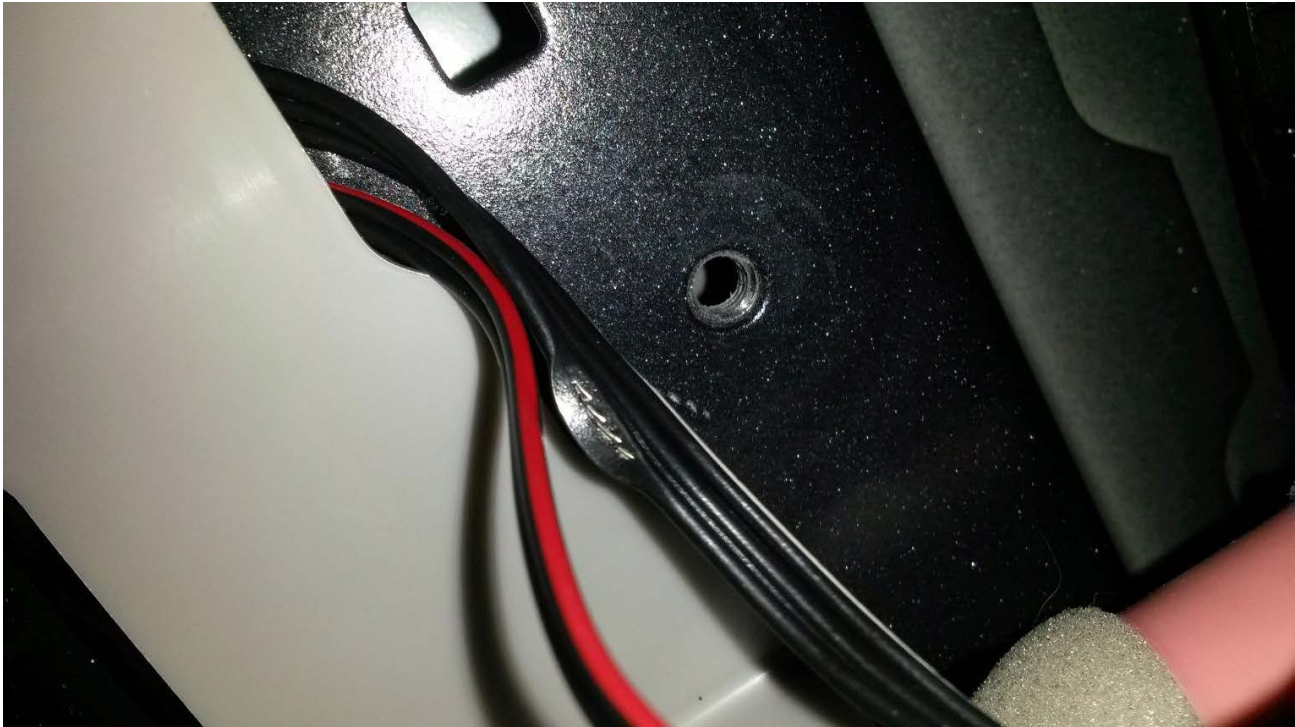
Figure 1

If you are diagnosing an electrical fault on a vehicle, do not forget to check all of the associated systems involved with the circuit in question. One example would be inoperative back-up lights and back-up camera on a 2016 Forester with a short to ground in power supply circuit **FB-35**. Check if the vehicle is equipped with the Auto Dimming and Home Link accessory mirror. If equipped, there is a possibility when the map light or Eye Sight® panel was reinstalled, the wiring harness may have been pinched if not routed correctly. **Figure 1** shows a damaged wiring harness in this case.

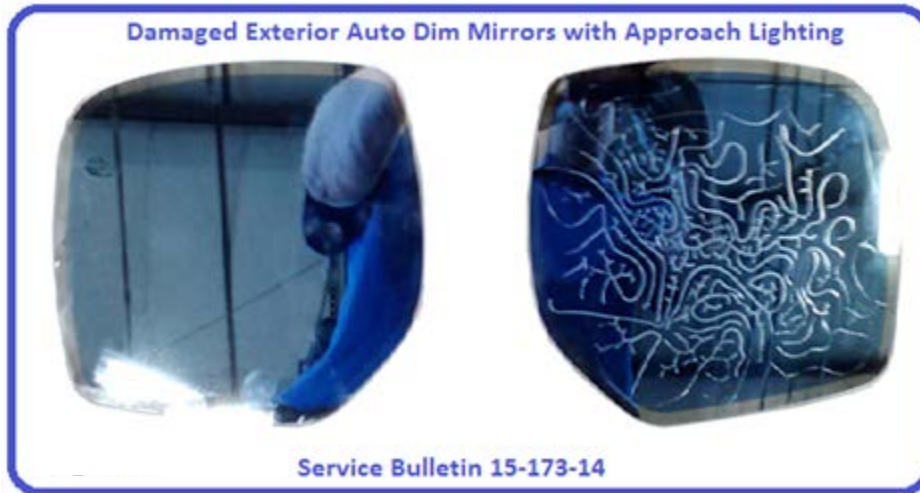
**Figure 5**

Multiple components could be affected on this 2016 Forester if the roof harness or Auto Dimming and Home Link accessory mirror harness is damaged. Reviewing **Figure 3** shows that any component on the reverse light circuit could be affected. Another symptom of this damage, shown in **Figure 5**, can be found in TSB 15-173-14 which is applicable to the 2014-2015 Forester models. Information found in this bulletin highlights damaged exterior auto dimming mirrors with approach lighting caused by a short to ground in the interior auto dimming mirror harness.

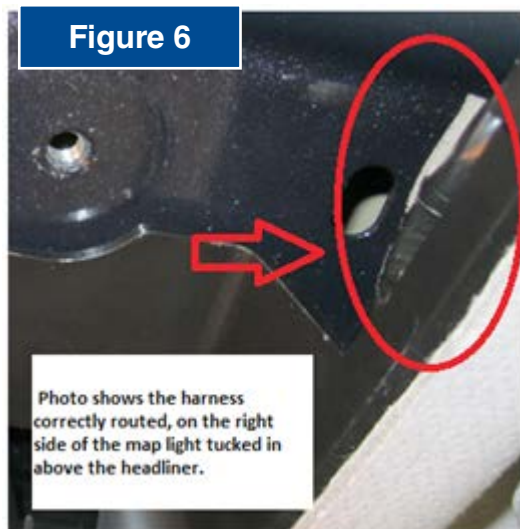
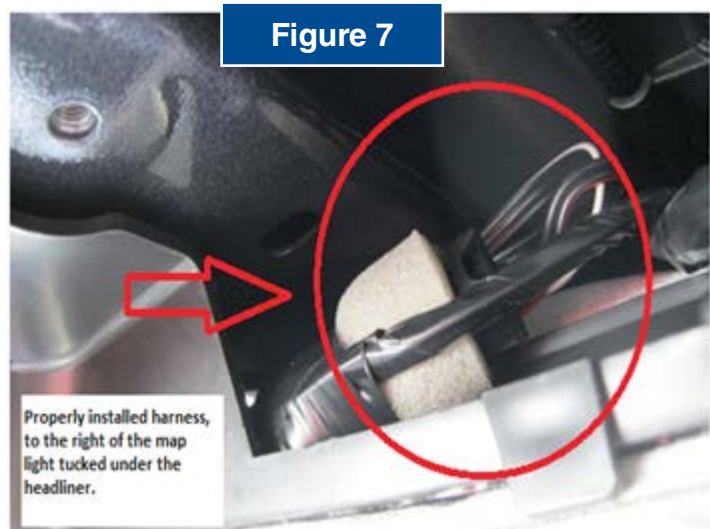
TSB 15-173-14 also includes detailed images of the harness damage, along with auto dimming mirror circuit testing when applicable. If inspecting this harness for damage, or replacement of the harness is necessary, it is required that the harness be routed correctly. **Figures 6 and 7** show the proper routing and placement of the roof harness and accessory mirror harness.

Keep in mind, not all vehicles are equipped with the accessory Auto Dimming and Home Link mirror but could exhibit similar symptoms if the factory roof harness is damaged. In order to eliminate the roof harness, a simple test would be to refer to the applicable Service Manual and use the split-half troubleshooting technique on the circuit in question.
