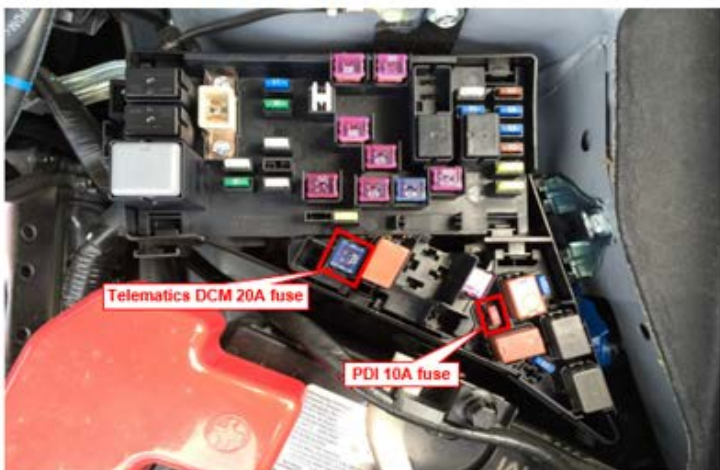
2016MY Forester N/A

The Techline has received a number of calls concerning vehicles with inoperative Telematics systems. A significant number of these vehicles were involved with retailer trades which may have resulted in an incomplete PDI at the original retailer. The associated claim details often described a missing Telematics fuse as the cause of failure. Reports have also been received on both Impreza and Crosstrek. For 2017MY Forester, both the amperage rating and location of the Telematics fuse found in the under-hood (M/B) fuse box have been changed. The system now utilizes a 10A fuse (vs. 20A in 2016MY). This change may also be causing some of the confusion as the PDI fuse is also 10A. In conclusion, it appears the 10A Telematics fuse may be getting confused with the 10A PDI fuse and removed in error but not replaced when the correct (PDI) fuse is identified and removed.

For Forester models, the Telematics fuse location changes are shown in the photos below. Reference photos are also provided for 2016MY Impreza, Crosstrek and 2017MY WRX (WRX uses a 20A Telematics fuse). The Forester's PDI fuse location is unchanged. If the Telematics fuse is found to be missing during the prep for sale PDI, install a 10A fuse as shown in the photos below and **always** confirm proper system operation before delivery. Please review this area with all your PDI Technicians, Get-Ready Personnel, and anyone else who routinely moves or removes fuses prior to test drives and / or vehicle delivery.
