ARTICLES CONTAINED IN THIS ISSUE

2017 SUBARU IMPREZA

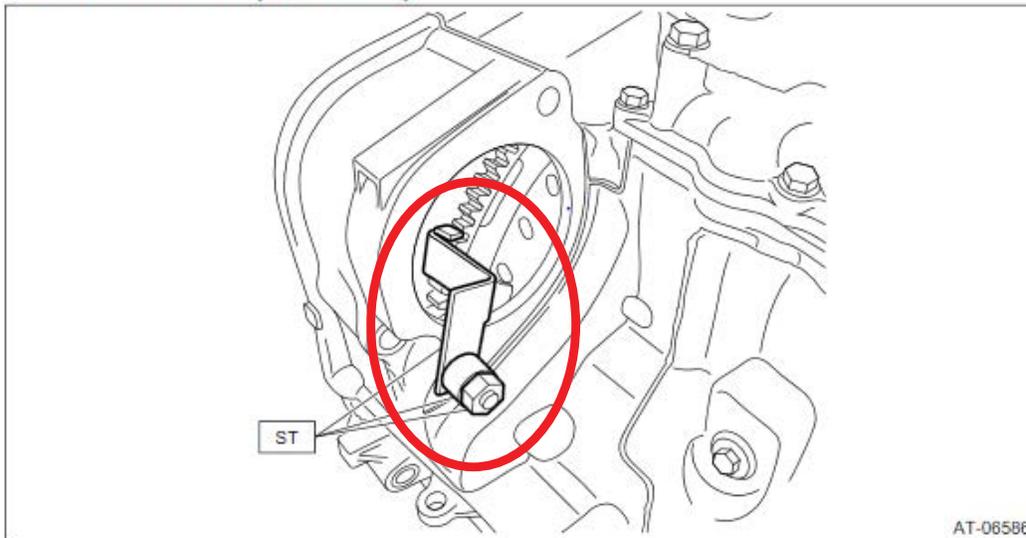
Figure 1 – From 2017 Impreza Service Manual Transmission Removal

During ANY engine or transmission removal, it is required you follow the Service Manual removal procedures. Recently, it has been brought to SOA's attention several CVT replacements have been needed after engine installation. Further investigation led to the conclusion that the CVT hydraulic oil pump was damaged due to the torque converter being dislodged from the pump drive gear. When installing the engine assembly, the torque converter was not properly reseated into the pump drive gear causing a binding condition, which ultimately led to pump failure. CVT hydraulic oil pumps are not a serviceable component, so CVT replacement is necessary to resolve the concern. When removing the transmission from the vehicle for any reason, the Service Manual states as follows in **Figure 1**:

14. Make sure the torque converter moves freely by rotating with finger through the starter installation hole.
15. Attach the ST to the converter case.

As seen above, the Service Manual shows the STOPPER SET (498277200) is required to be installed after removing the torque converter bolts and confirm the torque converter spins freely. Failure to install this tool could result in damage to the CVT unit as seen in **Figure 2**. Damage in this manner is not a matter for warranty.

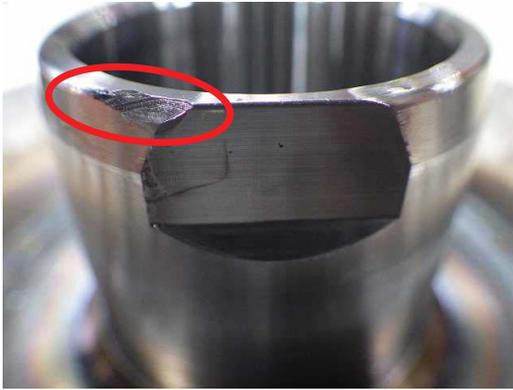
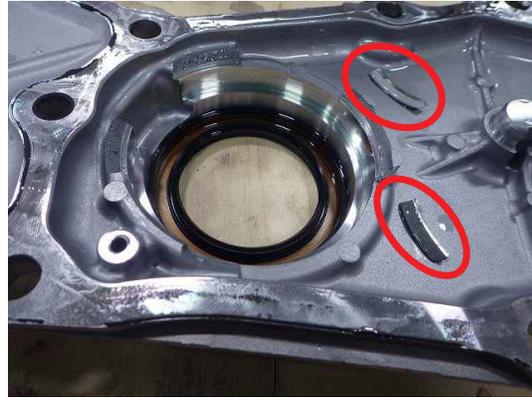
Figure 2 – Resulting Damage

Torque Converter

Oil Pump Chain Cover

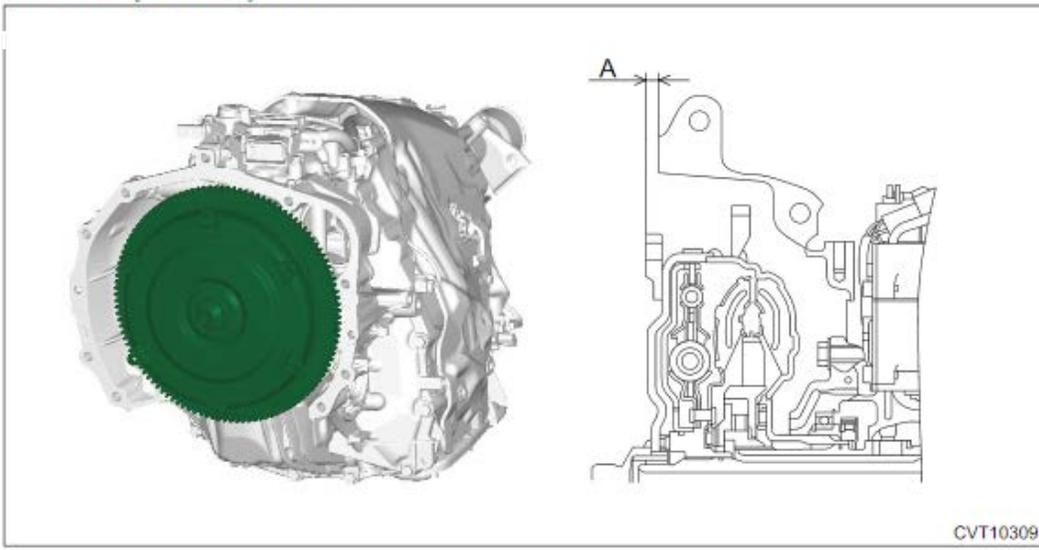
Figure 3 – From 2017 Impreza Service Manual Torque Converter Depth

If questioning whether or not the torque converter is fully seated into the CVT unit, the Service Manual provides an inspection procedure to confirm depth. **Figure 3** is directly from the 2017 Impreza Service Manual showing the procedure.

4. Measure depth "A", from converter case end surface to drive plate contacting surface.

6.8 mm (0.268 in) or less

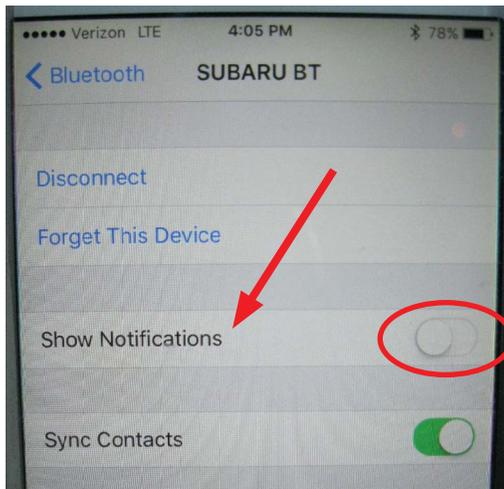
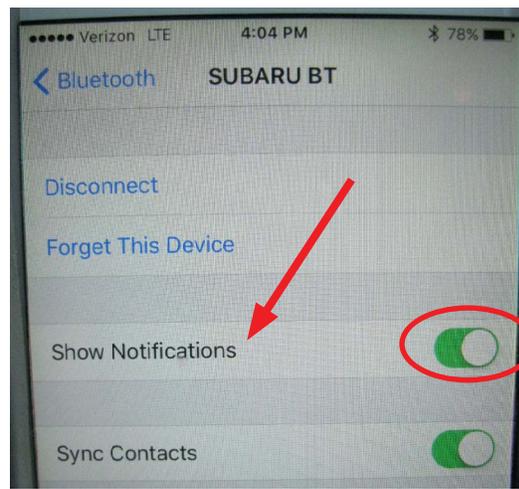
- The "Show Notifications" must be set to ON for the time displays to synchronize.

- Once "Show Notifications" is switched on, the device and vehicle clocks will synchronize automatically.

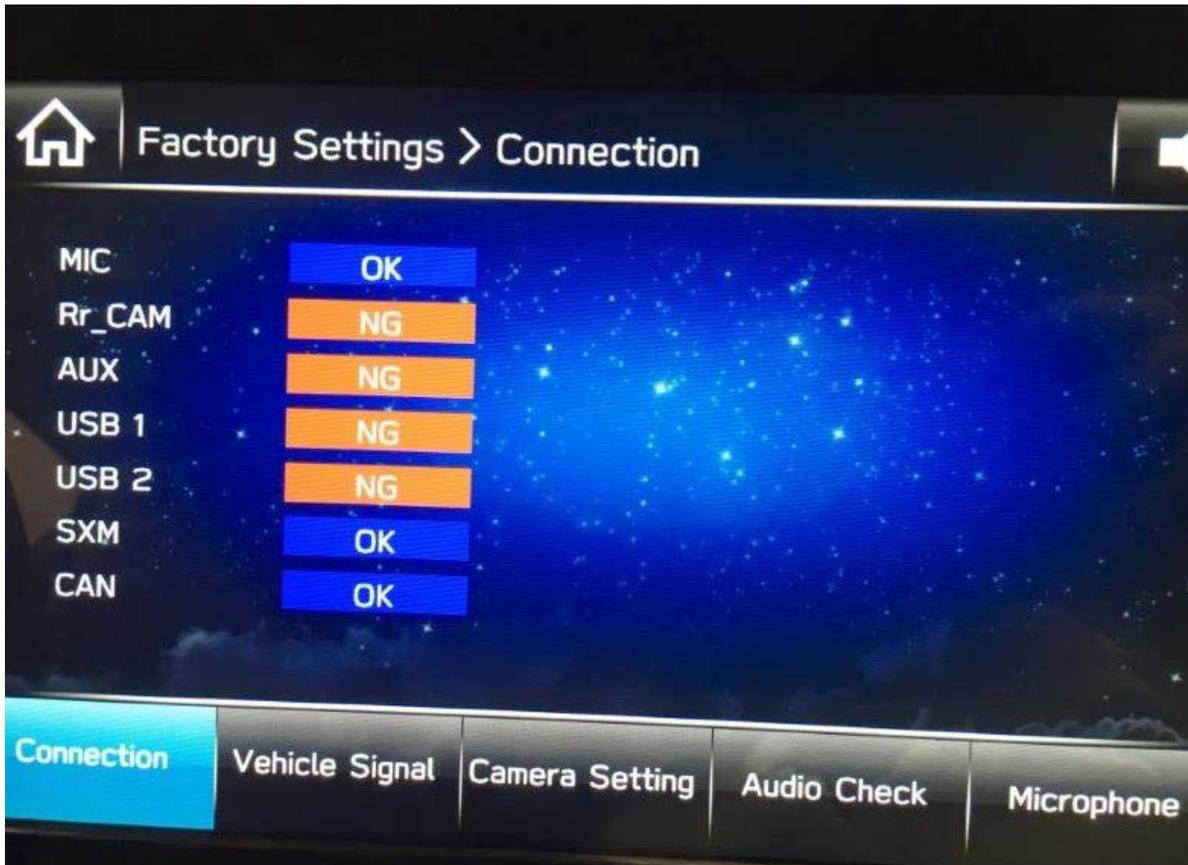
If you encounter an issue where the radio needs to be removed on a 2017 Impreza, it is important the Service Manual procedure be followed. The Service Manual advises to disconnect the battery before servicing the audio unit. If you fail to follow the instructions, you could have a customer concern of the backup camera is inoperative since the service. The reason for this is, when you connect power to the unit, a self-check is performed. If the backup camera has not been connected yet, the unit assumes there is no back up camera and renders it inoperative. If you run into this, a quick fix is to install the transit (PDI) fuse or remove and reinstall the negative battery terminal. The situation can be avoided completely by following the Service Manual and disconnecting the battery before the service.

CAUTION: The SXM ESN is assigned by VIN. Moving audio units between vehicles will disrupt SXM services. Below is an image of what you will likely see if a line check is performed before the issue is corrected:
