ARTICLES CONTAINED IN THIS ISSUE

SUBARU OF AMERICA

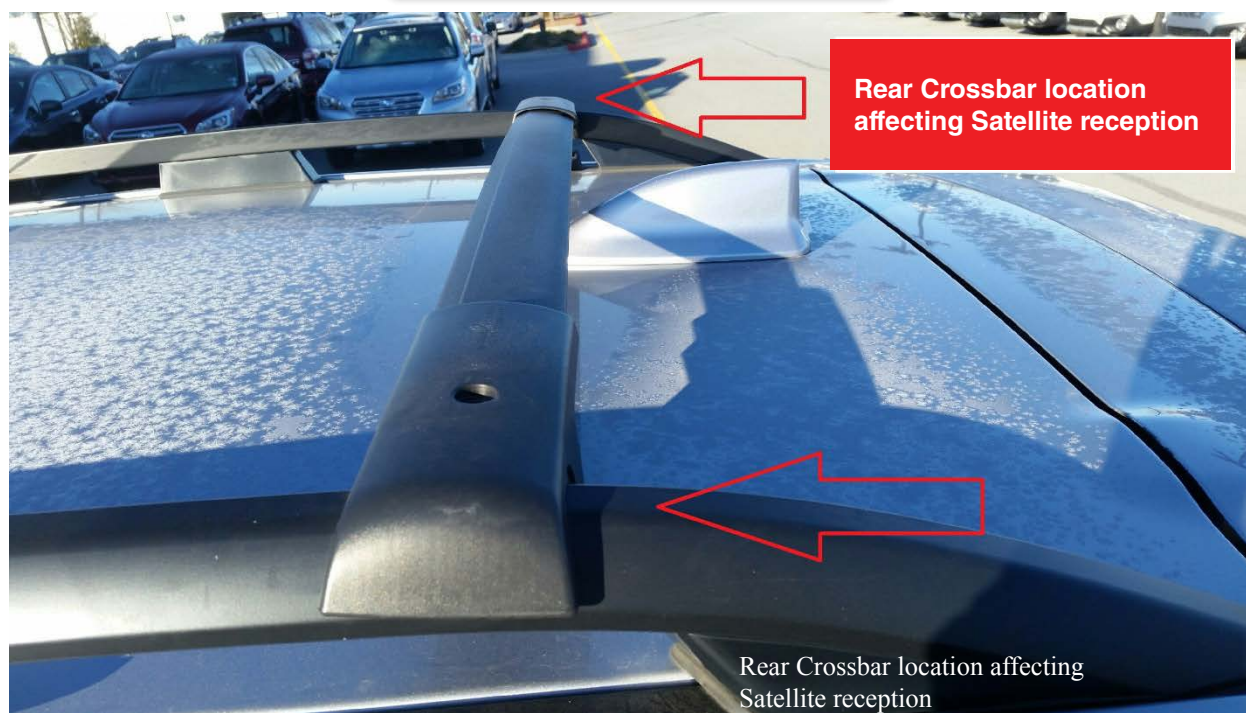
Figure 1 – Crossbar location

If you receive a customer complaint of their Sirius/XM cuts out or shuts off while traveling south, ask the customer if they recently moved the position of the rear roof rack crossbar. If the crossbar is in the rearmost position, there is the possibility of causing interference with the Sirius/XM signal reception. To test this, move the rear crossbar towards the front of the vehicle 3 inches, then test operation again. If the satellite reception has returned to normal, advise the customer positioning the roof rack crossbar in this location could potentially result in loss of satellite reception while traveling south. **Figure 1** shows the cross bar location affecting satellite reception.

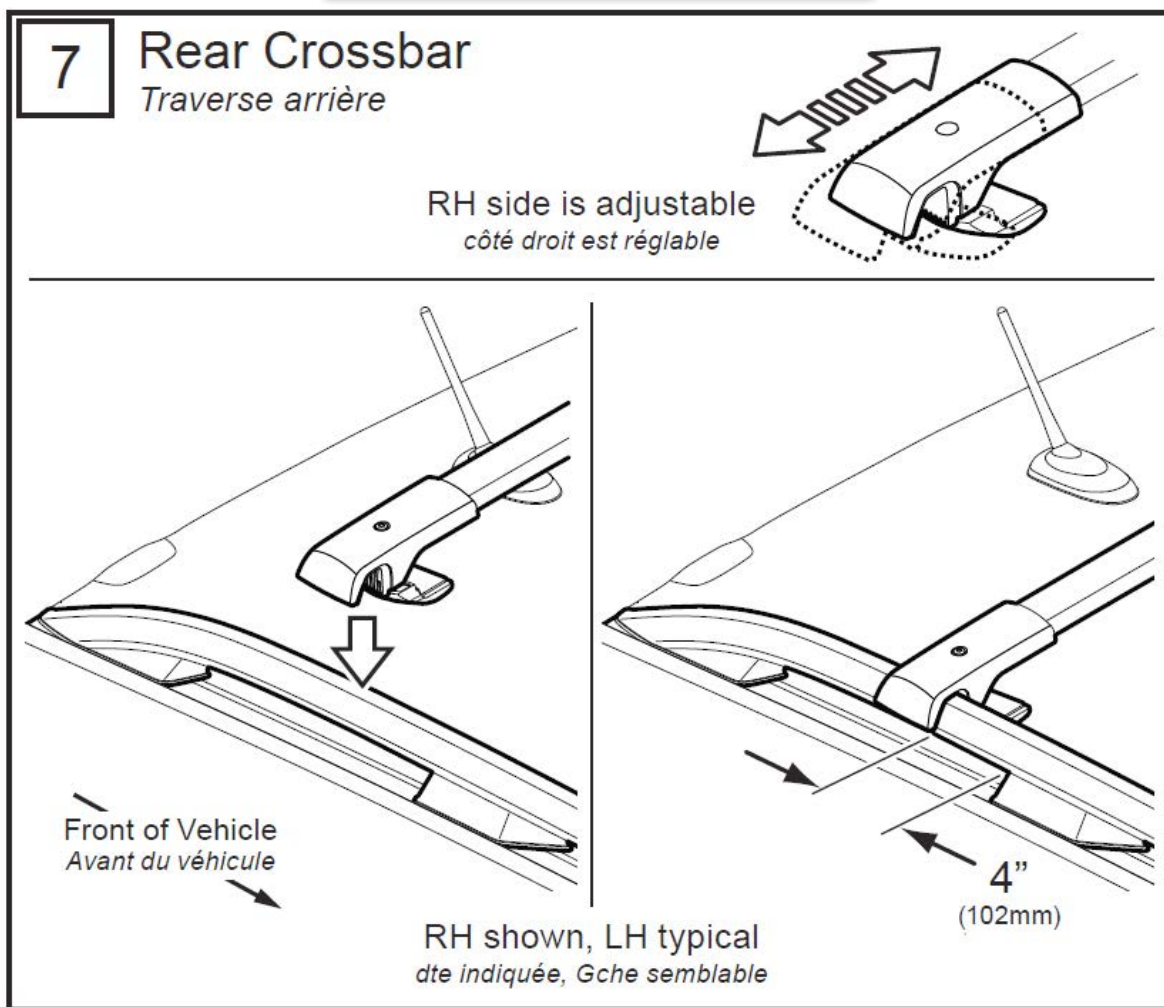
Figure 2 – Installation Crossbar location

According to the accessory installation guide shown in **Figure 2**, the typical location of the rear crossbar is 4" behind the roof rail base measuring point.

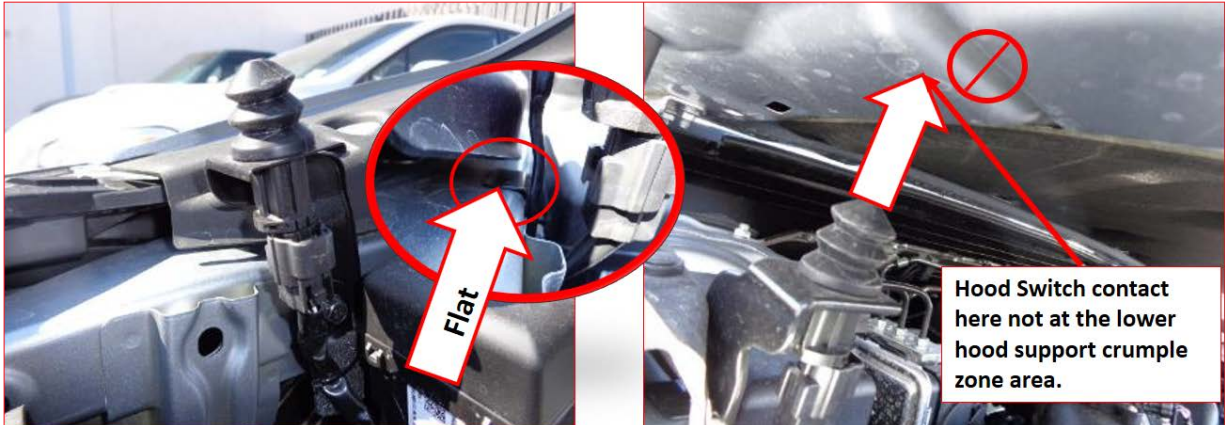
Figure 1 – Hood Switch Position Installed Correctly

The Techline has been receiving calls regarding vehicles not starting when using the Remote Engine Start (RES) intermittently. This symptom usually involves the vehicle's ignition powering up however, the user will receive abnormal feedback in the form of horn honks or transponder beeps. When encountering this concern, one thing to inspect is the hood switch placement. The hood has an indentation very close to where the hood switch sits. If the hood does not fully depress the switch when closed, the starting operation will be disabled for safety. To test operation, the hood switch can be ruled out by disconnecting the connector and attempting RES operation. If the vehicle starts normally with the hood switch disconnected, the next step would be to inspect the hood switch positioning. Be sure to follow the applicable instructions found in the troubleshooting guide and RES installation instructions during inspection (and possible replacement). **Figure 1** shows the correct installation of the RES hood switch while **Figure 2** shows the incorrect installation.
