ARTICLES CONTAINED IN THIS ISSUE

02 TOO MUCH OIL IN THE ENGINE REVISITED

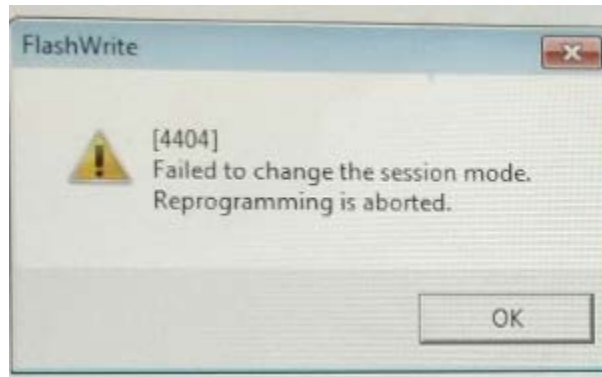
The Techline has received some calls from Technicians having issues with certain Pak files programming. The issue is usually accompanied with some kind of an error message. If this issue occurs, there are a few basic steps to take before attempting diagnosis.

07 PAK FILE ERROR MESSAGES

See example of error message below:

- Verify the correct PAK file and CID (where applicable)
- Make sure the GR8 has entered power supply mode and the battery voltage is stable
- Verify the CF Laptop is fully charged or being supplied a charge.

If you still have an issue after verifying the above, shut off the key, exit the vehicle, lock and unlock the car with the remote, then retry programming.
