### ARTICLES CONTAINED IN THIS ISSUE

### 01 QMR OF THE MONTH

## 12 MELTING PLASTIC PARTS

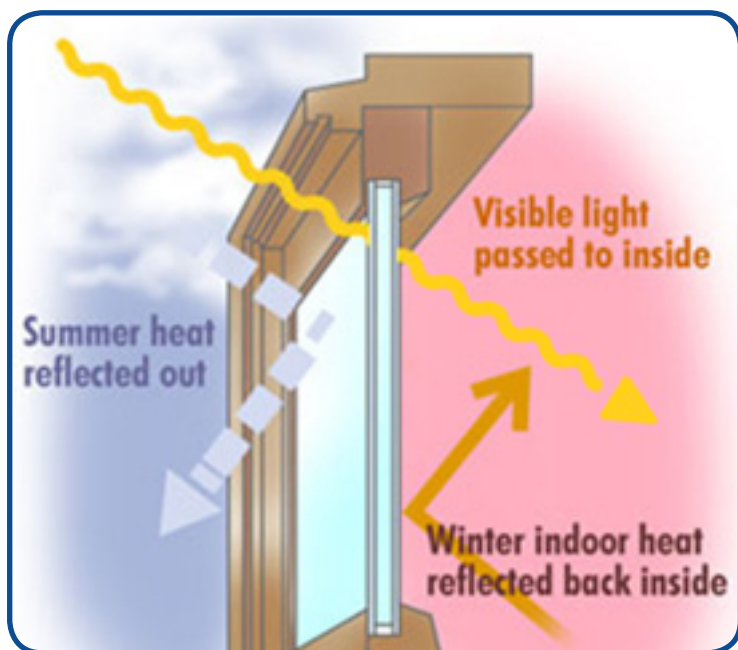
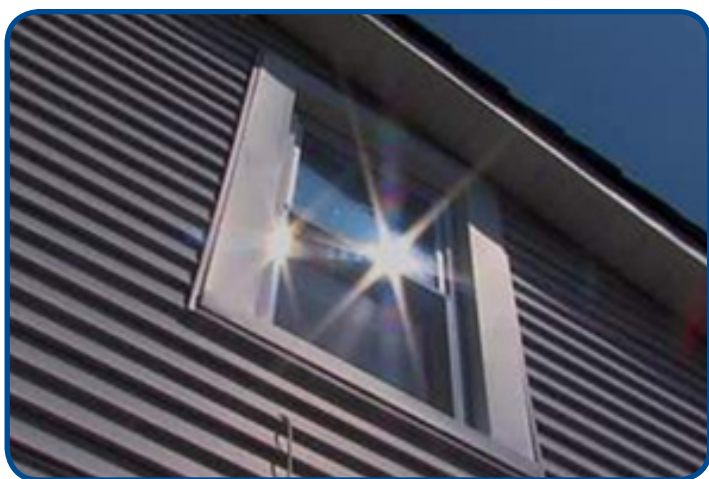
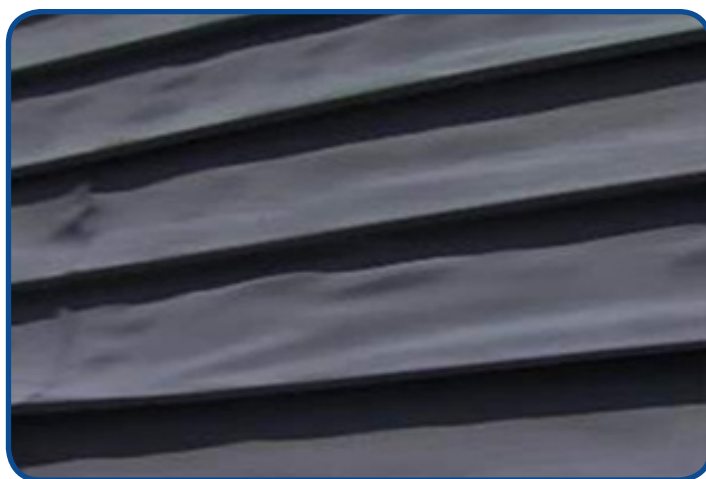
Under the right conditions, the heat from this concentrated sunlight reflection as shown on the left can reach up to near 180 degrees. That kind of concentrated temperature is more than hot enough to damage residential vinyl siding and in some cases, plastic car parts.

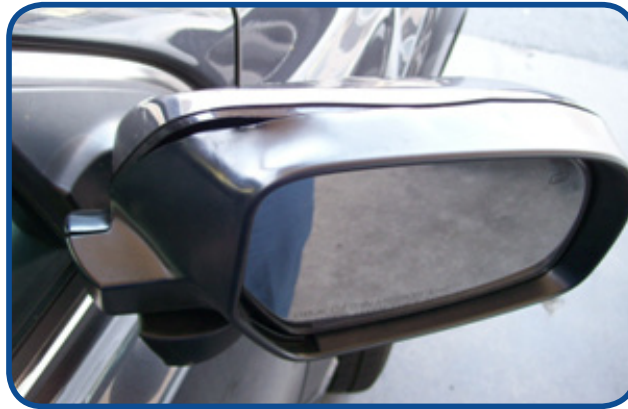
The photo below shows an example of a sunlight-damaged Subaru door mirror.

With springtime already here and summer on the way, you may experience these kinds of customer concerns at any time. Keep in mind, this kind of damage is not a defect and therefore, not a matter for warranty.

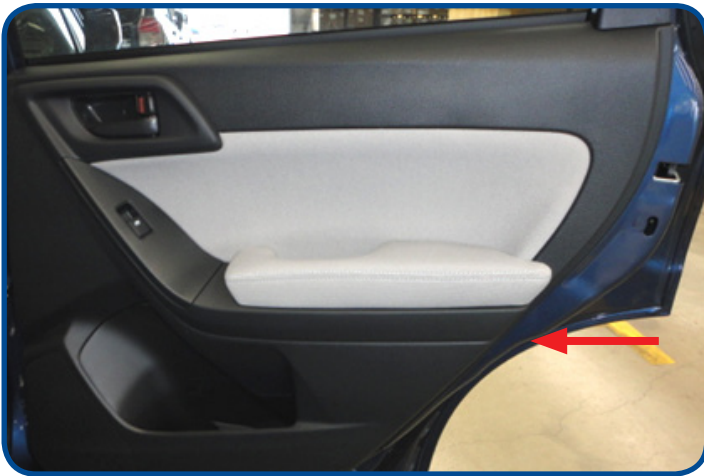
When removing the left & right rear door trim panels on the 2014 Forester, use caution to first release the clip designated below before releasing any other trim panel clips to avoid trim panel damage.

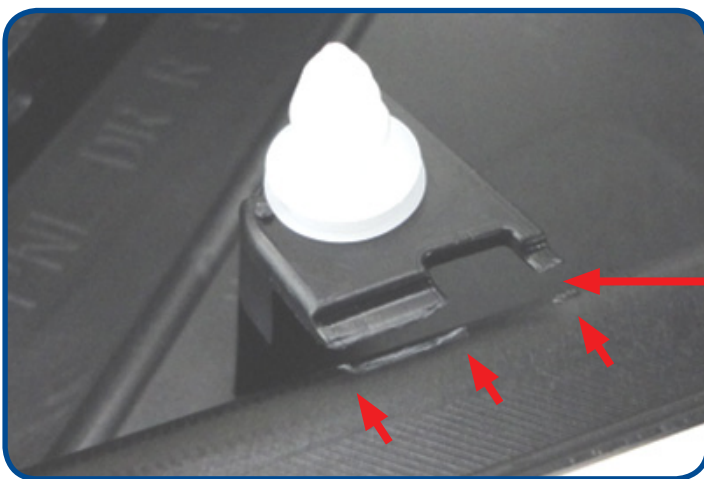
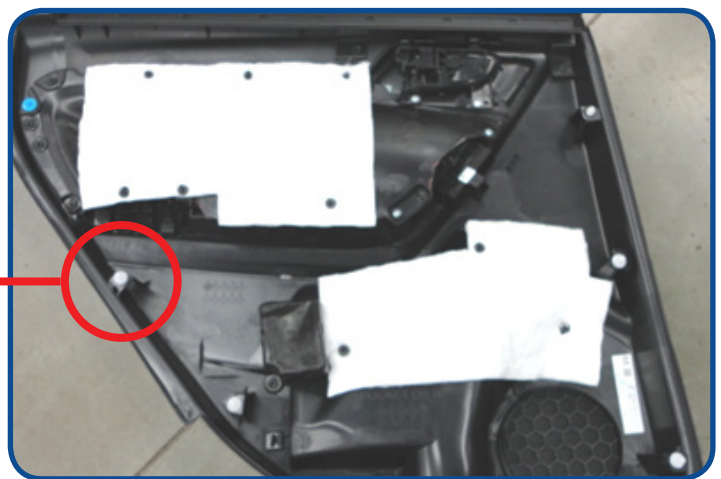
Without releasing the designated clip first, the molded clip support at this clip location is likely to break as per the photo above. The clip at this one location is much less supported than at all other rear door or front door trim panel clip locations.

Use a standard trim tool to widen the gap between the trim panel & the door panel near the clip location & then insert a slotted trim tool into place at the designated clip to carefully disengage the clip by twisting the tool.

This specific clip should be released first on both the right & left rear door trim panels. Then the other trim panel clips can be released by pulling with fingers while working around the edges of the trim panel normally.

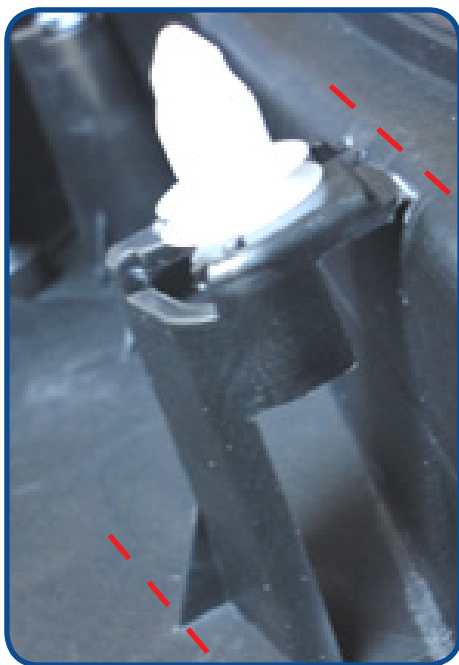
This one designated clip support is much less substantial than all other clip locations with support along two “lines” only

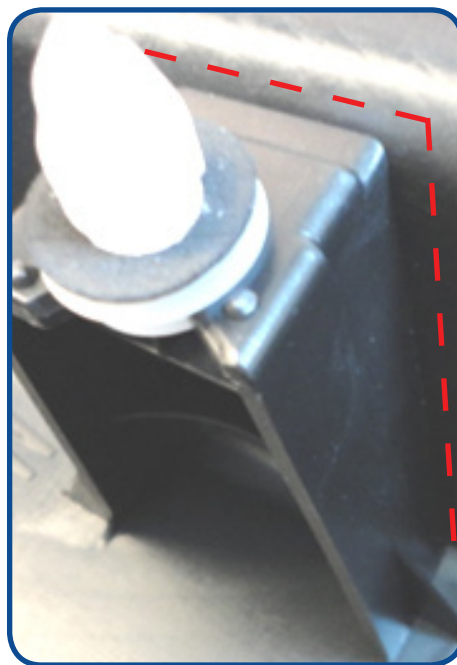
Other panel clips are much more supported in a variety of designs and we have encountered no damage to the supports at any other clip locations during panel removal

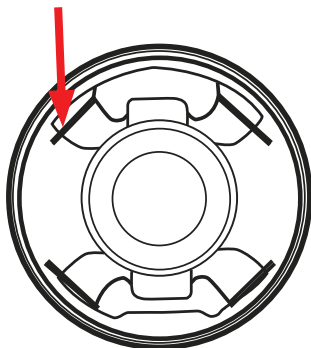
### Crack at 4 Positions

To further clarify the information that was released in May 2006 Tech Tips, it is not necessary to replace the bushings for cracks up to 15mm across the outside surface, and all the way through the bushing from one side to the other. The strength of the bushing is still 20 times stronger than specification. This information includes the current model (Legacy and Outback) with this style control arm bushing. Unless you receive a direct customer complaint regarding a suspension issue such as a knocking noise on acceleration or some type of noise generated when turning, you should not replace the control arm bushings based upon a visual inspection where cracks are found. Only replace the bushings when it is confirmed to have caused a problem and the customer has reported the problem to your dealership.

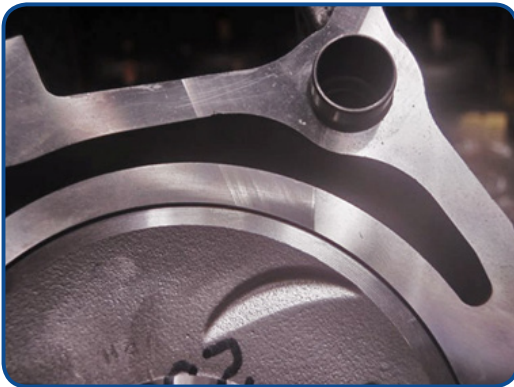
The deck surface of some remanufactured short blocks will sometimes exhibit a difference in finish texture, as shown in the picture.

This is caused during the remanufacturing process, when the cutter changes directions as it finishes its pass across the deck.

The change in textures can be differentiated with a fingernail, but it is a normal condition and the block can be installed without any issues.
