## ARTICLES CONTAINED IN THIS ISSUE

CODE	ARTICLE	PAGE
(00)	STIS New Releases	8-9
(01)	QMR of the Month	1-2
(01)	QMR of the Month Award Presentations	2
(01)	2019MY Forester Quality Monitoring Team New Model Launch	3
(01)	2019MY Forester: Auto Start- Stop and Driver Monitor System Diagnostic Information	4
(07)	Ascent Automatic Wiper Rain Sensor Initialization	5
(11)	2019MY Ascent: DTC P0606, Control Module Processor: Diagnostic Hints	5
(15)	Fujitsu/Denso 10 iPhone Contact Picture Display- Update	5
(15)	Sirius XM List and Voice Tuning Concerns on Gen. 2 & 2.1 Denso (D10) Audio Units	6
(15)	2019MY Impreza/Crosstrek Remote Engine Start (Key Start) - Control Module Installation	6-7
(16)	Service Manual Correction: Rear Transmission Crossmember / Transmission Mount Removal- Impreza and Crosstrek CVT Models	7

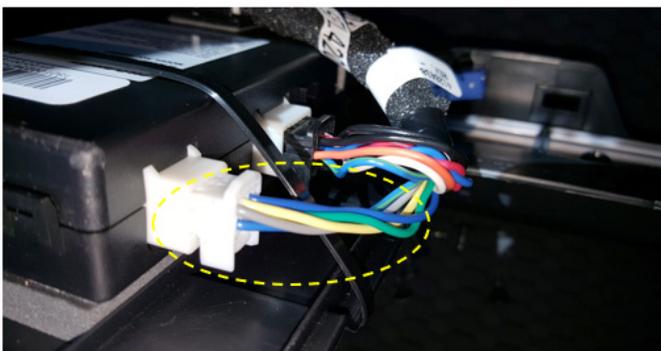
**Current Condition:** If proper care is not used when mounting the RES Control Module, the RES connector/harness could come in contact with a factory metal bracket following reassembly. SOA recommends a quick visual inspection of this area once the glove box inner cover is replaced. See below, Figure CC.

In the event of a “no-start” condition using the vehicle key, and vehicle fuse #33 (7.5A) in the main fuse box is blown, check the RES harness insulation (gray wire, pin 5 of 8-pin connector) for damage or potential short to a metal bracket. Remove and replace damaged harness if necessary.
