## ARTICLES CONTAINED IN THIS ISSUE

## 12 2015MY LEGACY / OUTBACK SEAT HEATER OPERATION OVERVIEW

## 13 PAINT CONDITION ON HOOD – MOISTURE STAIN

## 15 2019 FORESTER REMOTE ENGINE START CHANGES AND PRECAUTIONS

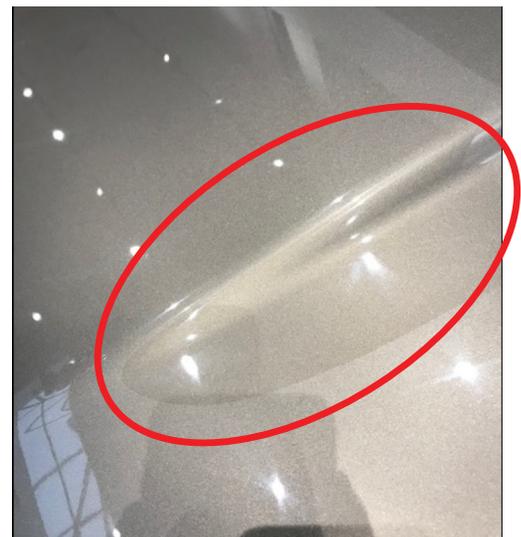
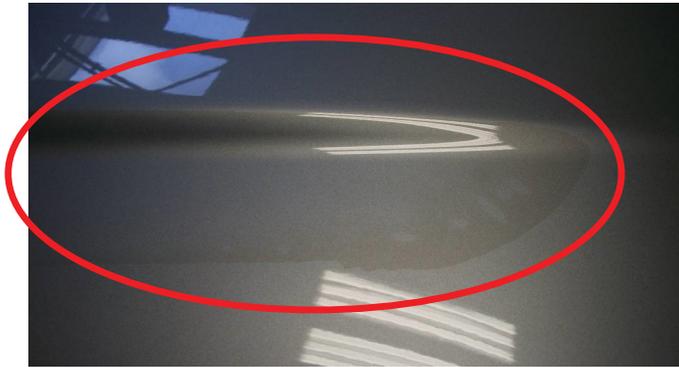
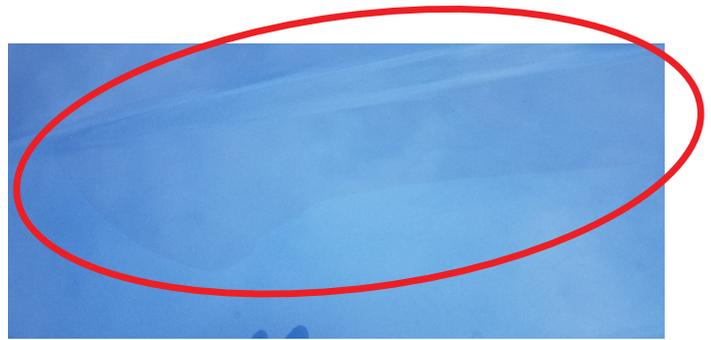
Retailers have reported several 2019MY Foresters with a paint condition found on the hood which appears to be a stain. This condition is actually a result of moisture intrusion into the paint. This condition may occur if water becomes trapped under the wrap guard on the hood for an extended period of time. If you encounter this condition, at first, place the vehicle outside where the hood will be exposed to direct sunlight for at least 2-3 hours to allow the moisture to be drawn from the hood. If this is not possible or the condition remains after direct sunlight exposure, CAREFULLY use a blow dryer or heat gun to GENTLY apply heat to the affected area to help draw the moisture out. Using this method, the stain should be gone after a few minutes. A blow dryer is recommended to avoid overheating or burning the paint.

To the right and below are some pictures of cases which have appeared in the field. Stain conditions are outlined in red.

Please be careful to not apply too much heat too quickly. To help minimize this risk, do not hold heat source too close to the surface or hold the heat source stationary (keep the heat source moving constantly).

**IMPORTANT:** Never attempt to remove this condition by buffing, sanding, or application of chemicals as this will only serve to damage the paint.

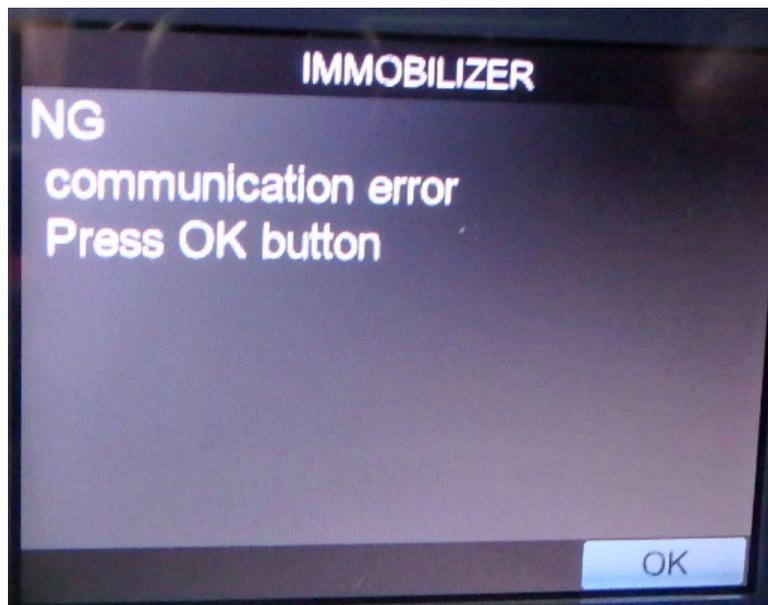
- Using the Denso DSTi Box, selecting 2019MY Forester and attempting to initialize the RES Push Button Start (SMART) system was not successful. A “No Good Error Code” message was displayed; see the DSTi Box picture below. Unplug the DSTi box and start over to initialize the RES system. Start by entering 2018MY Forester then selecting Immobilizer and the RES Push Button initialization will be successful.
