SPECIAL EDITION

10 2020 OUTBACK/LEGACY COCKPIT GEN1 INFOTAINMENT SYSTEM: HELPFUL OPERATING TIPS

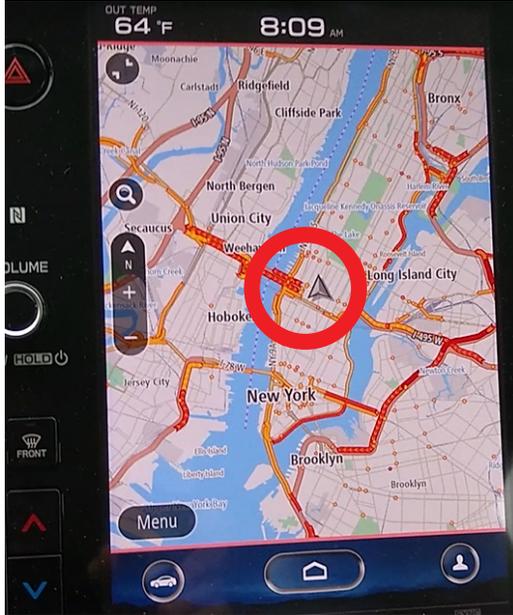
It is possible during Delivery Mode for the NAVI GPS display to show Manhattan, NY location all the time. This is a default setting for GPS in this mode. Other indicators of Delivery Mode are the arrow is gray color and clock is off. If a customer presents with this concern, confirm the PDI fuse is in the delivery position and not open.

Following Delivery Mode or Memory Initialization
(map icon is gray)

After the PDI Fuse is moved, the GPS starts receiving a signal to update the map to the current location. As soon as the GPS receives the current location, the map icon will turn cyan (blue/green) and the clock resets.

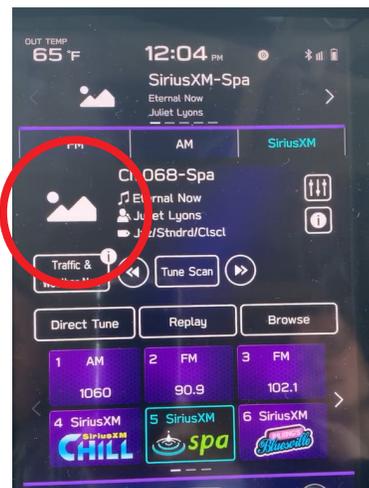
It is a normal characteristic for the SXM station artwork to disappear from the Cockpit Gen1 (CP1) Gen4 infotainment system CID when the vehicle is in motion.

Artwork is NOT displayed when moving

Please explain to customers this is a normal operating characteristic intended to reduce distraction. Replacing the head unit will not change this characteristic.

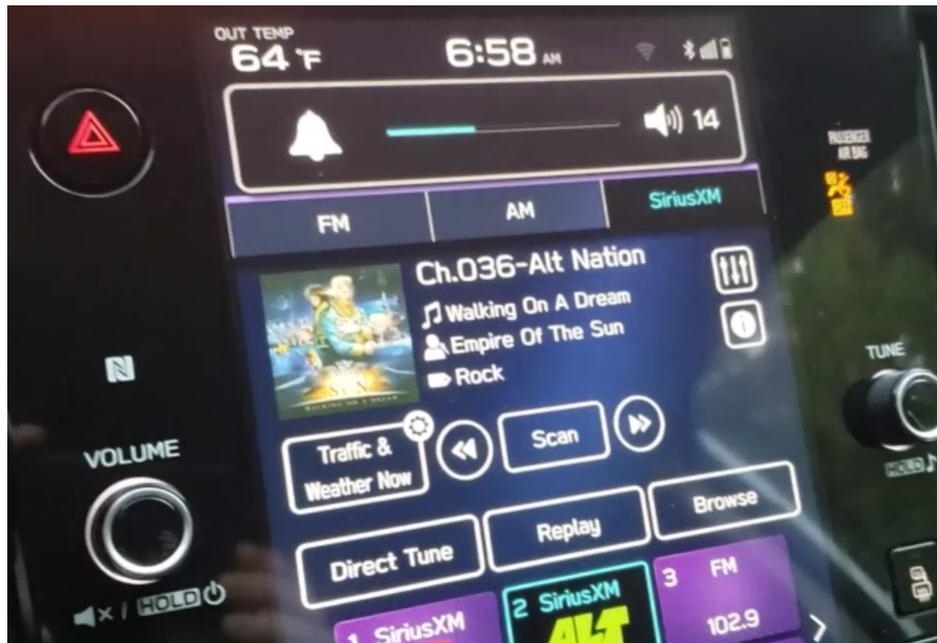
There are instances while using Android Auto when the audio volume intermittently cannot be adjusted. Instead, the notification volume is being adjusted when the volume control knob is used as shown below.

This condition can occur because Android Auto operation is being prioritized over the Cockpit Gen1 (CP1) Gen 4 infotainment system. This condition is temporary and will clear eventually. To expedite clearing and regain faster volume control for the audio source, there are some work arounds. One option is to relaunch Android Auto by disconnecting and reconnecting the phone to the CP1 system or short press the Talk button to start the native VR and say “cancel” after the beep is heard. The procedure from the Owner’s Manual regarding sound output shown below can also be used. Replacement of the head unit will not prevent this condition from occurring. Always confirm the customer has the latest Android Auto and Google application updates installed on their device as regular enhancements are released to ensure the best experience when using Android Auto.

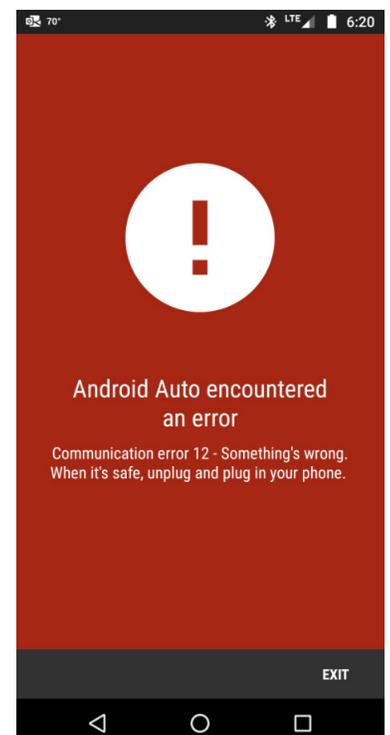
Reports have been received regarding a communication error message displayed on the phone as shown below.

When this message is displayed on the phone after connection to the Cockpit Gen1 (CP1) Gen 4 infotainment system, the Android Auto application fails to launch. Investigation has shown the source of this error is on the phone side and could be resolved by re-syncing communication disconnecting and reconnecting the phone. The communication error number (12 shown in the example) is irrelevant. Please explain this to the customer, when reviewing a similar issue. Replacing the head unit will not resolve this condition as it is not the cause of the error. It is a good practice to confirm an undamaged genuine cable is being used to connect the phone as well as the phone is properly set up to accept connection with a new vehicle.
