Articles Contained in this Issue

02 P0507 After Engine Service, Abnormal Idle Speed

02 Rough Idle with AVCS DTCs

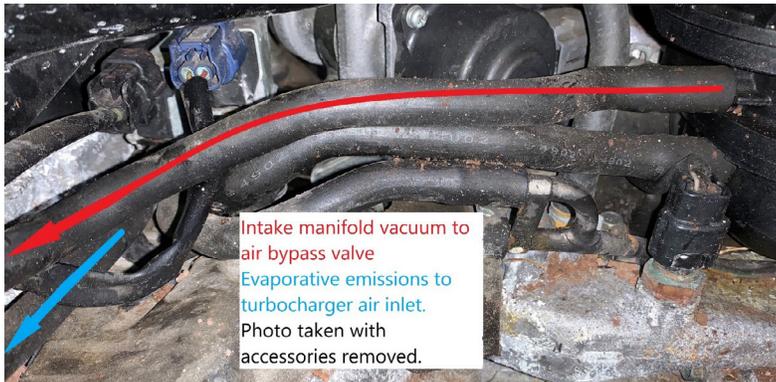
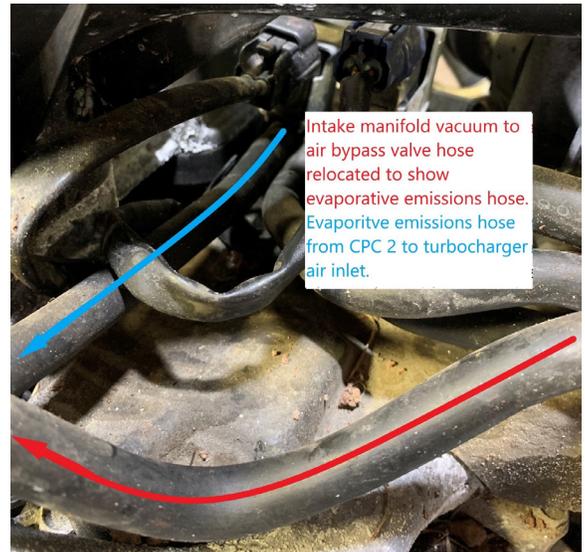
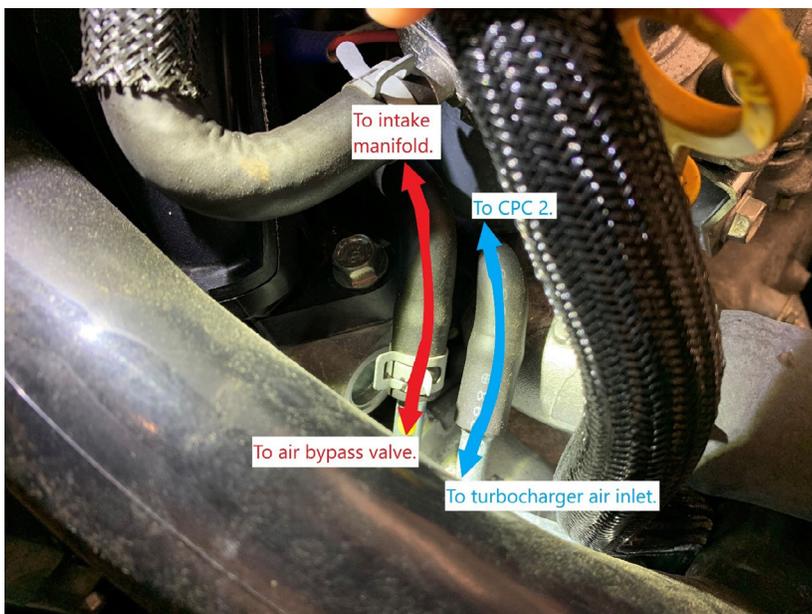
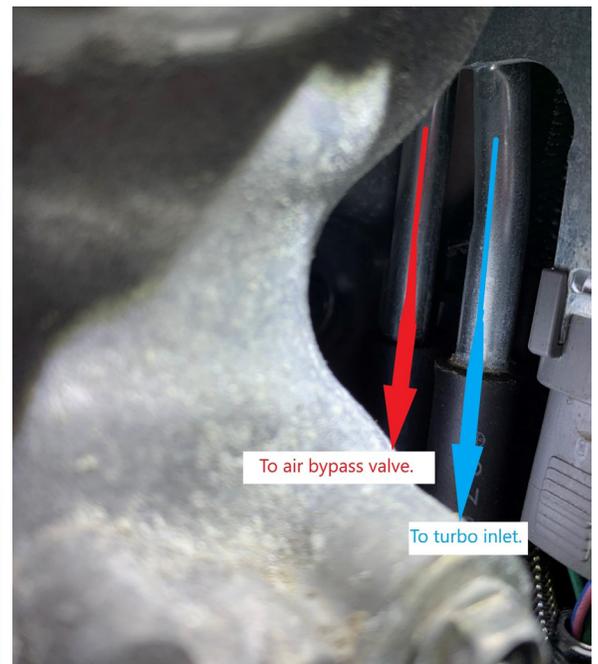
When servicing the 2.0L turbocharged, direct-injected engine, a common mistake made by Technicians will result in an abnormal idle and may set DTC P0507 Idle control system RPM – higher than expected. When removing the timing chain cover there are two vacuum hoses that run parallel to each other and transition to a metal pipe then back to rubber hoses before connecting to the turbocharger air inlet and air bypass valve.

These hoses come from canister purge control solenoid #2 and the intake manifold. When the hose intended for CPC 2 is connected from the turbocharger air inlet to the intake manifold it causes an internal vacuum leak. Normally, this hose would be sealed from the turbocharger air inlet by the CPC 2 solenoid valve.

When the air bypass valve hose is connected to the CPC 2 solenoid the air bypass valve will not operate. The best way to avoid these costly mistakes is to mark the hoses or take photos before removal.

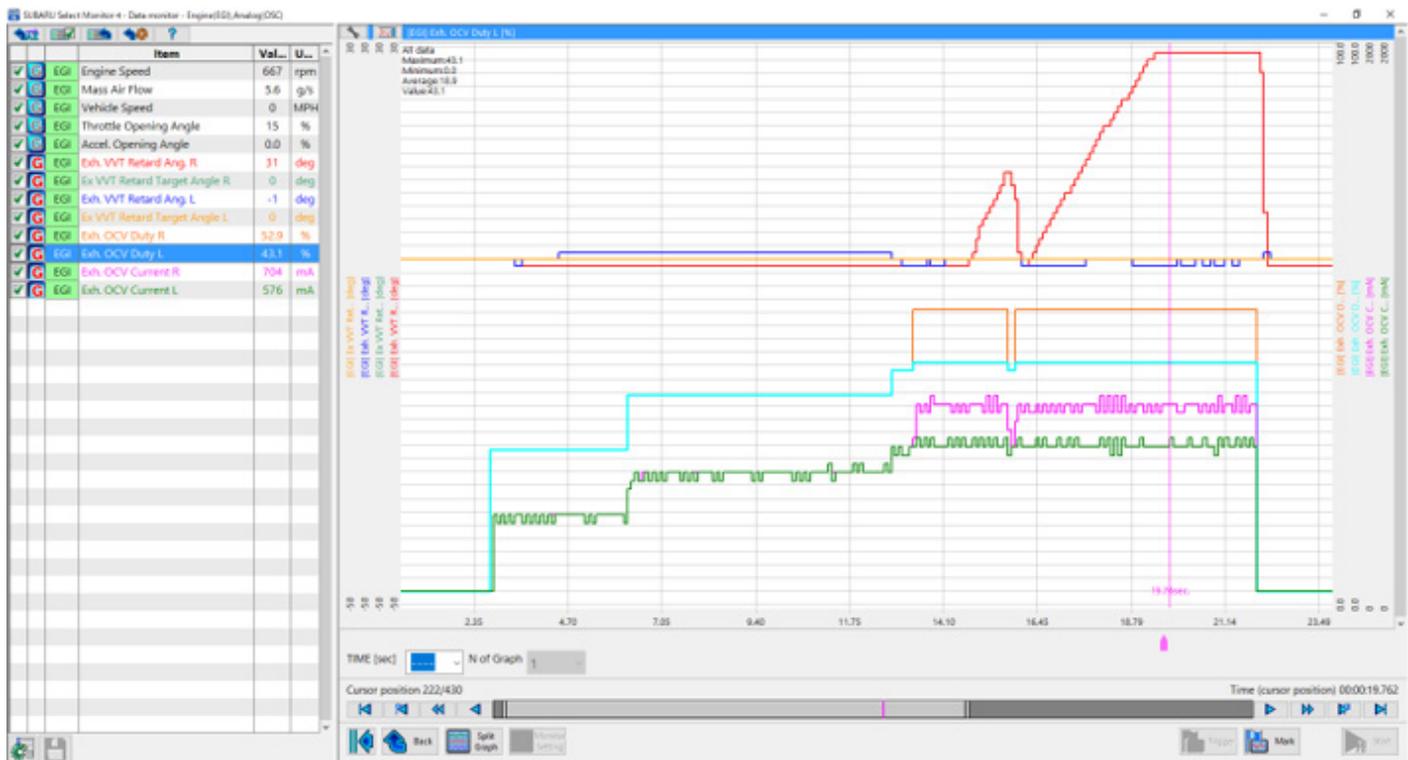
When diagnosing AVCS DTCs P0014, P0024, P000B, P000D or P0017, P0019 there is a possibility of a rough idle with the check engine light illuminated. The rough idle is due to false learning caused by a high deviation from the VVT exhaust retard angle at idle. If the VVT angle is excessively deviated from the target angle the learning will be affected and may cause a rough idle. The diagnostic method for this condition is as follows:

1. Check all DTCs and record all ECM PIDs while idling and driving with the engine at operating temperature.
2. Clear the ECM memory.
3. Record another ECM data file with all PIDs selected.
4. Confirm the rough idle is no longer happening after clearing the ECM memory.
5. Refer to the appropriate trouble tree if the rough idle is gone.

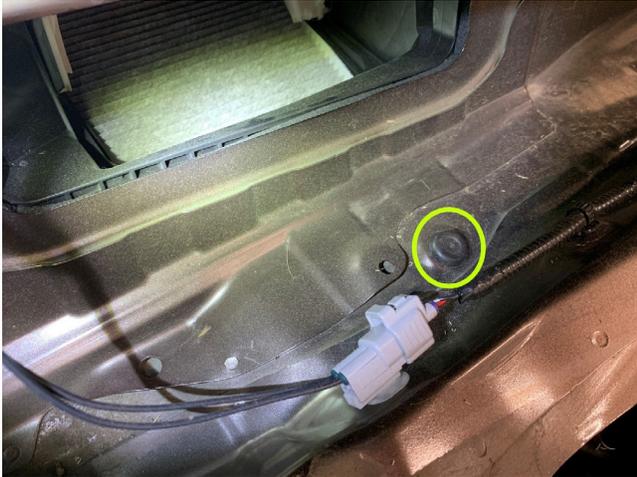
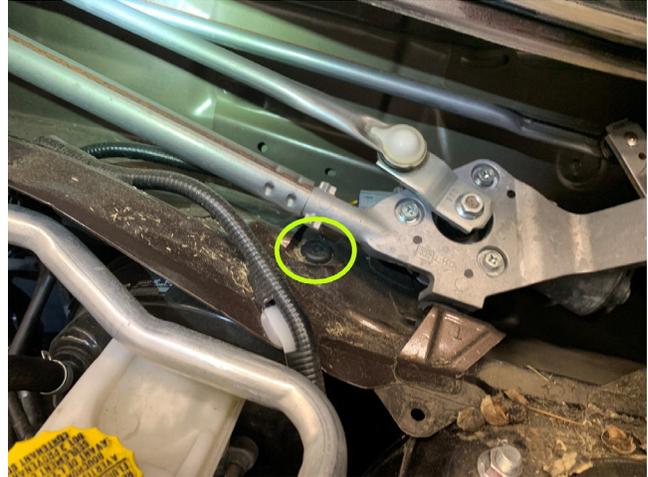
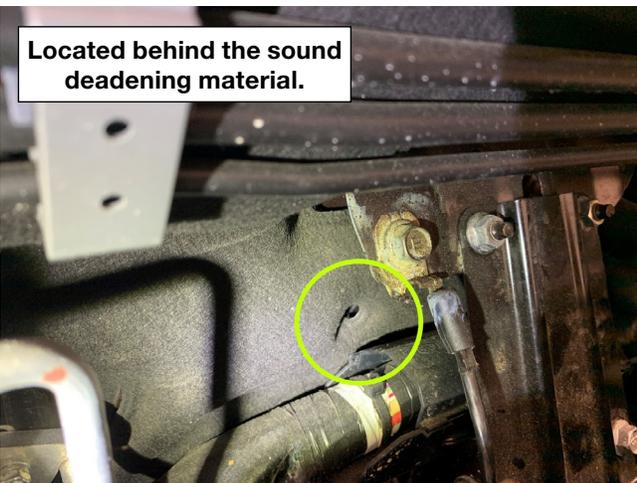
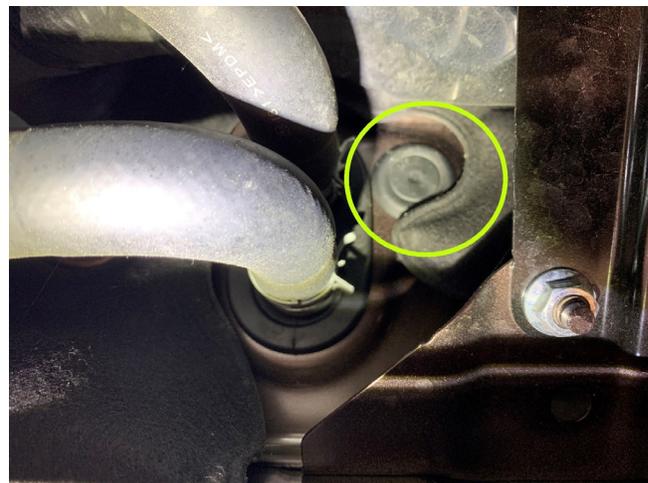
The Techline has received a few calls with customer concerns of a wind rushing noise while driving at speed. In some cases, this noise will fluctuate when the HVAC mode is changed from recirc to fresh air. During the Technician's diagnosis, the cowl area should be inspected. There have been isolated cases where some of the body plugs were missing or not installed.

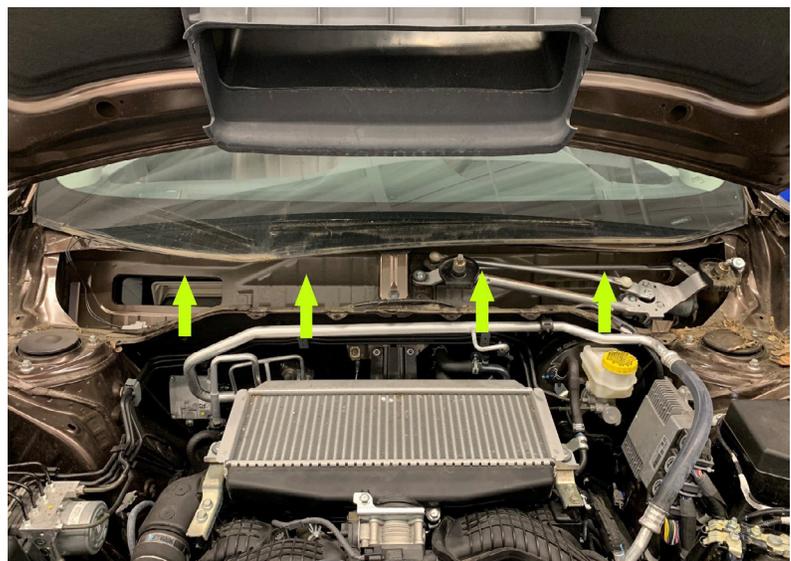
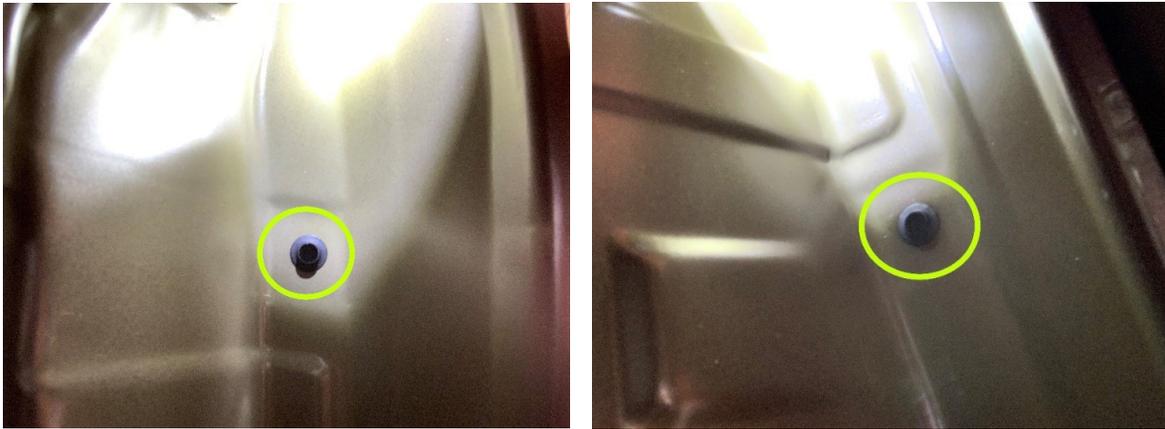
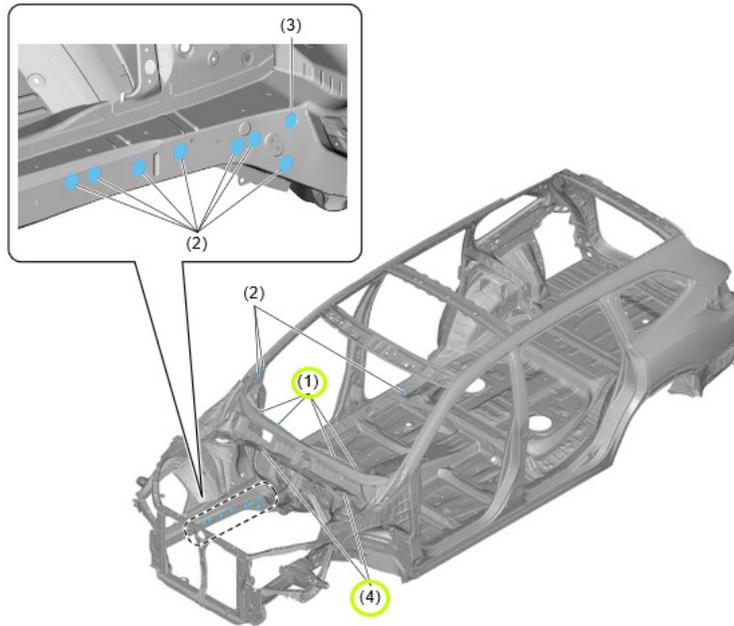
Remember to check the upper part of the cowl under the windshield. These plugs are smaller and can easily be overlooked. There are four located on this model and examples are found below.

Technicians can refer to the **Body & Electrical/WIRING SYSTEM -> Body Structure -> Plug/Grommet Sheet** section for proper plug / grommet location and types. In all cases where any are found missing, a QMR should be submitted.
