Articles Contained in this Issue

10 Recovery of Contaminated R-1234yf

12 Water Leaking Into Cabin From Door Trim- All Models and Model Years

15 Remote Engine Start/ Power Rear Gate Inoperative on Push to Start Vehicles

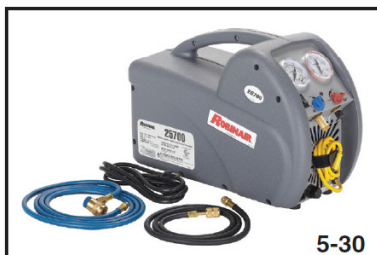
Contaminated Refrigerant Recovery Machine

When the system identifies the refrigerant is contaminated, a special procedure is required for recovery. Please use the Instruction Manual for the Robinair® AC1234-6 or the Robinair® AC1234-9 for specific instructions on how to recover the contaminated refrigerant.

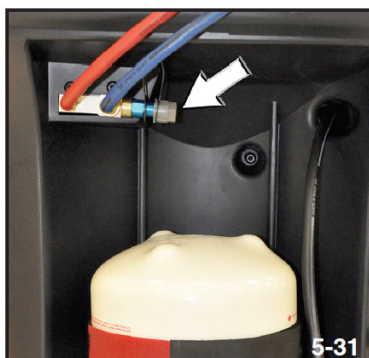
Contaminated Refrigerant Recovery Machine Connection Port

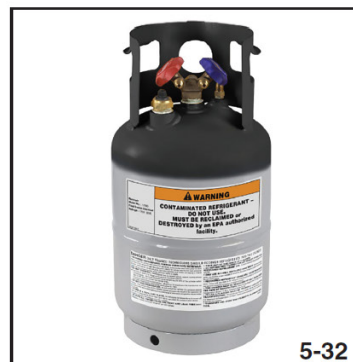
Contaminated Refrigerant Recovery Tank

NOTE: Recovery tanks for contaminated refrigerant are gray with a black top.

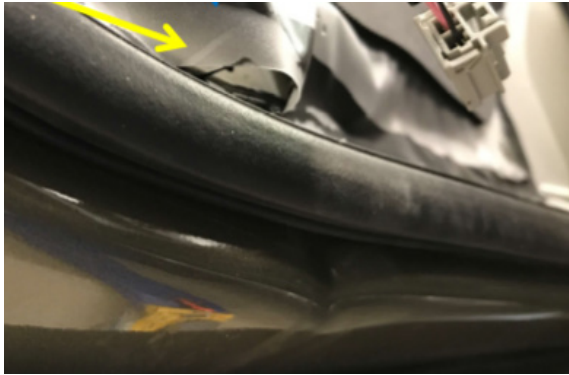
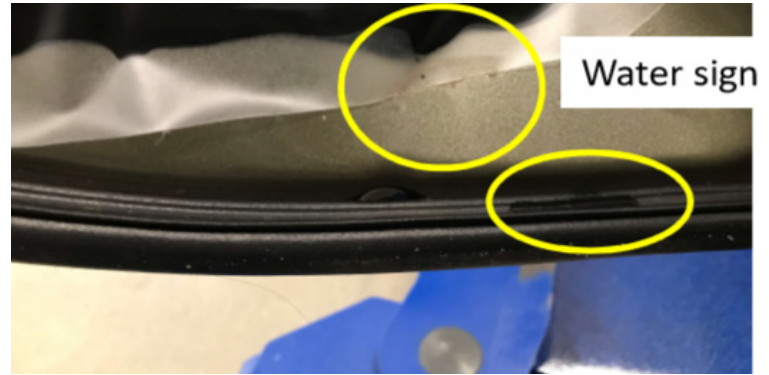
When a customer is concerned with water dripping from the door panel to side-sill or into the vehicle, do not overlook the sealing cover installation. Gaps in the cover's sealant can create a route for water to escape. This condition has been identified on all four doors and in some cases multiple doors on the same vehicle. When encountering this condition, first verify the door drain is free and clear by water testing. Water test with the window glass fully closed and the door open. Pour water down the glass from the outside of the vehicle. There is a small drain hole at the bottom of the door that water should drain from. If it does not, clear the drain and test again to confirm if debris blocking the drain was the only concern or not. After water testing the door and verifying the drain operates as designed, CAREFULLY remove the door trim panel and visually inspect the sealing cover. If inspection finds any gaps in the sealant, do not replace the sealing cover. Instead repair the condition by carefully removing and reinstalling the sealing cover (making sure to apply even pressure around the parameter of the cover) then visually verify there are no remaining sealant gaps. A final water test will confirm the is repair.
