Articles Contained in this Issue

01 QMR of the Month

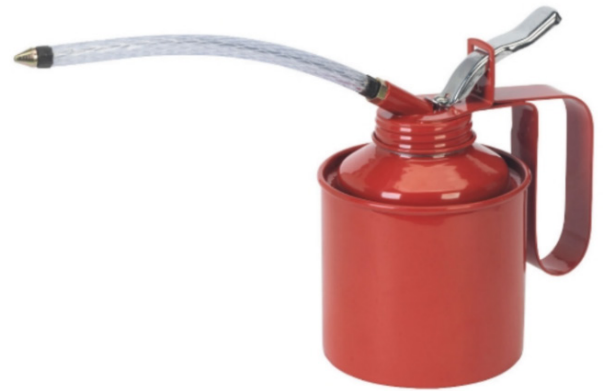
2. Short block inspection and preparation.

When removing the engine from the crate, inspect the cylinder walls and machining. Make sure no damage to the mating surfaces is found (gouges, sever pitting, etc). If no lubrication is found on the cylinder walls, apply a thin coat of clean engine oil to the cylinder wall surface with an oil squirt can. **DO NOT use a rag or fiber towel.** If a large puddle of oil is found at the bottom of the crate, or in the plastic wrap, apply a light coating of clean engine oil across the crankshaft journals (engine upside down). This should be done before any other components are installed onto the short block. After application, rotate the crankshaft clockwise one full rotation (still upside down) to have gravity help move the oil down onto the bearings. The crankshaft keyway should be returned to its original starting point (continuing in a clockwise rotation) to coincide with engine timing chain installation. **Do not rotate the crank shaft counterclockwise other than when instructed in the timing chain installation instructions.**

Be sure to review 02-157-14R, starting on page 7, for valuable information about cleaning, inspection and assembly of chain driven engine components.

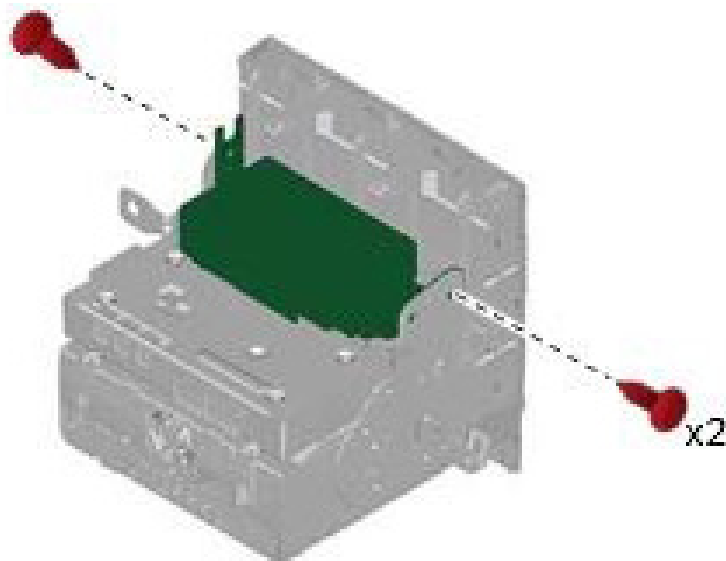
SL-11076

Techline has received calls about identifying a newly implemented device for the door lock system. The Battery Back Up power source was implemented into vehicles outlined in the chart below. The Battery Back Up unit provides power to the door locks in the event of a collision that disables the standard 12v power source. When the vehicle receives a strong impact, all the doors and the rear gate are automatically unlocked, so as not to trap the vehicle occupants. The device is mounted above or near the audio unit in most cases. Refer to STIS for specific model removal/installation, and inspection.

Note: When the ignition is turned on, the capacitor in the device is charged for 90 seconds.

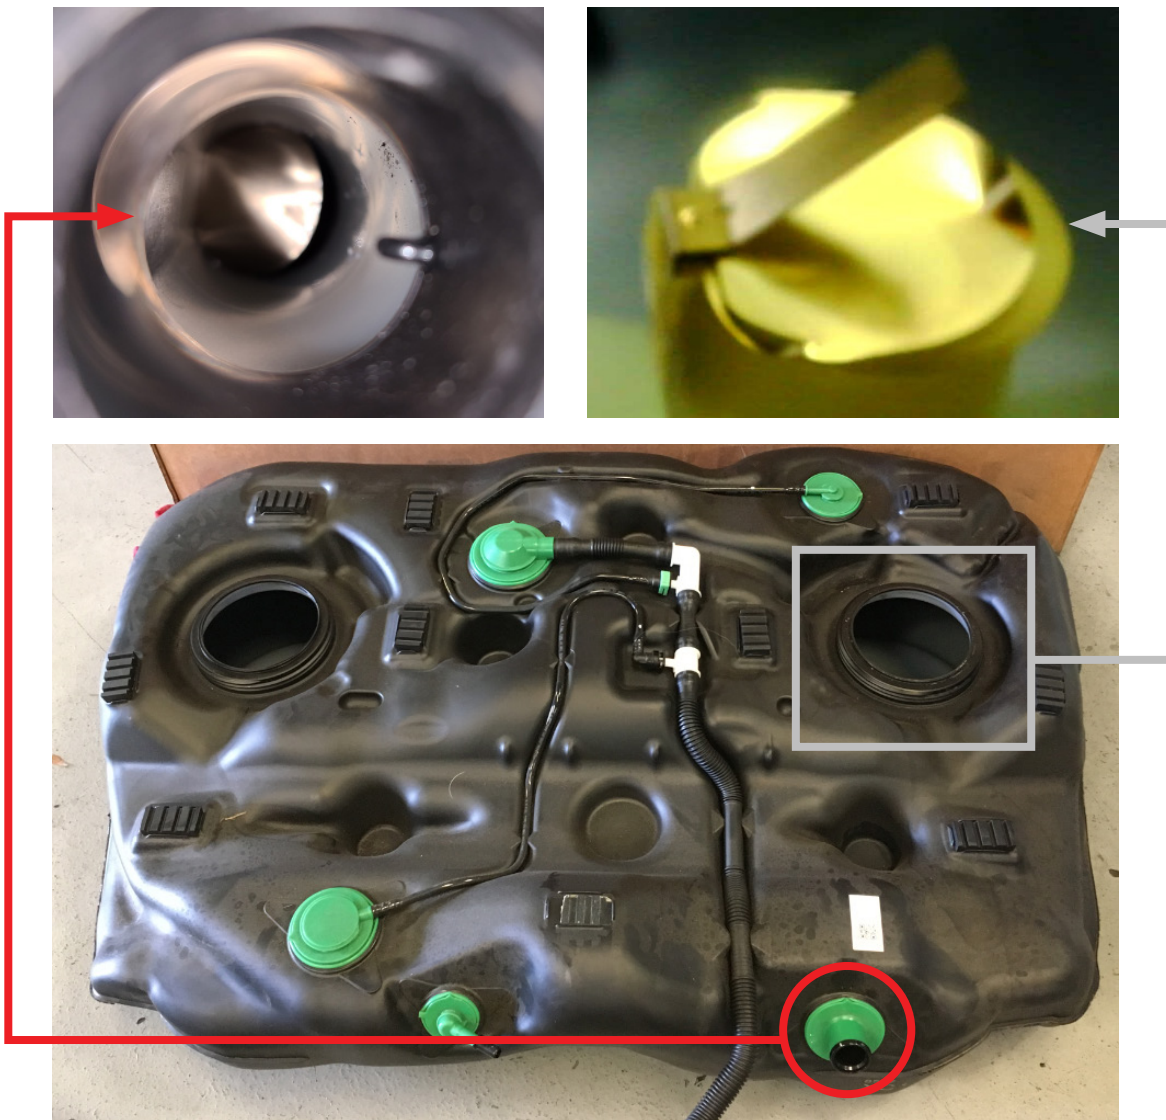
If encountering a vehicle with a customer concern of difficulty filling the fuel tank, do not overlook the July 2017 and September 2017 Tech TIPS. If the filler neck, EVAP vent line and EVAP filter are free and clear, look at the internal flapper valve of the fuel tank. This can be done easily with a borescope. Start by removing the inlet hose off the tank and perform the inspection. Confirm your findings by removing the fuel pump and inspecting the flapper valve from the inside of the tank. The photos below are an example of a deformed flapper valve.

Deformed valve

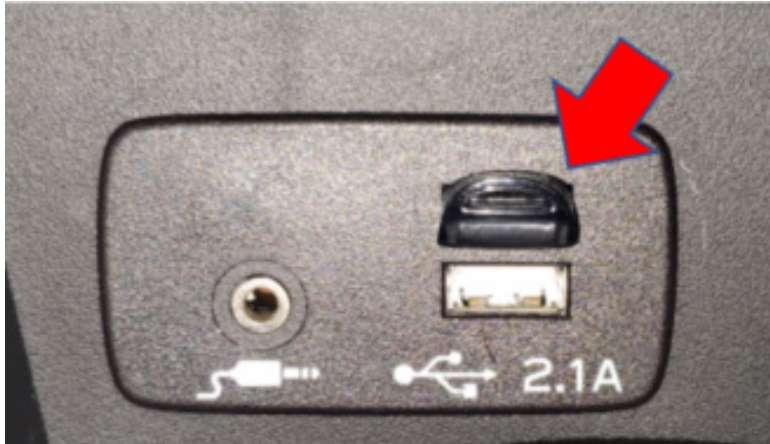
Example:

Prior to performing a software update via USB thumb drive, please check the USB Port for the presence of conflicting accessories (ex: additional thumb drives, chargers, etc.). Please remove all accessories connected to USB Port prior to performing update. Leaving conflicting accessories connected while performing an update may result in black display or the update failing.

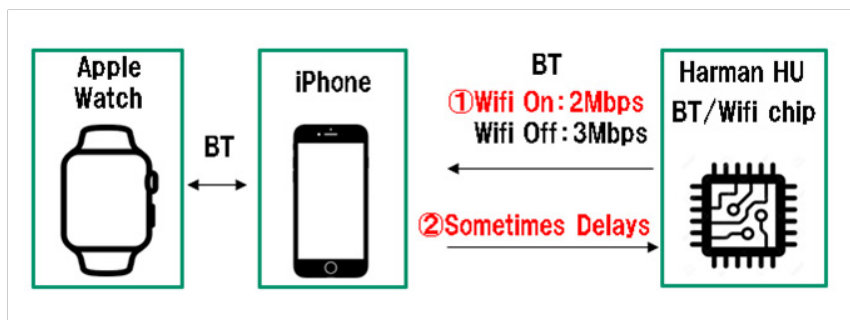
➤ Gen 3 BT streaming stuttering issue update aka BT Skipping with Apple watch paired

Techline has received reports from the field regarding stuttering/skipping concern while a customer is streaming music via Bluetooth connection with phone device. It was found the concern was consistent when the customer had their Apple Watch paired via Bluetooth to their phone device, and their Phone Device Paired via Bluetooth to the Head unit.

- For item 1, please request to confirm Wi-Fi status and verify the concern is duplicated with Wi-Fi OFF.
 - Temporary work around: set Wi-Fi to OFF
- For item 2, Apple is preparing a permanent fix. No schedule is available.
