### Articles Contained in this Issue

## 01 QMR of the Month

# TECH TIPS GREATEST TIPS

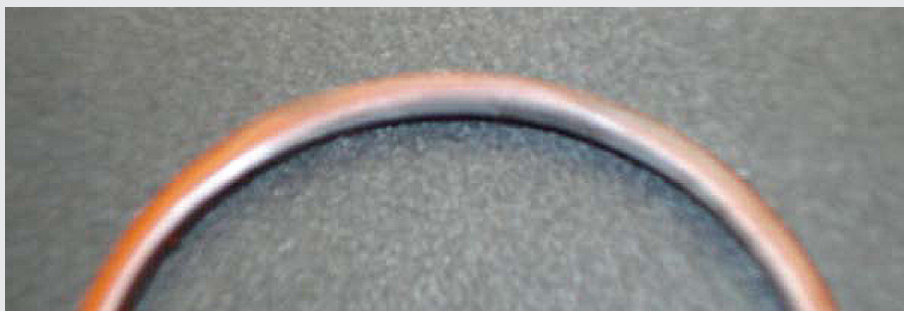
If you encounter a 2005 or newer M/Y turbocharged vehicle experiencing a Check Engine Light for DTC P0171 and/or a customer complaint of rough running for a short period after start-up when cold, check for a vacuum leak at the intake manifold. The complaint has been noted primarily in northern climates when the outside temperatures are often below freezing. There is an orange rubber o-ring type intake manifold gasket used between the plastic upper intake plenum and the tumble generator part of the intake manifold. In some cases, idle quality was compromised. At times the SSMIII showed a 25% enrichment from the A/F sensor and a slightly lower MAP reading. After removing and separating the intake components, a dirty, blackened tracing could be seen where the leak was occurring (see photo). Symptoms would diminish as the engine warmed up. After replacing the o-ring gaskets, readings returned to normal and idle quality was restored.

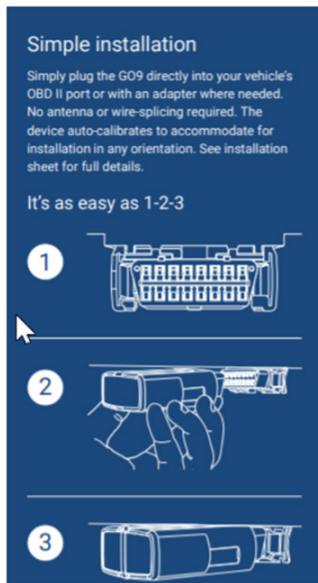
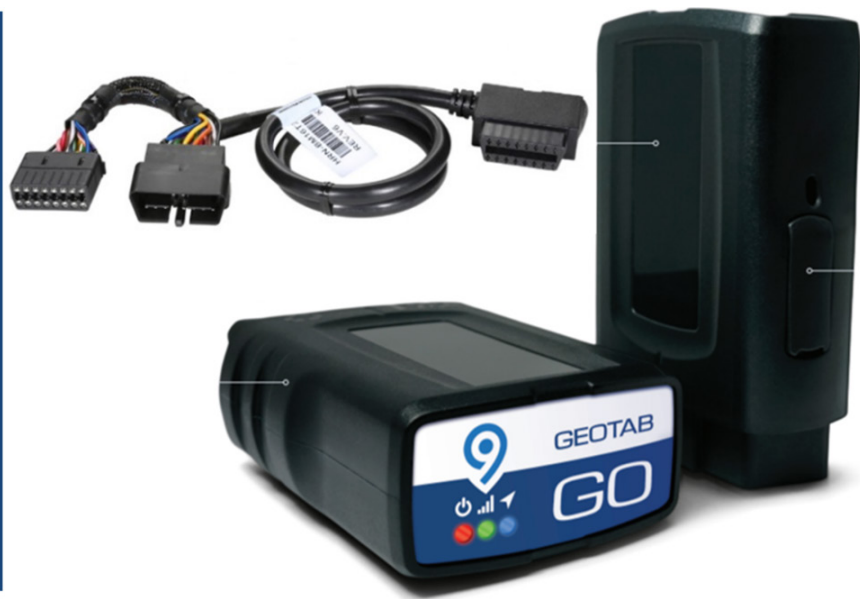
GeoTab is a brand name for a device used commonly across many vehicle manufacturers and fleet organizations. GeoTab has worked directly with SOA Fleet Sales, to ensure the best possible operation of the device. It is used for several purposes: insurance tracking, fuel mileage logs, maintenance, and for taxes. There are currently no known concerns associated with the use of a GeoTab device on Subaru vehicles. Recently, Techline has been informed that retailers are refusing to diagnose vehicles for conditions if the GeoTab is found to be installed. These conditions vary widely, from Apple CarPlay connectivity to CVT Chain Slip, as being related to the use of the GeoTab device. All conditions reported were later resolved through normal diagnostics when the GeoTab was still installed/connected. The device had no bearing on the conditions presented. The initial refusal to diagnose the vehicle resulted in an easily avoidable poor customer experience for those fleet drivers. Never refuse to diagnose vehicles equipped with GeoTab branded devices. If after performing diagnosis related to the condition, and you believe there may be a concern specifically related to the GeoTab device reach out to Techline for further review.

If a vehicle with a GeoTab device is brought into the shop for a concern, simply unplug the OBD portion from the OBD port while any SSM Diagnosis is being completed. If the device is hardwired, and the OBD port is not blocked, there is no need to attempt removal. Perform an All-DTC scan and visual inspection. If a communication code (U0XXX) is found with no obvious signs of failure, e.g. the SSM cannot establish communication with a particular module, diagnosis the concern as it presents. If no clear fault can be found after completing the related Service Manual Diagnosis, only then should it be recommended further testing be performed without the device installed.

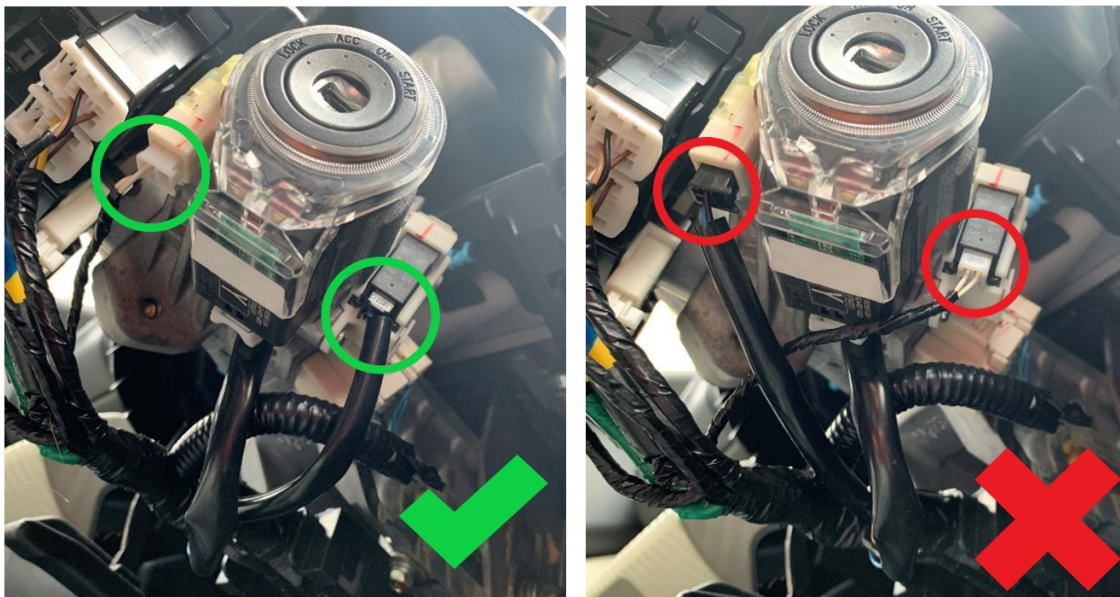
It has been brought to Techline's attention that some models have identical connectors at the Key Lock solenoid connector and Key Warning switch connector. If these two connectors are interchanged at any point, multiple systems can become inoperative. One of the most likely situations in which this could happen is during an ignition cylinder replacement or RES installation.

If the connectors are switched, there are two main concerns the customer could experience. First, the keyless entry will become inoperative because the BIU sees the key warning switch is always active. Second, the key chime does not function at all **OR** functions continuously even with the key physically removed. It is important to note the keyless entry will only work if the key is out of the ignition.

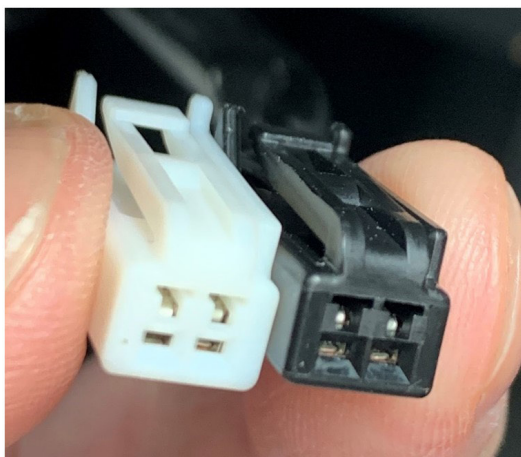
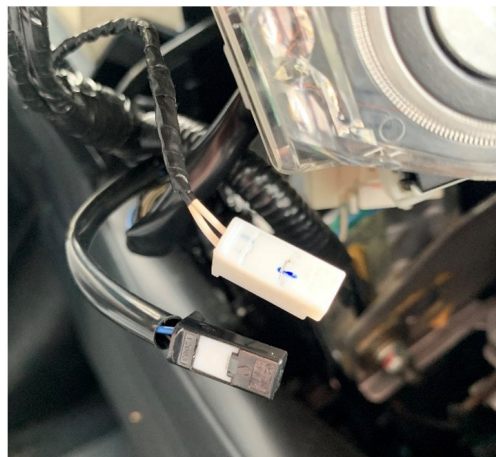
The other BIU live data PID that will need to be inspected is the Key-Lock Warning SW. The Key-Lock Warning SW will never switch to "OFF" if the connectors are installed incorrectly. If this is found to be the case, the next step would be to review the wiring and perform a visual inspection of the connectors.

**NOTE:** All pictures here are for reference. Different models may have the same connector color. The connectors are the same shape and pin count. It is a recommended practice to mark these wires with tape during disassembly, so reinstallation is correct.

A quick reference table has been made below to identify 'like' connectors in this situation only. Additional guidance can be found in the "Shift Lock Control System" section on STIS for the vehicle being serviced. It is highly recommended to match the wire colors to the correct connector. Always consult the appropriate service manual on STIS when performing any diagnosis.
