# TECH TIPS GREATEST TIPS

## 03 Squeak/Chirp Sound from High-Torque CVT When Shifting from P/N to D

## 03 Hub Bearing and Backing Plate Replacement

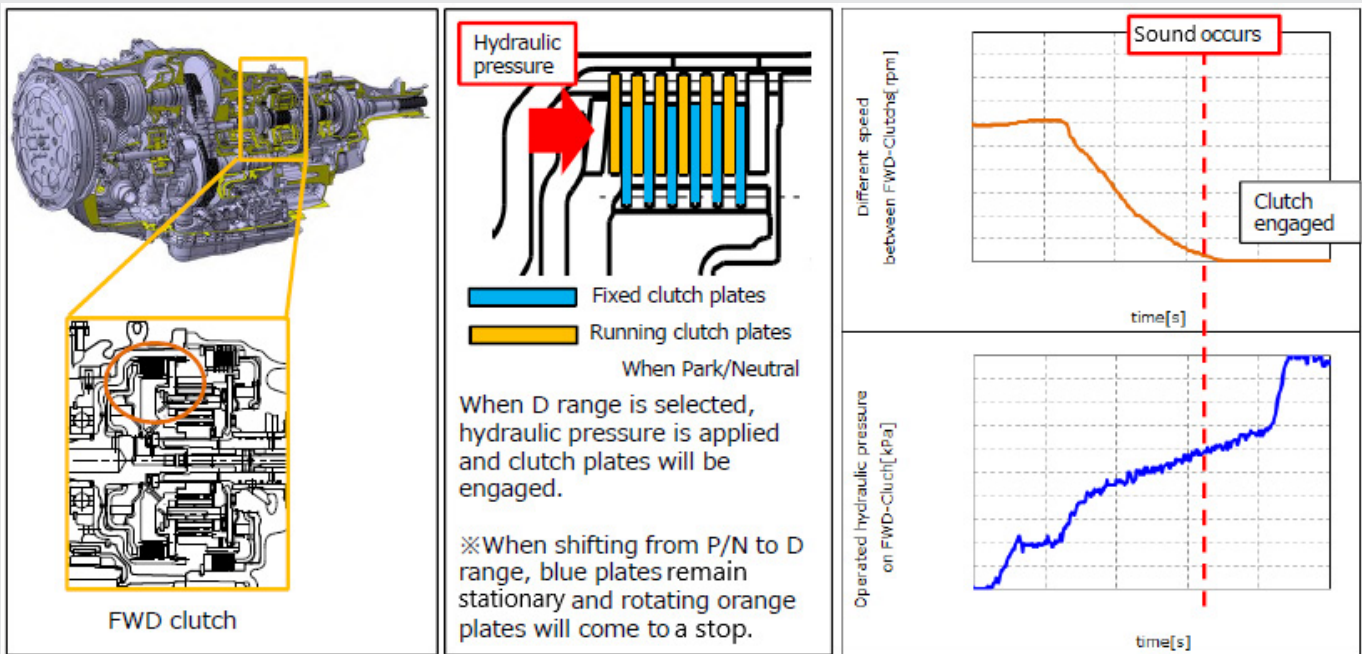
The High-Torque CVT equipped in the 2019+MY Ascent, 2015+MY Legacy/Outback 3.6R and XT, 2014-2018MY Forester XT, and 2015MY+ WRX (CVT equipped), may emit a brief squeak or chirp sound when shifting the transmission from park or neutral to drive. This sound is caused by the operation of the forward clutch, just before the clutch fully engages. The sound is caused by the clutch plate friction materials sliding against each other. These plates are designed to accept this type of contact. The sound does not affect the performance or reliability of the transmission and is characteristic of its operation so, no attempt should be made to try to repair it. It is important to ensure there are no DTCs stored as current or in history, there are no drivability concerns present and, the sound only occurs while the vehicle is stopped and under the conditions described above.

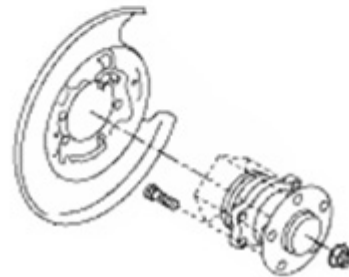
This bulletin announces a design change made to the rear wheel / brake backing plates. Under certain circumstances, some customers may have a concern regarding a howling-type sound from the rear of the vehicle later diagnosed as a faulty hub / bearing assembly. Unevenness of the backing plate surfaces may affect the concentricity (roundness) of the hub / bearing after torqued during assembly and over time, cause the howling -type sound to develop. Production changes for the backing plates have been implemented to optimize their mounting surface quality.

It has come to SOAs attention that Technicians are not replacing the backing plate when faced with hub bearing replacement. It is important to replace the backing plate along with the hub bearing assembly to avoid repeat bearing failures. TSB 05-70-19R is available to review this information.

Description	Part Number
HUB / BEARING ASSY	28473FL040
BACKING PLATE RH	26704FJ002
BACKING PLATE LH	26704FJ012

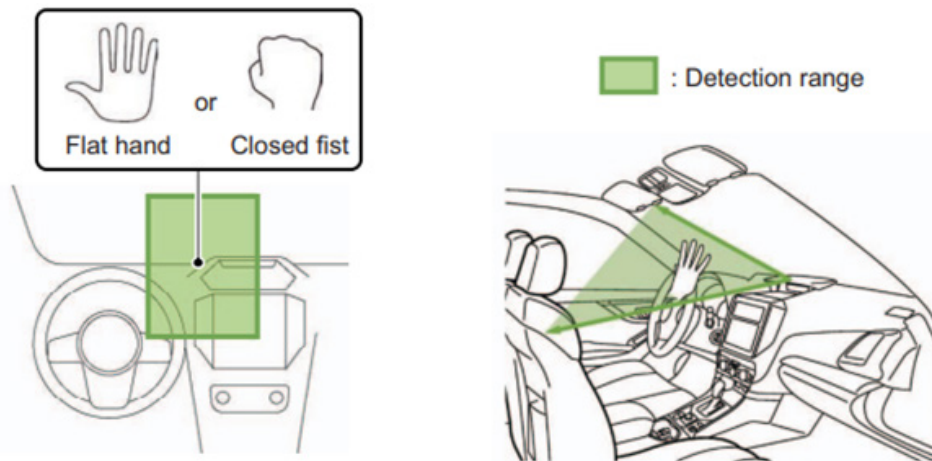
A new feature that will be integrated into Subaru vehicles is Gesture Control. The driver will be able to make hand gestures to control HVAC features through the Driver Monitor System (DMS). The Gesture feature is designed so that the customer can change their temperature settings without taking their eyes off the road. To accomplish this the driver will place their hand in front of the occupant recognition sensor. The gesture of an open palm with the fingers spread will raise the temperature of the air conditioning while a gesture of a closed fist will lower the temperature. The customer should be aware that if they are wearing gloves it may interfere with the recognition of the gesture being made. If a customer has a concern that involves the intermittent changing of climate control features the Gesture Control may be the cause. The Technician should confirm that the feature is active and interview the customer to ensure that they are aware of its function and confirm that they know proper operation.

Be sure to interview the customer about objects that are on the dash or rearview mirror area that they may remove when they drop off the vehicle as they may contribute to a false command being recognized. There has been confirmation that some objects hanging from the rearview mirror have triggered the Gesture Control to change settings. Technicians should confirm the concern by test driving the vehicle with all the customer's items present in the vehicle. Once the concern has been duplicated a second test drive should be performed with objects such as parking passes, handicap placards, graduate tassels, or beads removed from the rearview mirror to confirm if they are associated with the customer concern. The Gesture Control can be temporarily turned off by the customer, but it requires them to turn off the Driver Monitor System. The system will turn back on if the ignition is cycled, or the driver's door has been opened and closed. The Gesture Control can be disabled with SSM through Driver Monitor customization functions. Additional information regarding activation conditions.
