Articles Contained in this Issue

TECH TIPS GREATEST TIPS

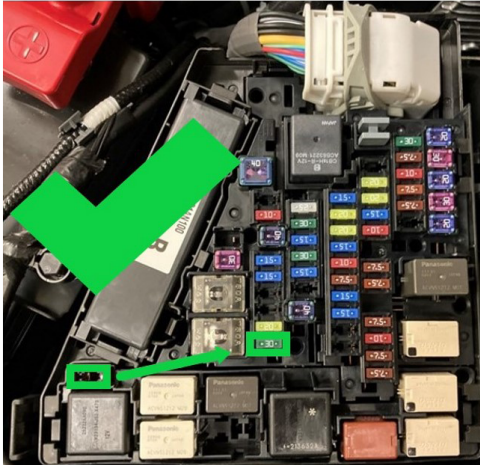
22MY WRX **Correct** PDI fuse movement

During the Pre-Delivery Inspection process for any model year, it is important to keep in mind the PDI fuse movement. It has been brought to Techlines attention that if the incorrect fuses are moved it may result in features not operating properly. Recently, a 22MY WRX had a concern that the windshield wipers would not turn off unless the vehicle was completely powered off. The Technician diagnosing the concern found DTC B1A01 stored as current. The Technician followed the Diagnostic Trouble Tree and found three fuses installed in the wrong place. These fuses dealt directly with the front relay control module. Taking power away from MB fuse No. 40, resulted in the wipers defaulting to 'on'. This was traced back to the possibility of incorrect fuses being moved during the PDI process.

Technicians should refer to the appropriate manual on STIS for the proper PDI process.

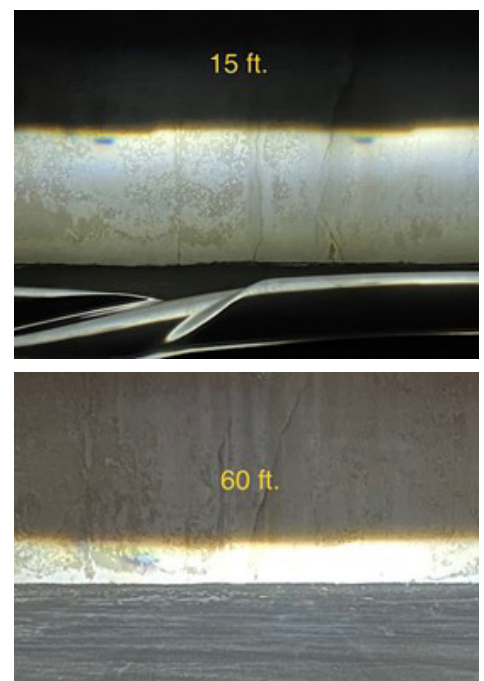
Subaru has received recent reports of concerns with headlight beam and pattern appearances. To satisfy the markets' desire to illuminate far distances, a more concentrated headlight illumination pattern has been adopted. As headlight patterns and beam clarity improve year after year with the evolution of headlight elements from halogen, HID and LED, drivers have noticed a dark area or “dark spot” in the beam. This black spot is to satisfy both Federal Motor Vehicle Safety Standards (FMVSS), and Insurance Institute for Highway Safety (IIHS) rules that certain points of the beam should not be illuminated. The “dark spot” is incorporated into the beam so as not to “dazzle” corresponding vehicles or pedestrians.

The example shown here is from the new 2022 Forester, notice the patterns' “dark spot” is less defined as the distance increases. When presented with a customer concern of a “dark spot” or “black spot” in the headlight pattern, it is best practice to confirm the condition and compare with a like year and model vehicle that is equipped with like headlights.

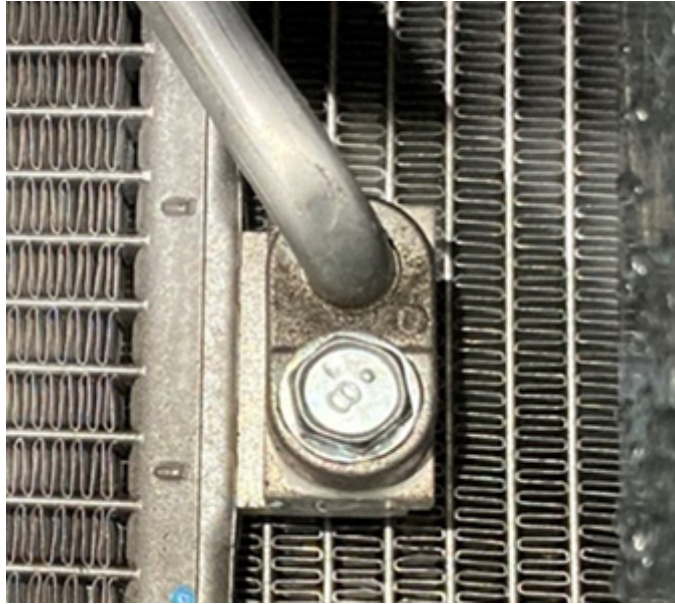
When diagnosing an A/C concern, take note that you may notice oil residue where the A/C line connects to the condenser. During production, oil is applied to the pipe and O-ring to ease installation. If you notice this, it does not indicate a leak or defect. Simply clean the oil off the connection, operate the AC system and then reinspect this location. If there are no signs of a leak no further action is necessary.

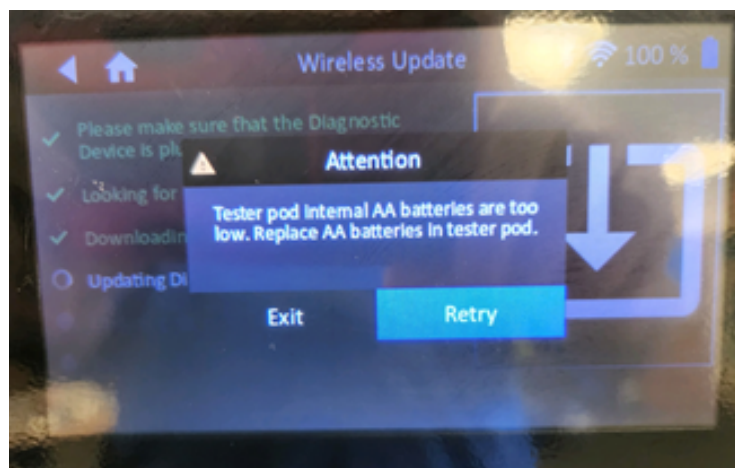
This message appeared while attempting to install the latest software version (currently “O” for the DSS-5000 and “I” for the DCA-8000 Dynamic Diagnostic Charging System).

Although the DSS was in the dock, the dock properly connected to AC via the AC adapter and a strong WiFi signal confirmed on the display, the update still could not be installed successfully. On the Main Menu screen, there was a small red indicator in upper corner of the Messages icon. The message referred to checking (replacing) the six (6) “AA” batteries of the Internal Battery pack located inside the base of the Tester Pod. To access the Internal Battery, remove the two small Phillips screws and slide the cover downward.
