Articles Contained in this Issue

TECH TIPS GREATEST TIPS

07 2010-2016 FORESTER, TPMS LIGHT FLASHING, SENSOR REGISTRATION ISSUES

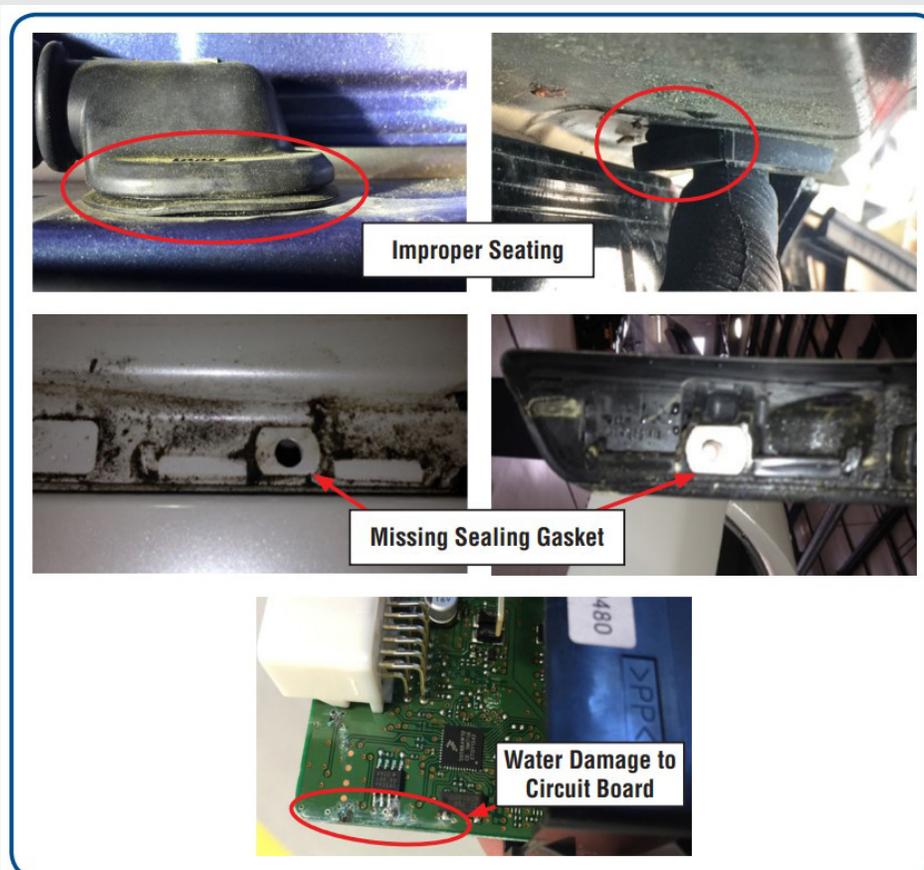
The Techline has received a number of calls regarding flashing TPMS warning lights. After initial diagnosis, if you are even able to communicate with the TPMS system, sometimes codes are stored, but most of the time there are none. If you encounter this condition, and for example, only 3 of 4 TPMS sensors are able to be registered, always check the TPMS control module for signs of water intrusion before replacing any parts. Also, always inspect the connectors and pins at the module carefully for corrosion if this condition is verified. Most cases have been traced back to the passthrough rubber harness cover / bellows between the body and the rear gate not being fully seated as shown in the photos below. The improper seating area has been primarily on the front side which can make it hard to see if not inspected carefully. There have also been isolated cases of a missing sealing gasket on the rear roof rail mounting stud. When either of these conditions occur, water can enter the vehicle, follow down the rear gate harness and drip directly onto the TPMS control module, eventually causing internal damage as seen in the bottom photo of a damaged circuit board. If you verify this concern, make sure to thoroughly clean and fully re-seat the pass through harness cover and re-check to verify any water leak has been repaired. To complete the repair, it will be necessary to replace the TPMS control module and re-register all the transmitters.

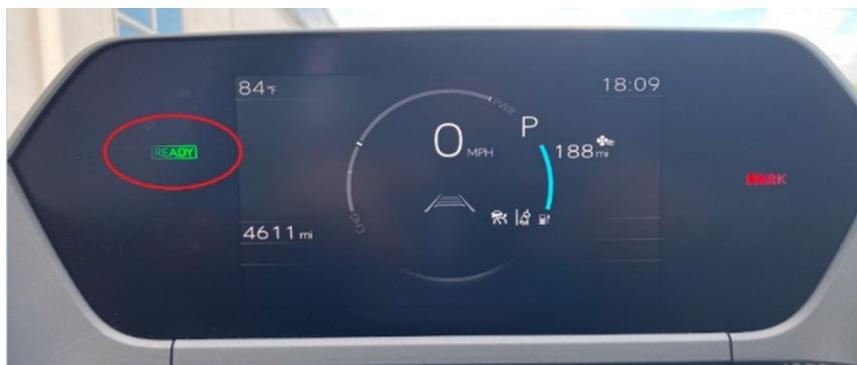
Fig 1: Ready-ON is displayed in the red circle.

1. Disconnecting the 12V battery (auxiliary battery) terminal(negative) with EV mode Ready-ON.
2. Disconnecting the 12V battery terminal while the System Main Relay (SMR) is in overheat protection mode.

SMR overheat protection mode is started when Ready-ON ↔ Ready-OFF is repeated many times in a short period of time. This could include several quick ON/OFF cycles as the vehicle is written up in the service drive, moved to the parking lot and then moved into the service bay.

If you disconnect the 12V battery during this time, these DTC's may set.

- (1) Do not disconnect the 12V battery during Ready-ON (see Fig 1).
- (2) When disconnecting the 12V battery, wait 3 minutes after IG-OFF as described in the service manual (see Fig 2).

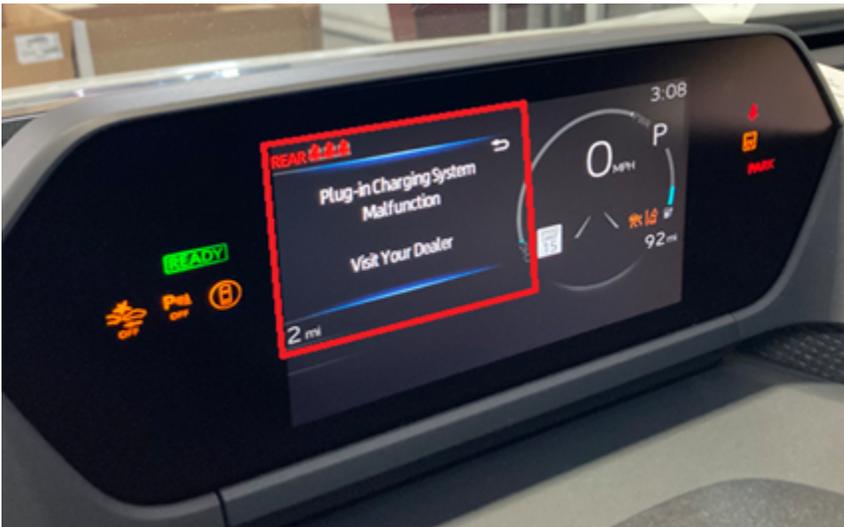
During PDI, a warning message (Plug-in Charge System) may display on the instrument panel (Fig 3) and U113B87 might be detected. This DTC indicates a failure in the CAN BUS between the Plug-in ECU and the Communication ECU (the unit used to communicate with the charging stand).

Figure 3: Warning message on the instrument panel.

If U113B87 is detected, or was detected in the past, you can clear it using the SSM.

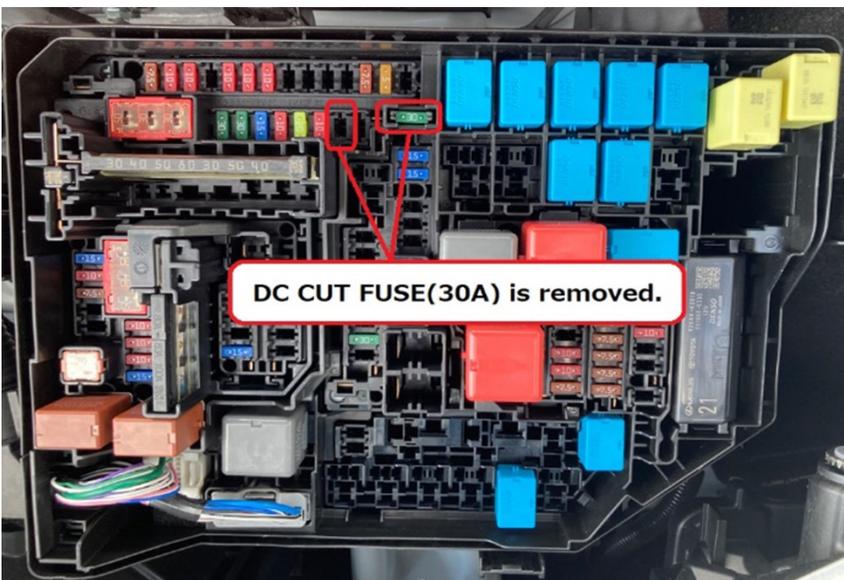
When the DC cut fuse (30A) is not installed (Fig 4), the power supply to the communication ECU is cut off.

If the Plug-in ECU tries to communicate with the Communication ECU, U113B87 will be set, and a warning message will be displayed on the instrument panel.

Figure 4: DC CUT FUSE (30A) is removed.

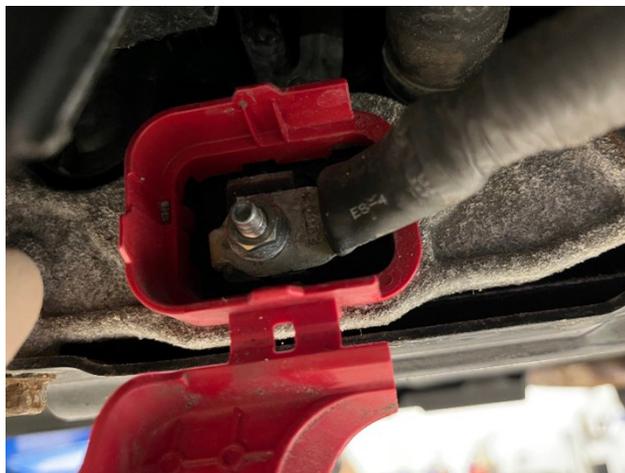
When installing a new Inverter Cable on a Hybrid Crosstrek, it may be tempting to use dielectric grease or some other kind of protectant when installing the cable. Research performed by the SOA engineering department discovered that applying grease may accelerate corrosion and cause unfavorable results. The terminal end and cable should be clean and free of debris. Be sure to always follow STIS closely for the proper installation process and do not add unapproved chemicals/sealants to this cable terminal.
