ARTICLES CONTAINED IN THIS ISSUE

CODE	ARTICLE	PAGE
(00)	New STIS Releases from 02/01/2013 to 02/28/2013..	10
(01)	QMR of the Month	1
(01)	New Model Launch Activities	3
(02)	Too Much Oil in the Engine .	9
(07)	Appearance of Water in BRZ Back-Up Light.....	6
(11)	Getting to the Bottom of Extended Cranking.....	8
(12)	WQA-37 Campaign	7
(15)	Voice Clarity	5
(15)	F-10 Diagnostics	4
(15)	Voice Recognition	2

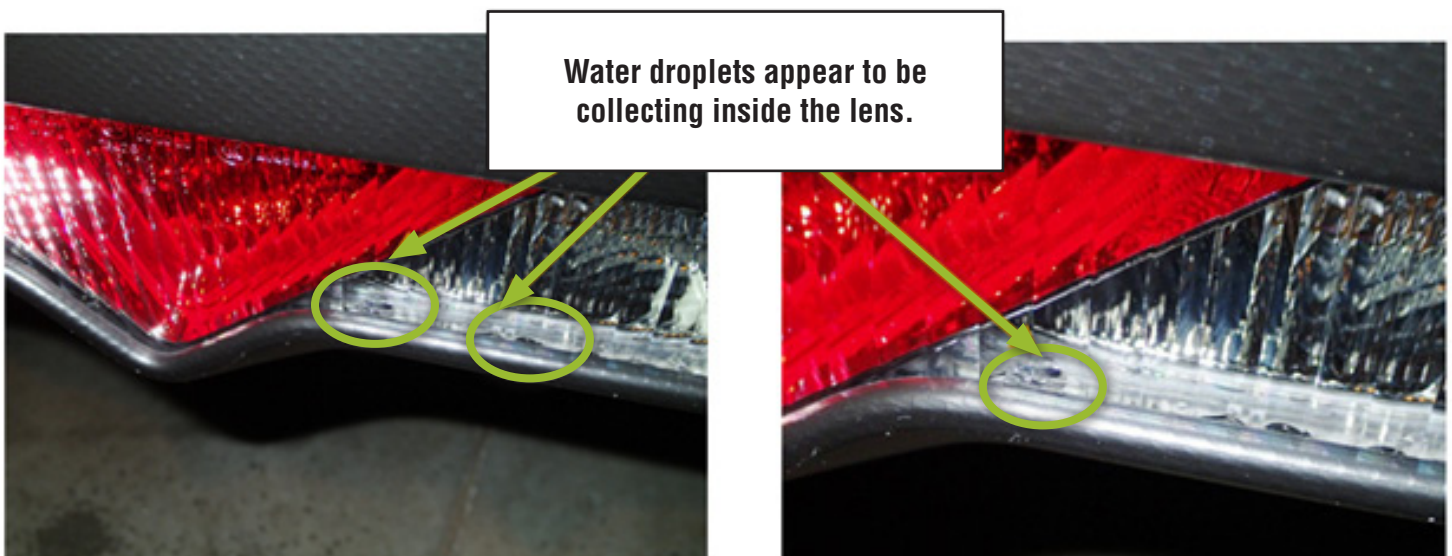
If you receive a customer concern of what appears to be water collecting inside the back-up light assembly, be sure to inspect the bottom of the lens area closely as shown in the photos below. Water droplets may collect along the bottom edge of the lens giving the indication they are inside the assembly when in fact, they are on the outside. To avoid unnecessary replacement of the back-up light assembly, simply remove the accumulated water droplets with compressed air. There is no need to replace the light as this is not a defect.
