## ARTICLES CONTAINED IN THIS ISSUE

CODE	ARTICLE.....	PAGE
(01)	QMR of the Month.....	01
(01)	Don't Forget to Check the Basics When Diagnosing Driveability Complaints .....	02
(01)	Troubleshooting Guides on STIS a Reminder .....	02
(01)	BUI Replacement and Keys ....	03
(05)	Tire Pressures "Check That Spare".....	02
(06)	Brake Override System Operation and Hesitation Complaints ....	04
(07)	2014 Forester Seat Heater Operation and Switch Functions .....	03
(07)	Headlight Adjustment Reminders.....	04

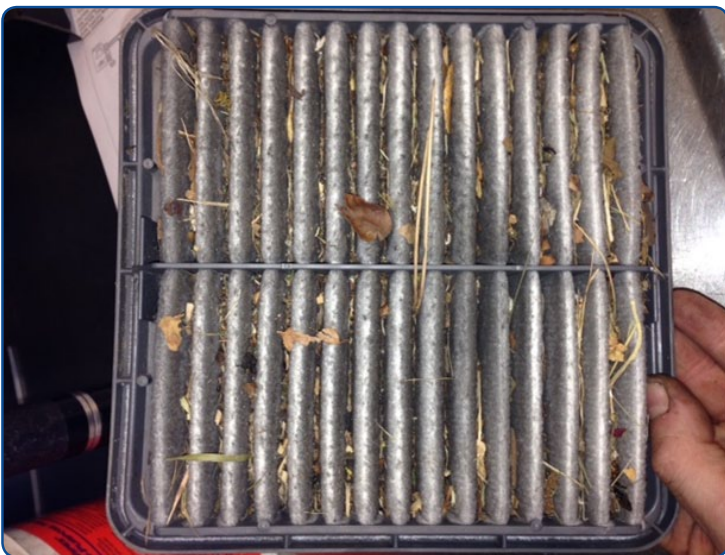
When performing diagnostics for engine-related problems, don't forget the simple items which can easily be overlooked. Recently, a vehicle with only 27,420 miles was brought in to a dealership for misfire codes P0301, 302, 303, 304. The air filter was almost completely clogged (see photo to the left). Even when a vehicle has not reached a point where maintenance items would be inspected or replaced (ex: air filter at 30K), they should still be checked as part of the diagnostic procedure.

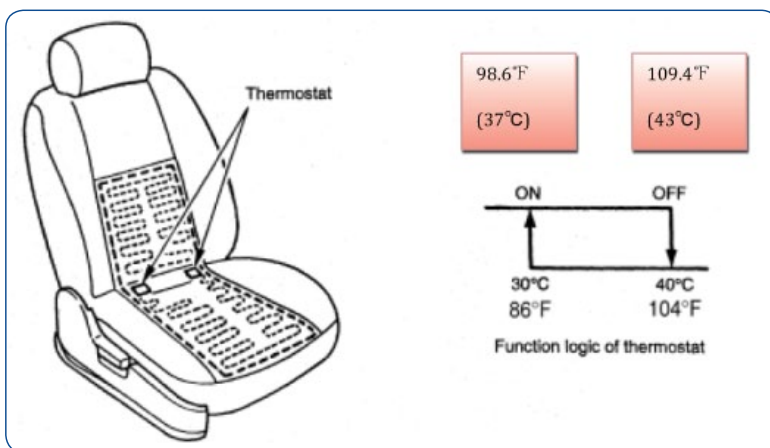
The system uses 7 contact points on the seat cushion and 4 contact points on the seat back to keep the system within this operating range by utilizing two thermostats located within the seat elements. They are positioned so the customer cannot feel them when seated. See the attached illustration below for thermostat locations. The switch functions are not a high and low type system like those used in previous models. When the seat heater switch is put in the high position, the elements heat up and into the operating range as fast as possible. When the switch is placed in the low position, the same amount of heat is generated but at a slower rate to reach maximum temperature. Once the maximum temperature is reached, the elements shut off until they cool below operating range then cycle back on again. The switch stays illuminated whenever the system is in use.

If no continuity exists, replace the seat heater switch with a new part.
