### Articles Contained in this Issue

## 01 UNDERSTANDING POWER SUPPLY

## 15 All Vehicles Equipped With CP 1.5, Auxiliary Port Noise

## 15 Repairing STARLINK Telematics DTCs

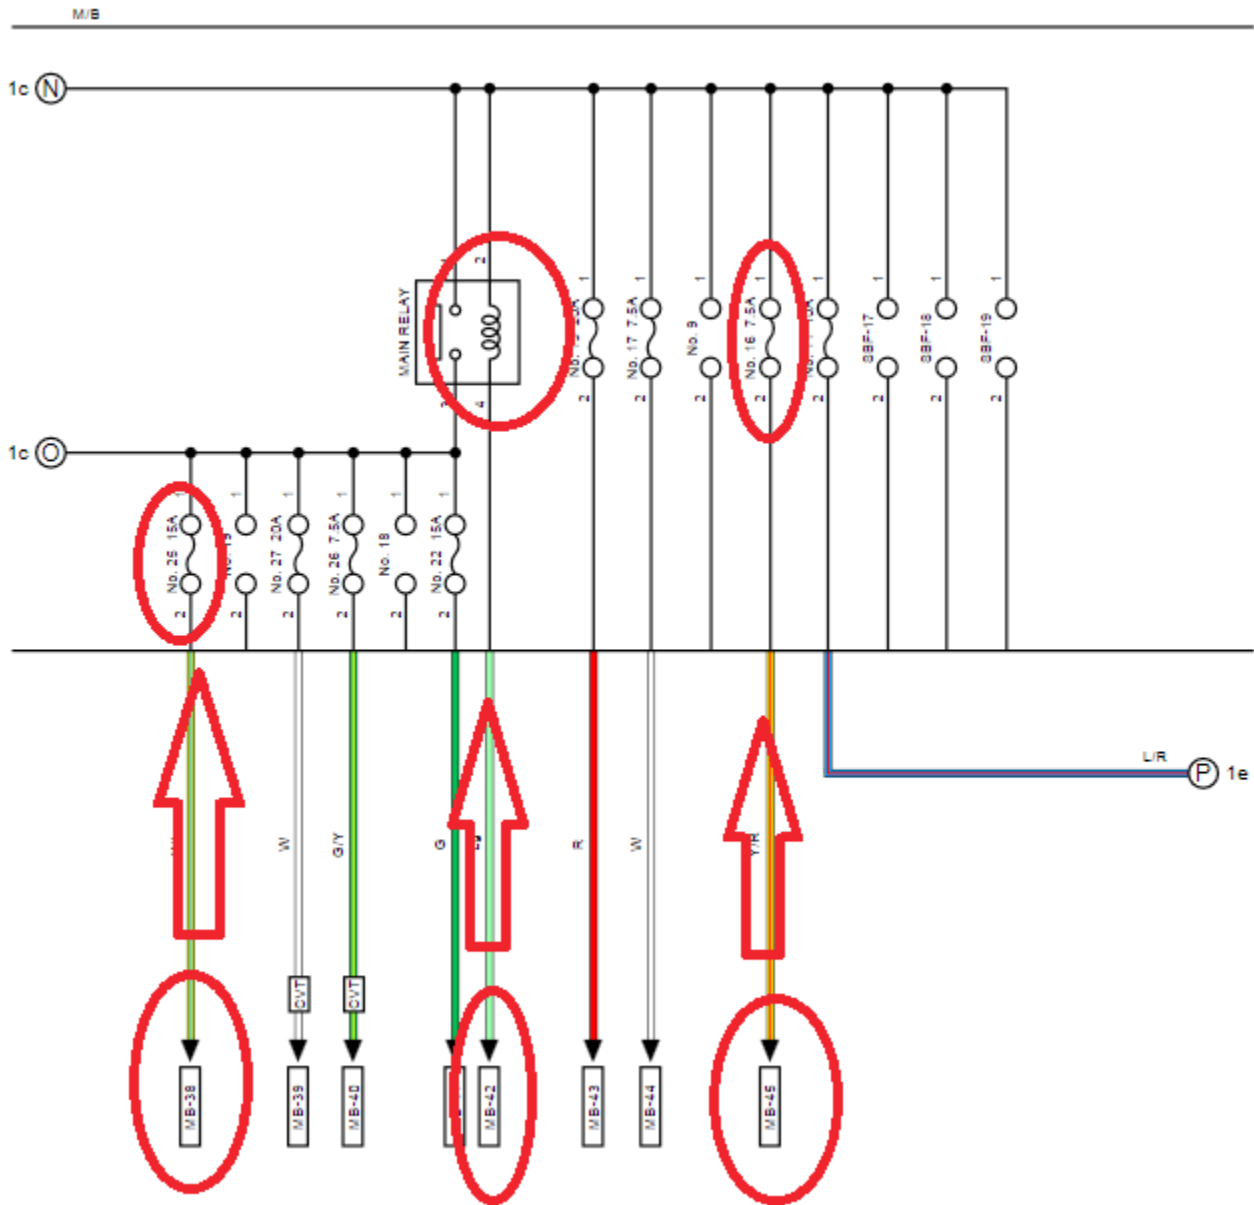
WI-65429

After scanning all systems and finding no communication to the ECM, the Technician should be checking the power supply next. A quick review of the power supply shows MB-38, MB-42 and MB-45 all supply power to ECM. Find the circuits (MB-38, MB-42, MB-45) then follow up the page to see where they get powered. MB-38 is powered by fuse #25. MB-42 is power for the main relay coil side. MB-45 is powered by fuse # 16. The next step is check the fuses. In this example fuse #25 was blown.

A quick review of the Power supply reveals all three affected circuits are on MB-21. MB-21 is supplied power by the horn relay. A continuity check on the coil side of the horn relay yielded a faulty horn relay.

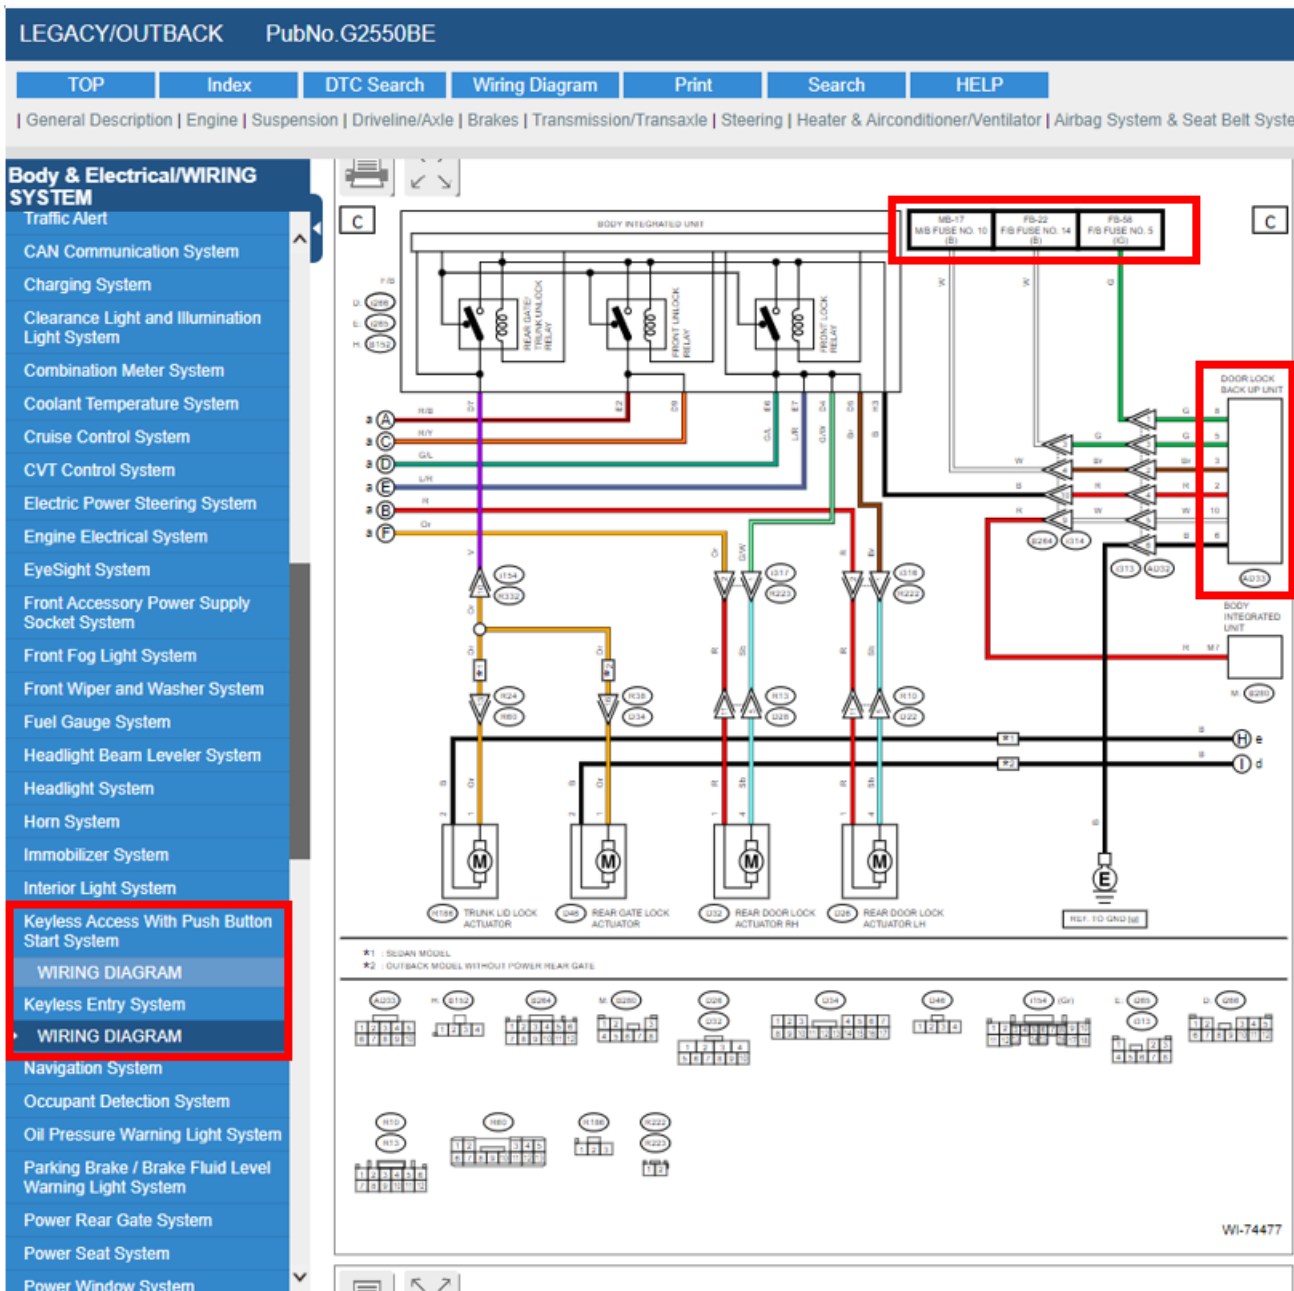
Below is a wiring diagram from a '19 Outback. Always use STIS to verify the wiring diagram for the vehicle being repaired.

On this '19 Outback, the 3 fuses powering the Backup Unit are the same for Push Button (Keyless Access) or turn-key (Keyless Entry) vehicles. Techline has found in almost all cases **one of these 3 fuses is missing or blown** causing the door rear locks to become inoperative after the engine is shut off and the Backup Unit capacitor is depleted.

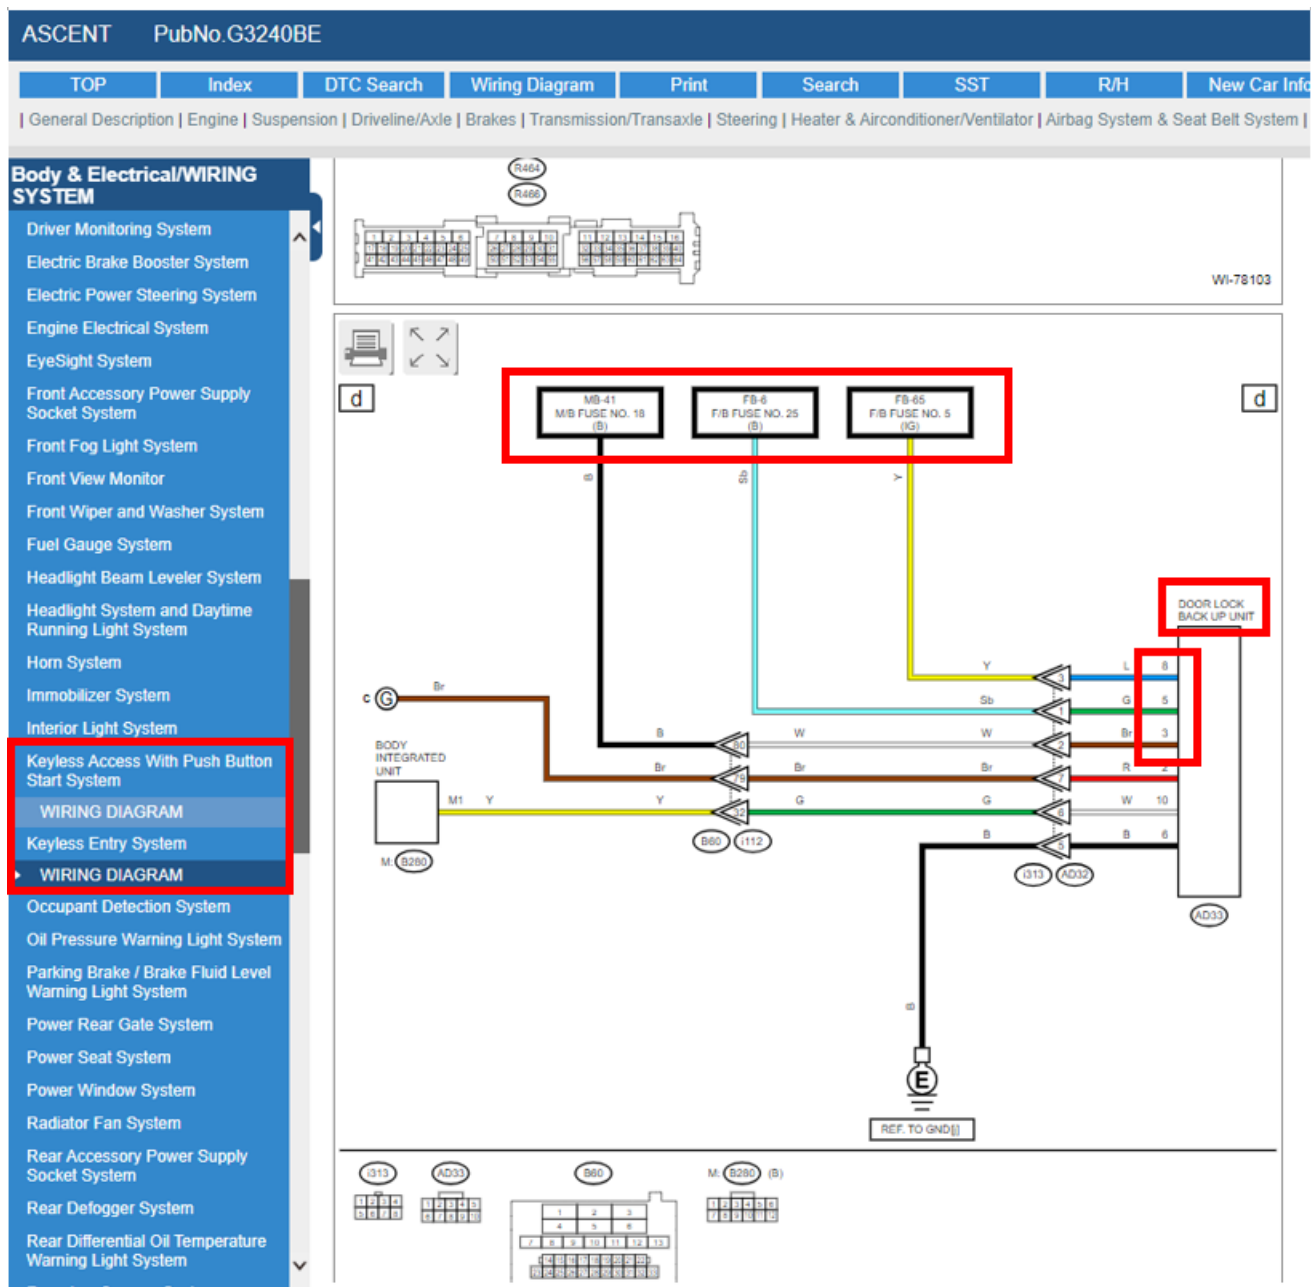
Below is an example of a '23 Ascent wiring diagram showing the fuses that need to be inspected.

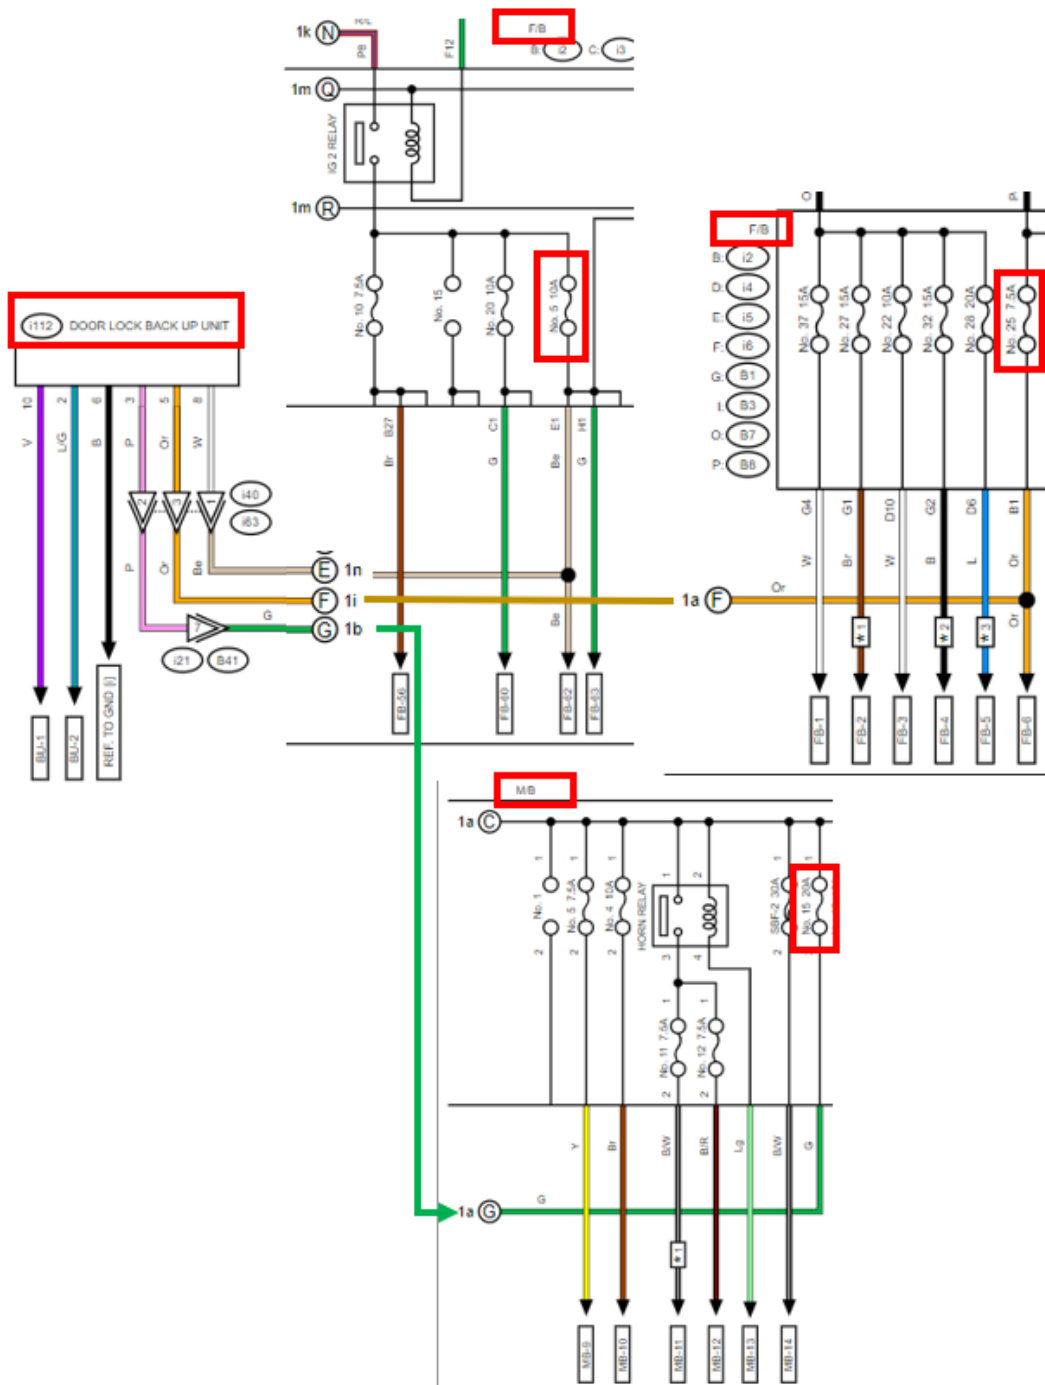
Following the wires highlighted above will lead to the 3 fuses needing to be inspected. Please see the wiring diagram shown below showing those 3 fuses.

Techline has found that in almost all cases **one of these 3 fuses is missing or blown** causing the door locks to become inoperative after the engine is shut off and the Backup Unit capacitor is depleted.

After verifying the 3 fuses to the Backup Unit are not missing or blown, the next step would be to verify power is received at the Backup Unit on the 3 pins listed in the vehicles wiring diagram.

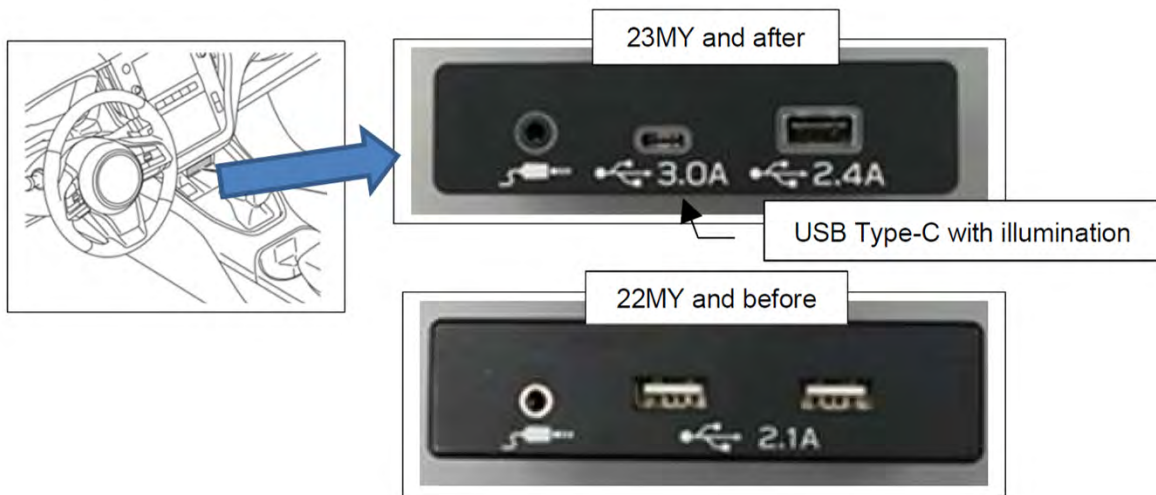
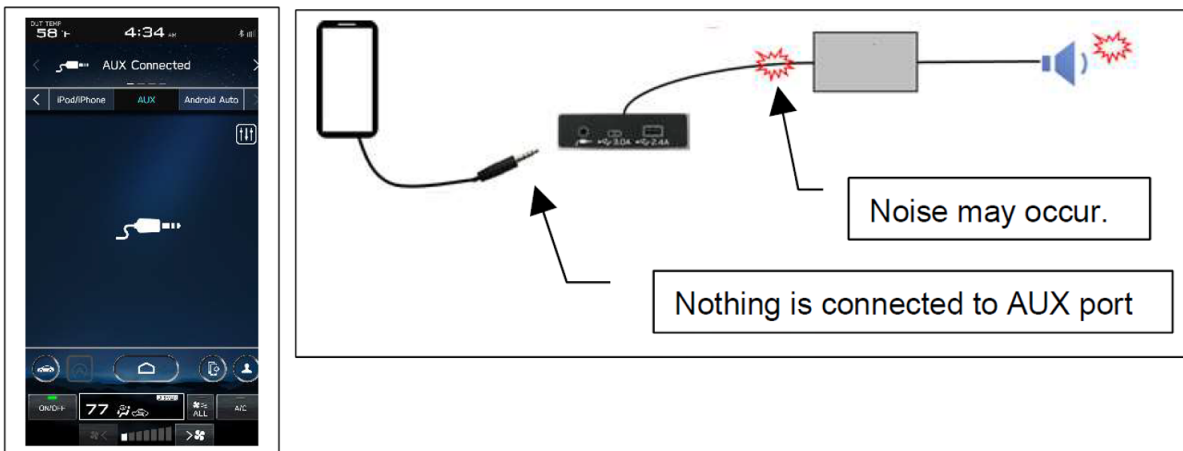
Starting with 23MY Legacy/Outback and Ascent, a new UNIT-AUX TERMINAL with illuminated USB-type C port is incorporated as part of the CP1.5 infotainment system.

On this type of AUX port, when AUX is selected as audio source without any device connected to UNIT-AUX TERMINAL, a buzzer type noise may be heard from the audio system while the illumination light is turned on.

If the customer reports a noise coming from the audio system while the headlights are turned on, the above-mentioned characteristics may be the cause.

To prevent this noise, do not select “AUX” as the source without a device plugged into that port.

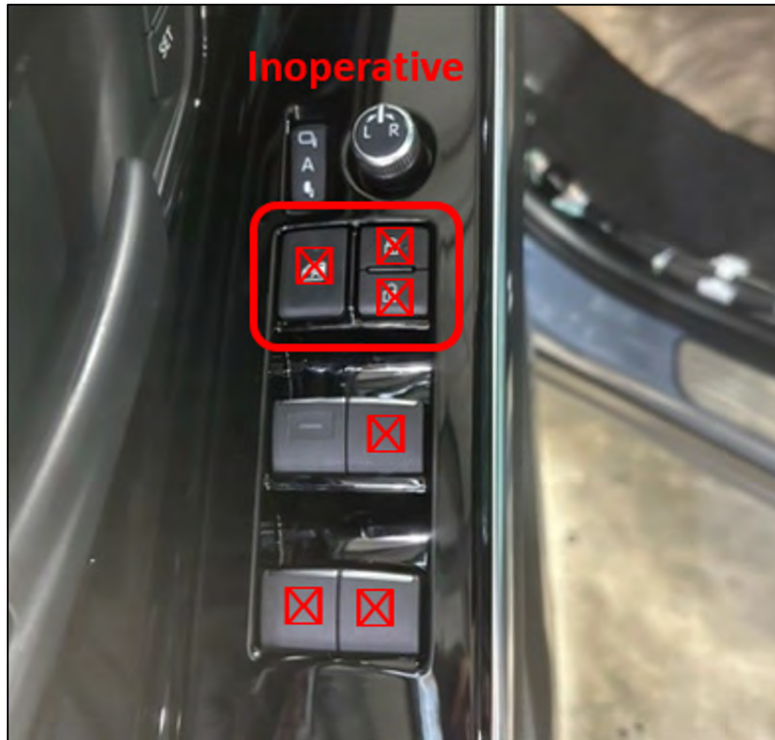
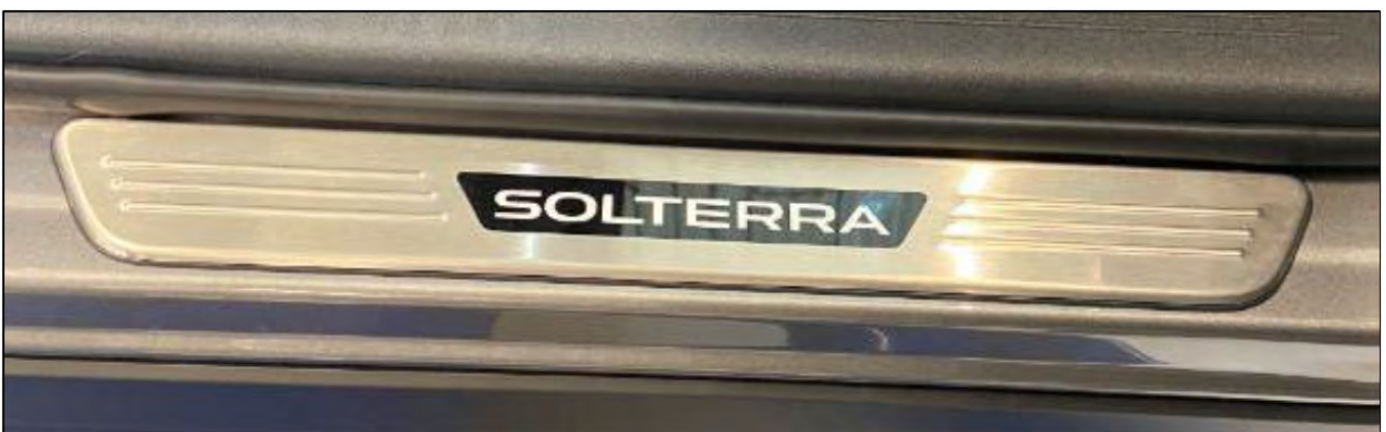
When diagnosing an inoperative power window master switch on a Solterra, first check to see if the vehicle is equipped with the accessory Illuminated Side Sill Plates. If the vehicle is NOT equipped with the accessory Illuminated Sill Plates, use STIS to continue normal diagnostics. If the vehicle is equipped with the OE Subaru accessory Sill Plates, begin by inspecting the LH connector housing behind the LH kick panel to verify proper Bridge Connector orientation. The port accessory installation directions found [here](#) have directions for the removal of the kick panel. It has been found if the Left and Right Bridge Connectors are installed in the wrong locations, power window/lock functions will not operate properly from the driver side master window switch and other issues may occur as well.

Correct Bridge Connector orientation shown below:

The left-side accessory Bridge Connector should be White with a Blue OE body harness connector.

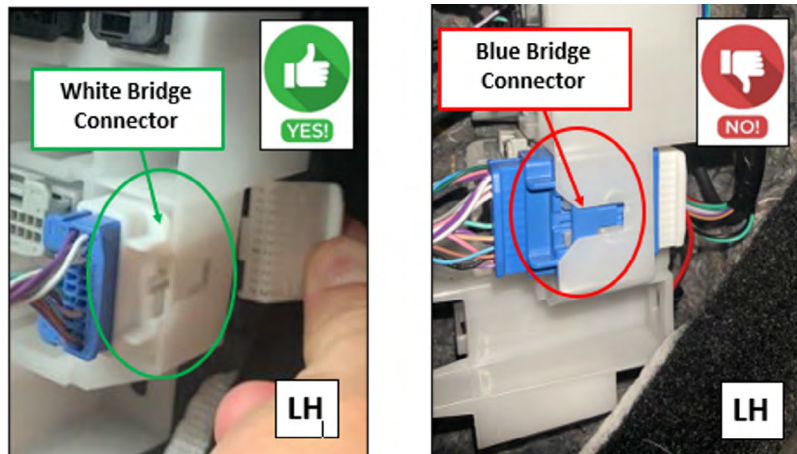
The right-side Bridge Connector should be Blue with a White OE body harness connector.

If the Bridge connectors are found to be in the wrong locations, refer to the [Solterra Illuminated Side Sill accessory installation instructions](#) to correct the condition (see page 10 - 14 for the correct installation process). Once corrected, re-check power window and lock functions on the master window switch.

In some cases, it was found the inoperative power window symptoms remain after the Bridge Connector error has been corrected. In this case, and after the Bridge Connectors have been properly installed, you must clear any DTC's that may have been set and perform the window initialization procedure below on the sub switches of each door to restore proper operation.
