Aftersales Bulletin

Phantom (RR11/ RR12) Cullinan (RR31) Reversing Camera Programming -Safety Recall – 19V-684

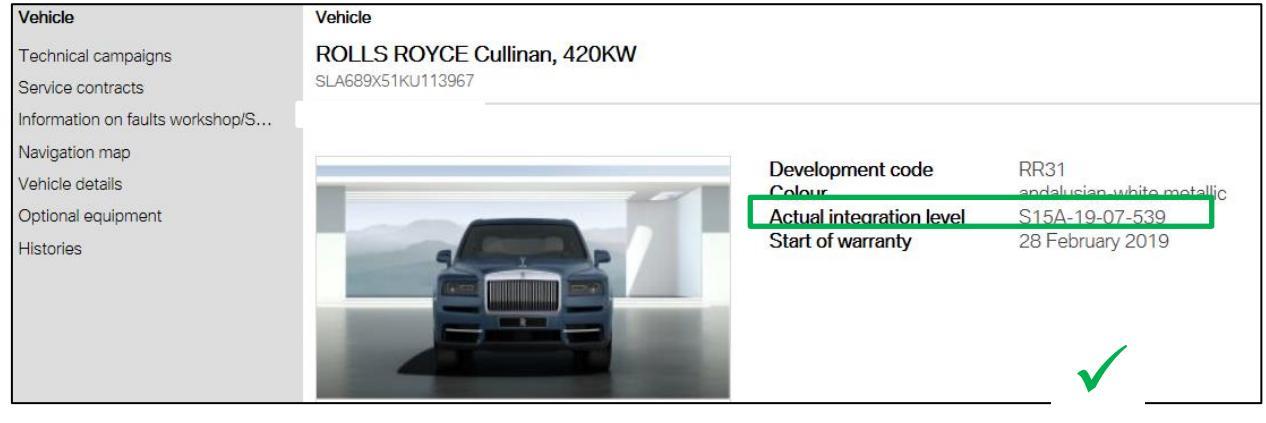
Check the current vehicle integration level using AIR:

Automobiles I-stage at or greater than S15A-19-07-539: No further action is required.

Automobiles I-stage at version below S15A-19-07-539: Update automobiles using the latest version of ISTA programming data (4.18.3x or higher):-
