Safety Recall Code: 69BY

Subject	Passenger Occupant Detection System (PODS)					
Release Date	February 17, 2022					
REVISION SUMMARY	Updated PODS programming information					
Affected Vehicles	Country	Beginning Model Year	Ending Model Year	Vehicle	Vehicle Count	
	USA	2015	2019	A3 CABRIOLET	11,736	
	USA	2016	2018	A3 ETRON	9,573	
	USA	2015	2020	A3 SEDAN	113,168	
	USA	2017	2020	RS3 SEDAN	4,147	
	USA	2015	2020	S3 SEDAN	14,536	
	CAN	2016	2020	A3 CABRIOLET	1,742	
	CAN	2016	2018	A3 ETRON	1,384	
	CAN	2016	2020	A3 SEDAN	10,665	
	CAN	2018	2020	RS3 SEDAN	1,610	
	CAN	2016	2020	S3 SEDAN	2,804	
Problem Description	✓ Cam ✓ If Els the s The passenge passenger a However, th	paign status mu sa shows other of same time the ve ger occupant of irbag even the e airbag sys	ist show "open open action(s), shicle is in the detection sys ough the sea tem and the	" inform your customer so that the work workshop for this campaign. stem (PODS) may detect a malfu at may be occupied. e warning strategy operate as	<i>can also be com</i> nction and swi designed. If t	ipleted at

Subject: Safety Recall 69BY – Passenger Occupant Detection System (PODS)

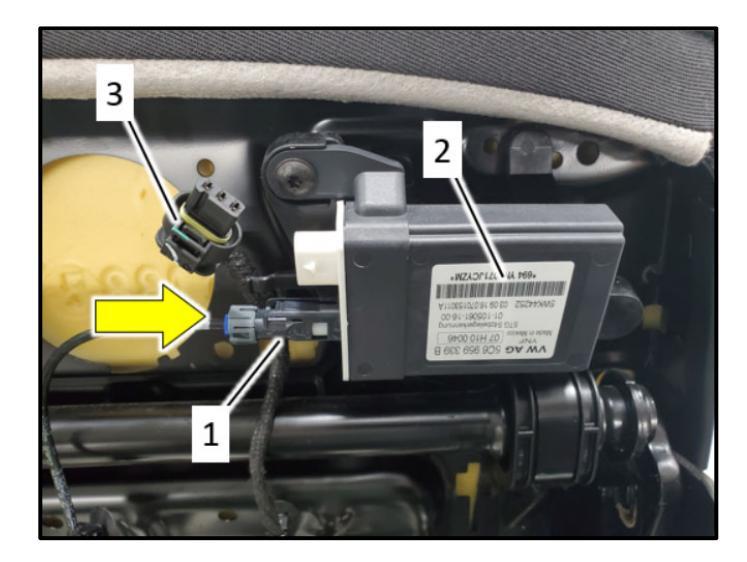
The connector must be installed exactly parallel with the PODS ECU. The center pin in the PODS ECU and connector is fragile and must not be bent during installation. A damaged center pin will cause PODS faults. Damage to the PODS ECU is not covered under this action.

The PODS ECU will be updated using the PODS Programmer at PODS ECU connection <3>.

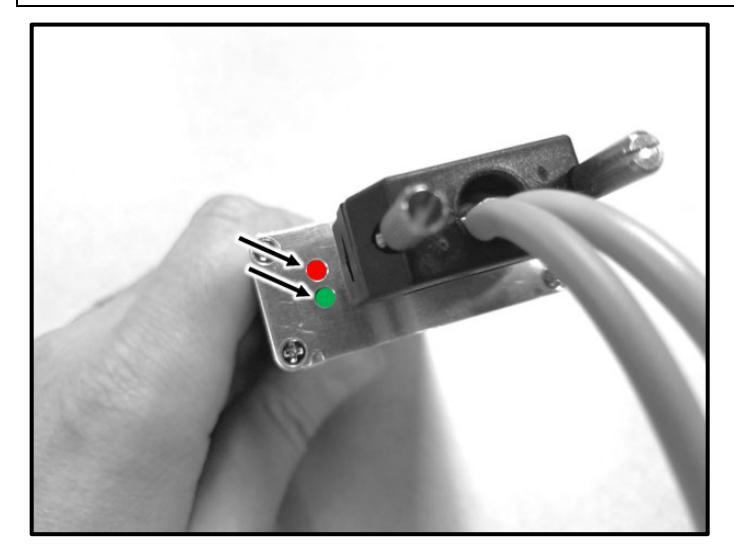
- If the start-up procedure fails, the red and green lights will <u>flash</u> simultaneously.
- This means the maximum number of stored records has been reached.
- If this situation is encountered, create an Audi Technical Assistance WEB ticket and wait for further direction.

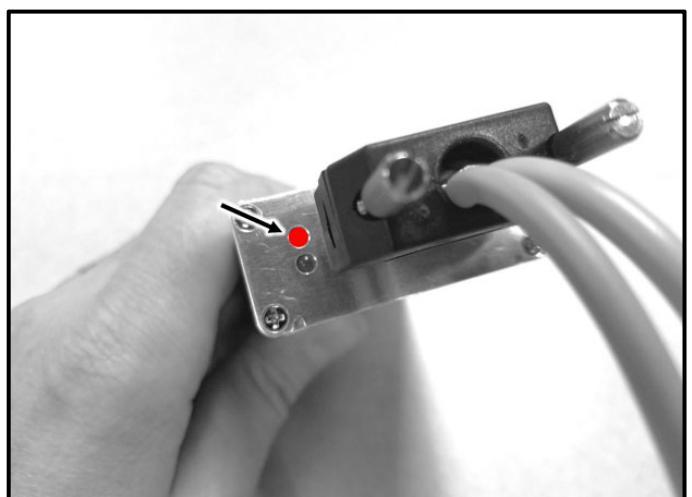
If the programming has failed the red light will flash and one of the following may have occurred:

- If the Red light flashes and there are no connection or voltage issues:
 - The PODS control module must be 0 replaced.
 - The only way to receive a PODS 0 control module is to order the complete PODS repair kit.
 - Once the kit is received, only install 0 the PODS control module. The seat cushion and sensor mat do not require replacement.
