July 2021  
FL880A-E  
NHTSA #21V-206  
Transport Canada #2021-172

## Subject: Western Star ACM Ground Splice Pack

**Models Affected: Specific model year 2019-2022 Western Star 4700 and 5700 vehicles manufactured October 24, 2018, through March 15, 2021.**

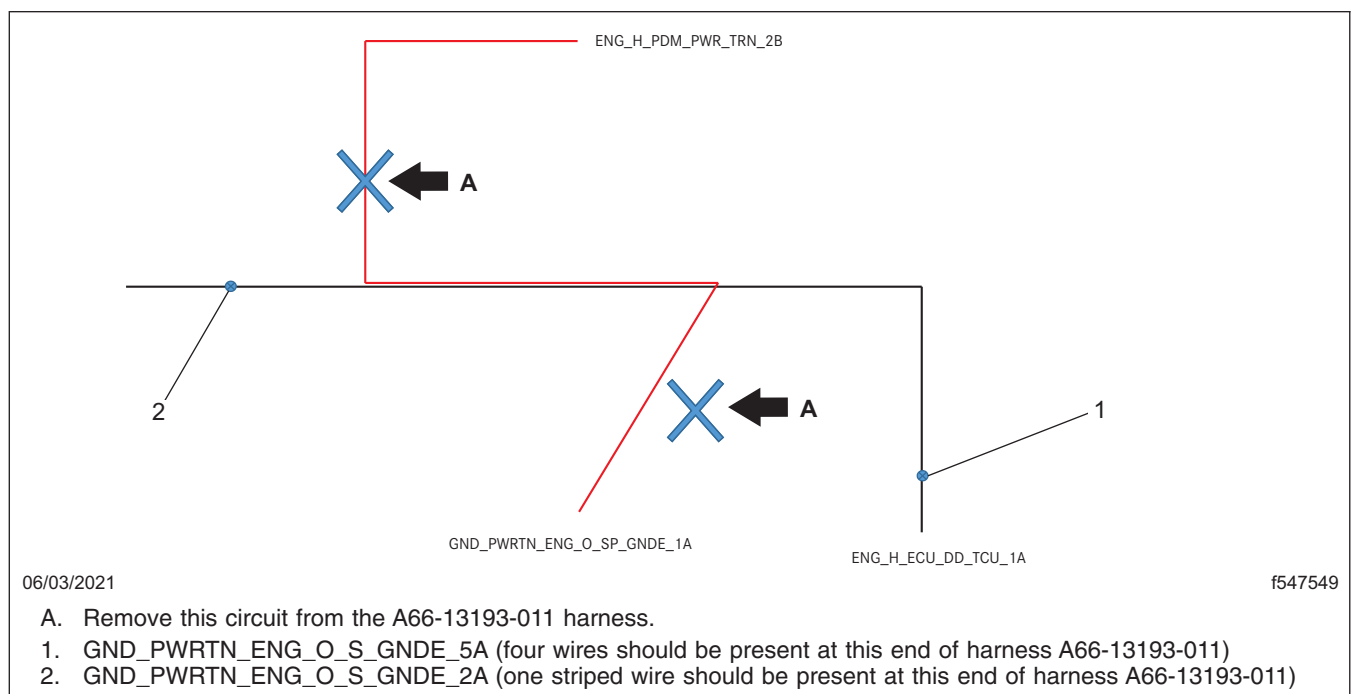
**Fig. 9, Removing the Additional Circuit from A66-13193-011 Harness**

NOTE: The DT12 TCU ground overlay harness A66-13193-011 has an additional circuit which is not required. This circuit is typically routed to the PTPDM, and back to the LH side splice, and will not be used for this repair. A circuit is already incorporated into the existing wiring on the vehicle, to meet its purpose.

10. Remove the circuit from the A66-13193-011 harness as shown in [Fig. 9](#). Once removed, the harness will now have four terminals at the TCU side, and a striped wire at the other end.
