GROUP	MODEL
	Safety Recall Campaign	2021MY
		Sorento (MQ4a) and
		2021-2022MY
		K5 (DL3a)
		w/2.5L T-GDI
	NUMBER	DATE
	SC214	July 2021
SAFETY REC	CALL CAMPAIGN	
HIGH-PRESSURE F	UEL PIPE INSPECTION	DN,
		,)1 /)
		-14)

This bulletin provides information to inspect and, if required, replace the high-pressure fuel pipe on some 2021MY Sorento (MQ4a) and some 2021-2022MY K5 (DL3a) vehicles equipped with Theta III 2.5L T-GDI engines (refer to table below for production dates). Also, whether the fuel pipe is replaced or not, dealers are to ensure it is tightened with the proper torque. The fuel pipe connecting the high-pressure fuel pump to the fuel rail may have been installed with insufficient torque during assembly. In addition, a limited number of fuel pipes may have been manufactured out of specification for concentricity. As a result of insufficient torque or improper concentricity, fuel may leak at the pipe connections. Leaking fuel increases the risk of a fire, thereby increasing the risk of injury.

HIGH-PRESSURE FUEL PIPE INSPECTION, REPLACEMENT AND TIGHTENING (SC214)

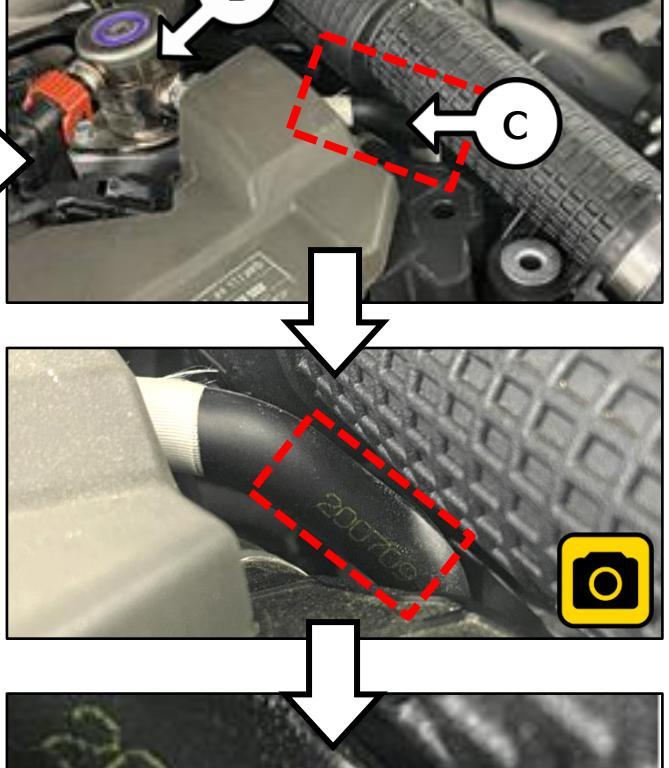
2b. <u>Check the lot number</u> printed on the highpressure fuel pipe insulator.

- 3a. If the Lot Number is 210111 (NG), replace the high-pressure fuel delivery pipe by referring to the 'Replacement Procedure' on page 4.
- 3b. If the Lot Number is NOT 210111 (OK) (as shown), then proceed to step 4 on page 3.
- 4. Remove the high-pressure fuel pump foam cover (D).

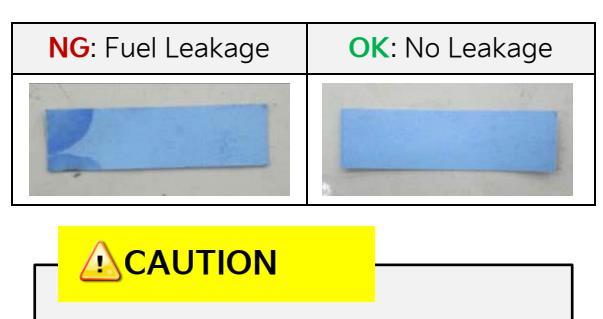
- 'Start' the engine and press the accelerator pedal, two to three (2-3) times, up to 5,000 RPMs. Then allow engine to idle.
- 8a. Inspect the high-pressure fuel delivery pipe/flare nuts (F & G) for any smell/visual fuel leaks.
- 8b. Inspect the two (2) high-pressure fuel delivery pipe flare nuts (F & G) for fuel leak using a sheet of test paper (see below). <u>Check both sides</u> (L&R) of each flare nut with test paper.

- 9a. If a fuel leak is found (NG), replace the high-pressure fuel delivery pipe by referring to the 'Replacement Procedure' on page 5.
- 9b. If no leak is found (OK), reinstall all of the removed parts in the reverse order of removal.
