October 1, 2021

Safety Recall: 2022 Odyssey Bridgestone Tire Inspection

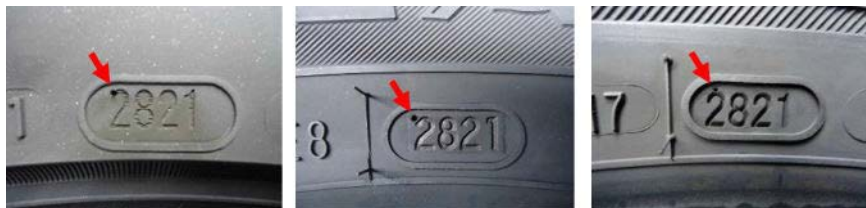
Are blemishes or marks present on any of the tire date codes 2821?
