**January 19, 2022**

## Safety Recall: 2022 Odyssey Bridgestone Tire Inspection

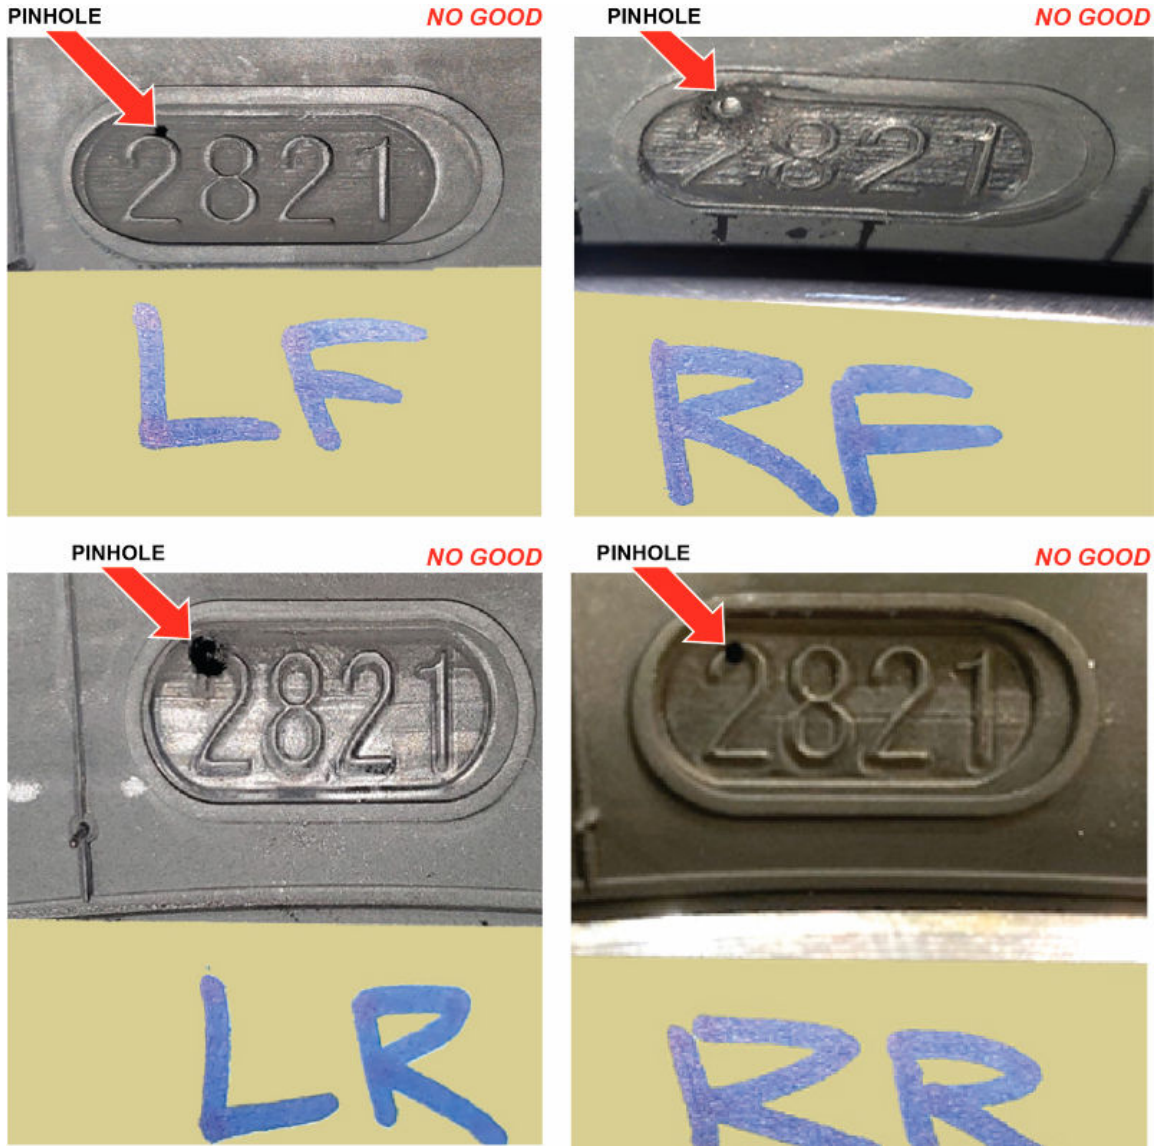
(Examples of tires that do NOT have a pinhole but may have minor blemishes or irregularities in the date code etching are OK and do NOT require replacement.)

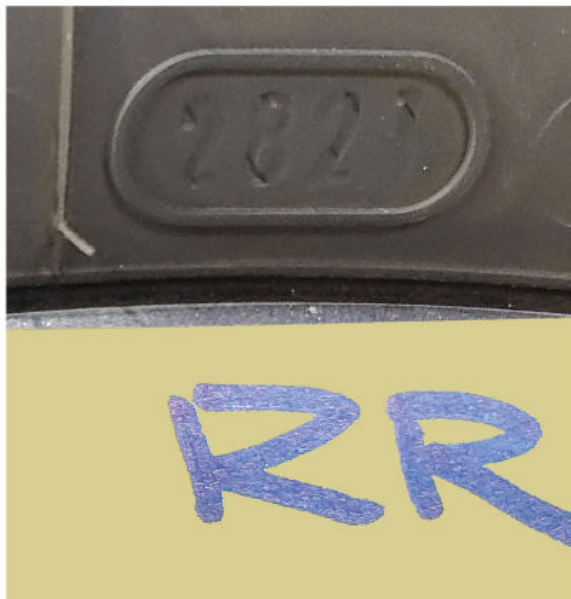
*Is a pinhole present on any of the tire date codes 2821?*
