TECHNICAL INSTRUCTIONS

SAFETY RECALL 22TA02

PRE-COLLISION SYSTEM (PCS) INOPERATIVE WITHOUT WARNING INDICATOR

CERTAIN 2021 MODEL YEAR C-HR

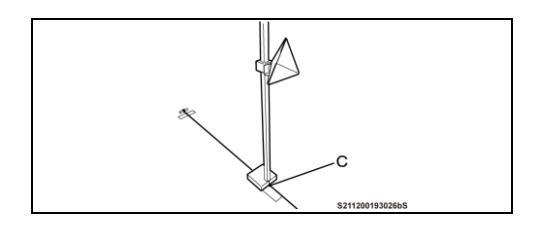
Install the SST (reflector) by aligning the scribe line of the SST (reflector) with point C as shown in the illustration.

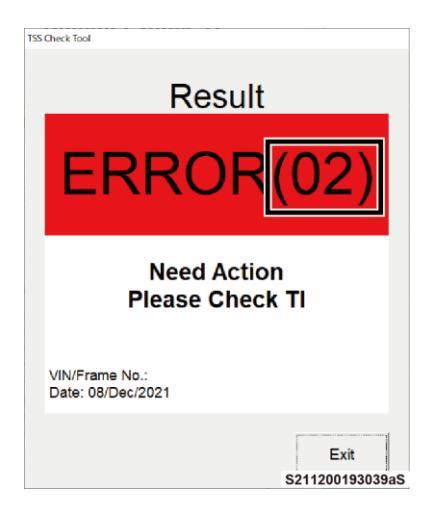
Refer to the following table while referencing the error identification number shown in the error result to determine and eliminate the cause of the error.
