## RECALL 22V143 / 2022-109 REMEDY INSTRUCTIONS

### CERTAIN MODELS:

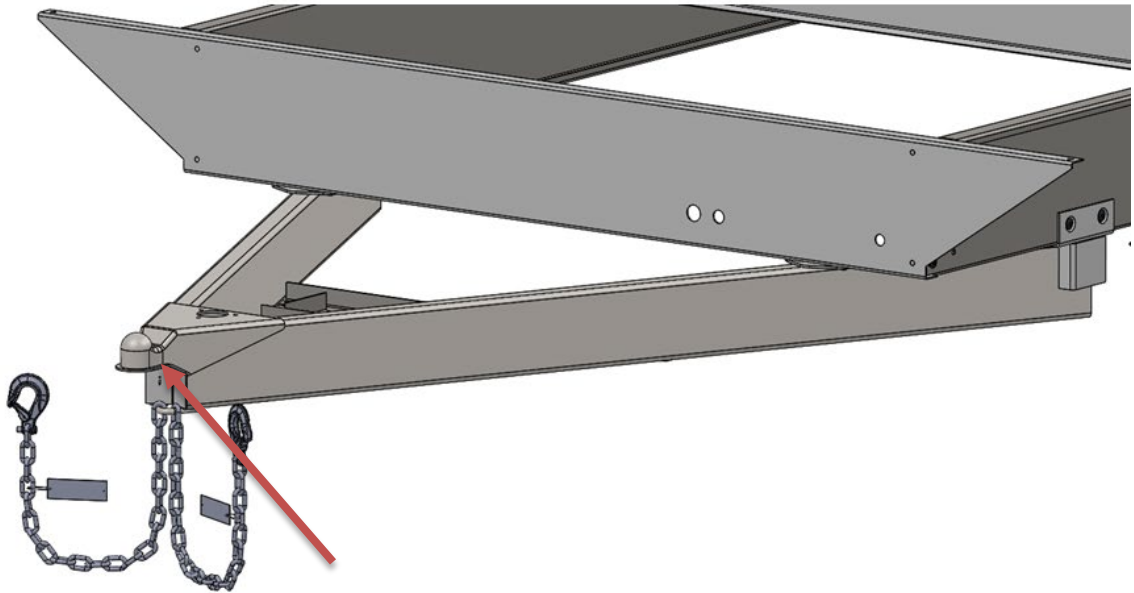
- 2) Underneath the coupler, use a flashlight to inspect the welds at each side of the bottom coupler plate.
- a. To Pass Inspection: A weld bead should run along each side of the plate.
  - b. To Fail Inspection: A weld bead will not run along the side of the plate and there will only be tack welds

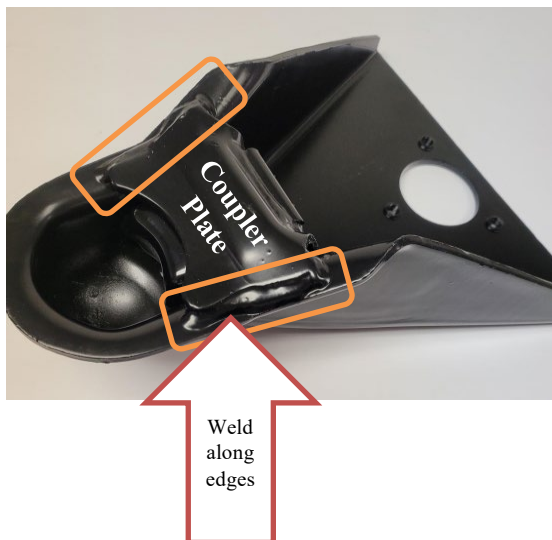
**FAIL (Unpainted View)**

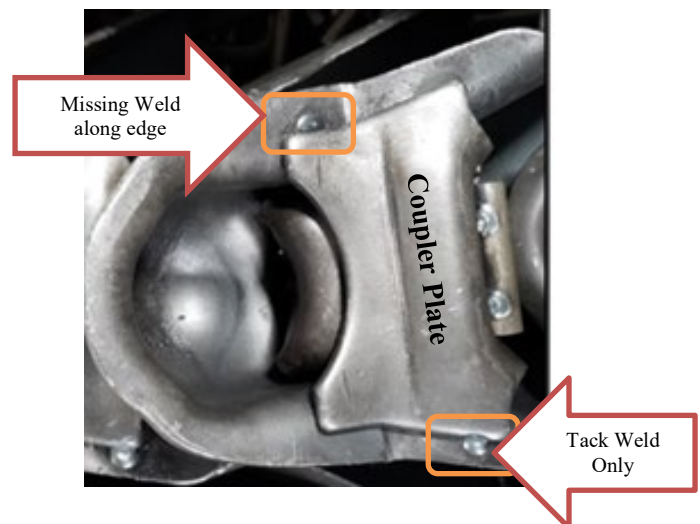
**NORCO INDUSTRIES APPROVED REPAIR PROCEDURE****STEP 2: REPAIR IF VISUAL INSPECTION FAILS**

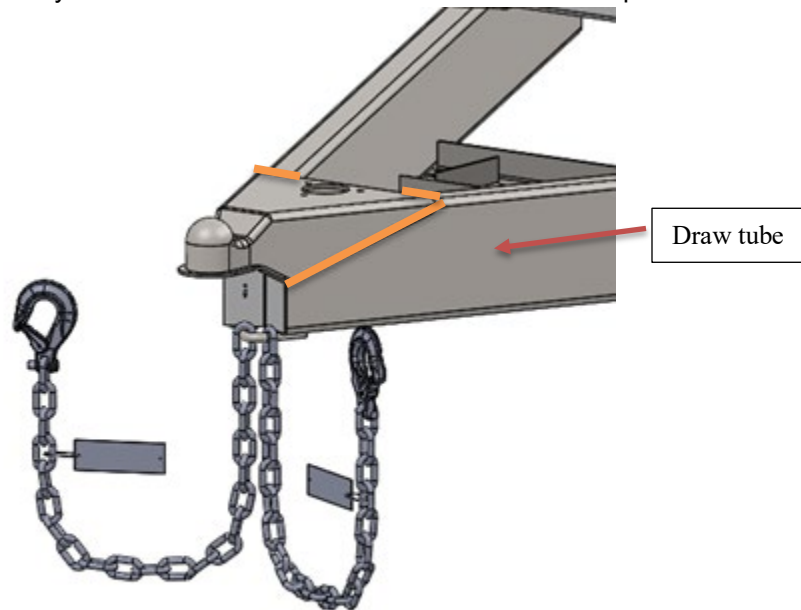
- 5) Prep the replacement coupler by removing the paint from the weld locations.
- 6) Weld the replacement coupler in place just as the original was welded.
- 7) Paint raw steel areas.
