## **IMPORTANT SAFETY RECALL**

### **Airstream Travel Trailer**

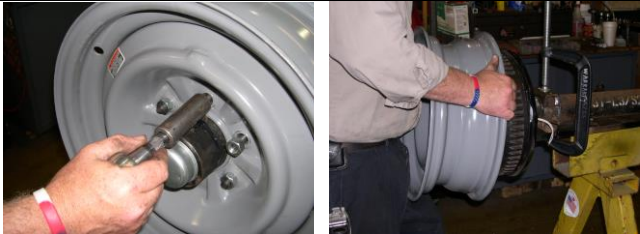
<p>3. Remove the Grease Cap using a cap remover, socket, or a hammer and flat head screwdriver.</p>

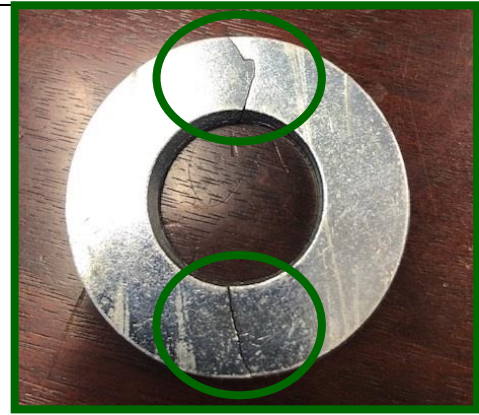
**ALL PIECES PRESENT. PROCEED WITH SPINDLE WASHER REPLACEMENT.**

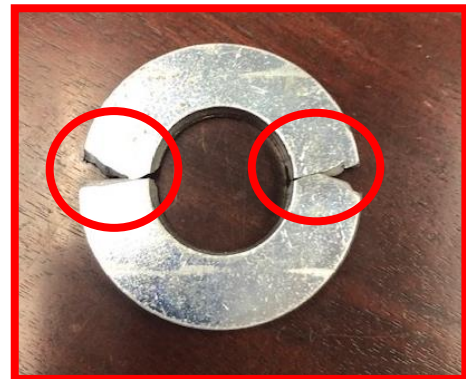
**SPINDLE WASHER IS MISSING PIECES WHICH COULD NOT BE LOCATED. THE HUB MUST BE REPLACED.**

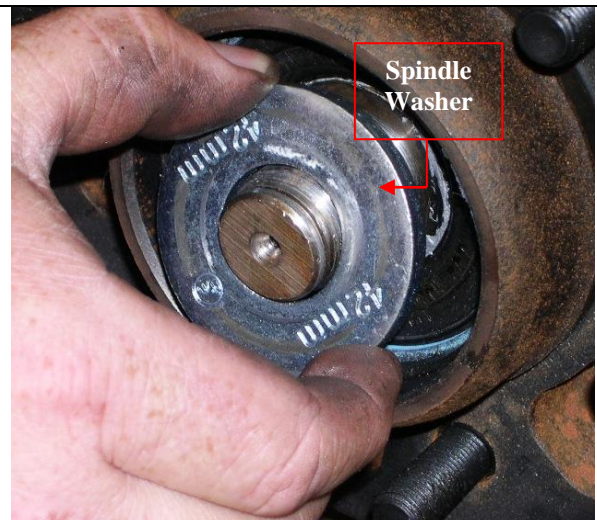
7. Install the Spindle Nut. Make sure to Start and run the Spindle Nut by Hand to avoid cross threading the Spindle Nut onto the Spindle.
