Recall Campaign Bulletin

Campaign No. 2022070006, August 2022

SUBJECT: **Model GLS-Class (167 platform)**
Model Year 2020

Repair Upfront Airbag Sensor Wiring Harness Routing

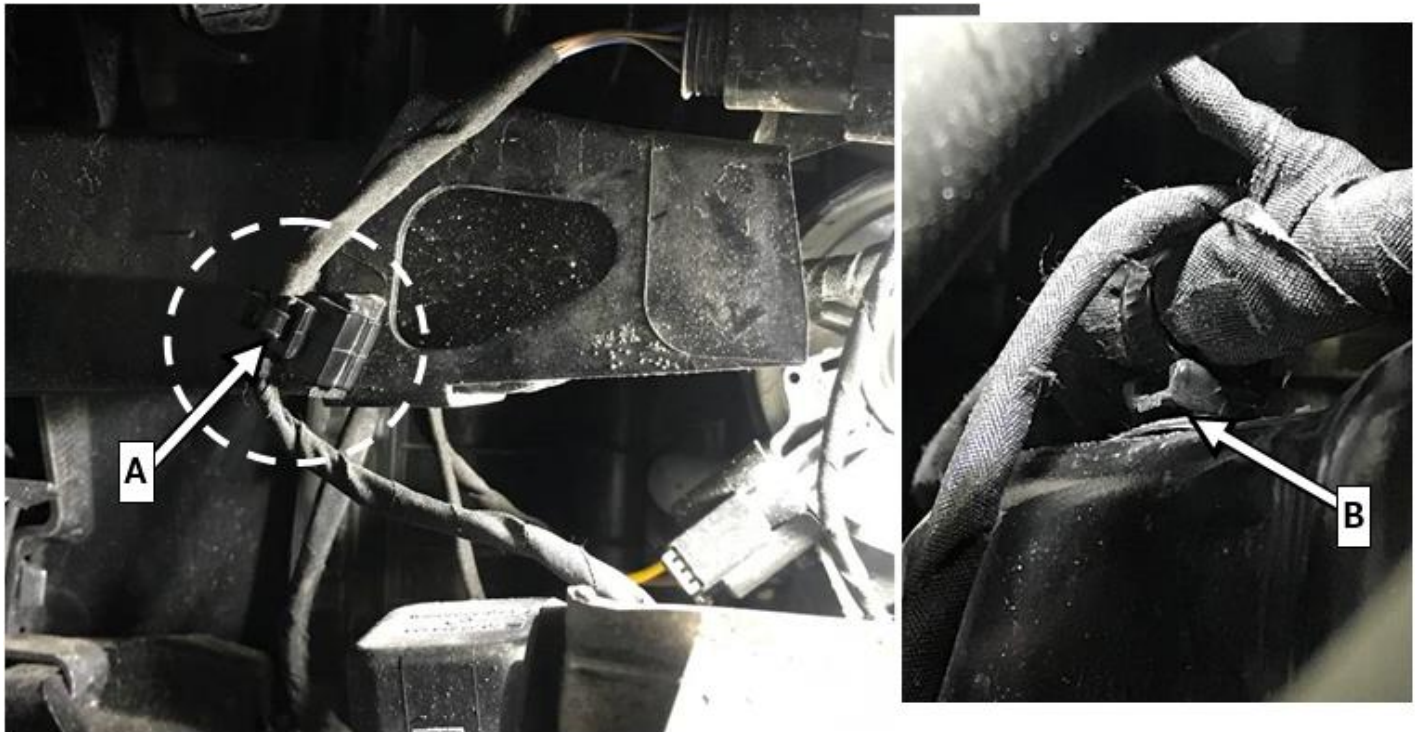
i Figure 3 depicts the original brackets, cable ties, and wire routing for easier identification.
