SR23-82

BAD GPS CONNECTION AT THE VECU CONTROL UNIT 9700 (B13R)

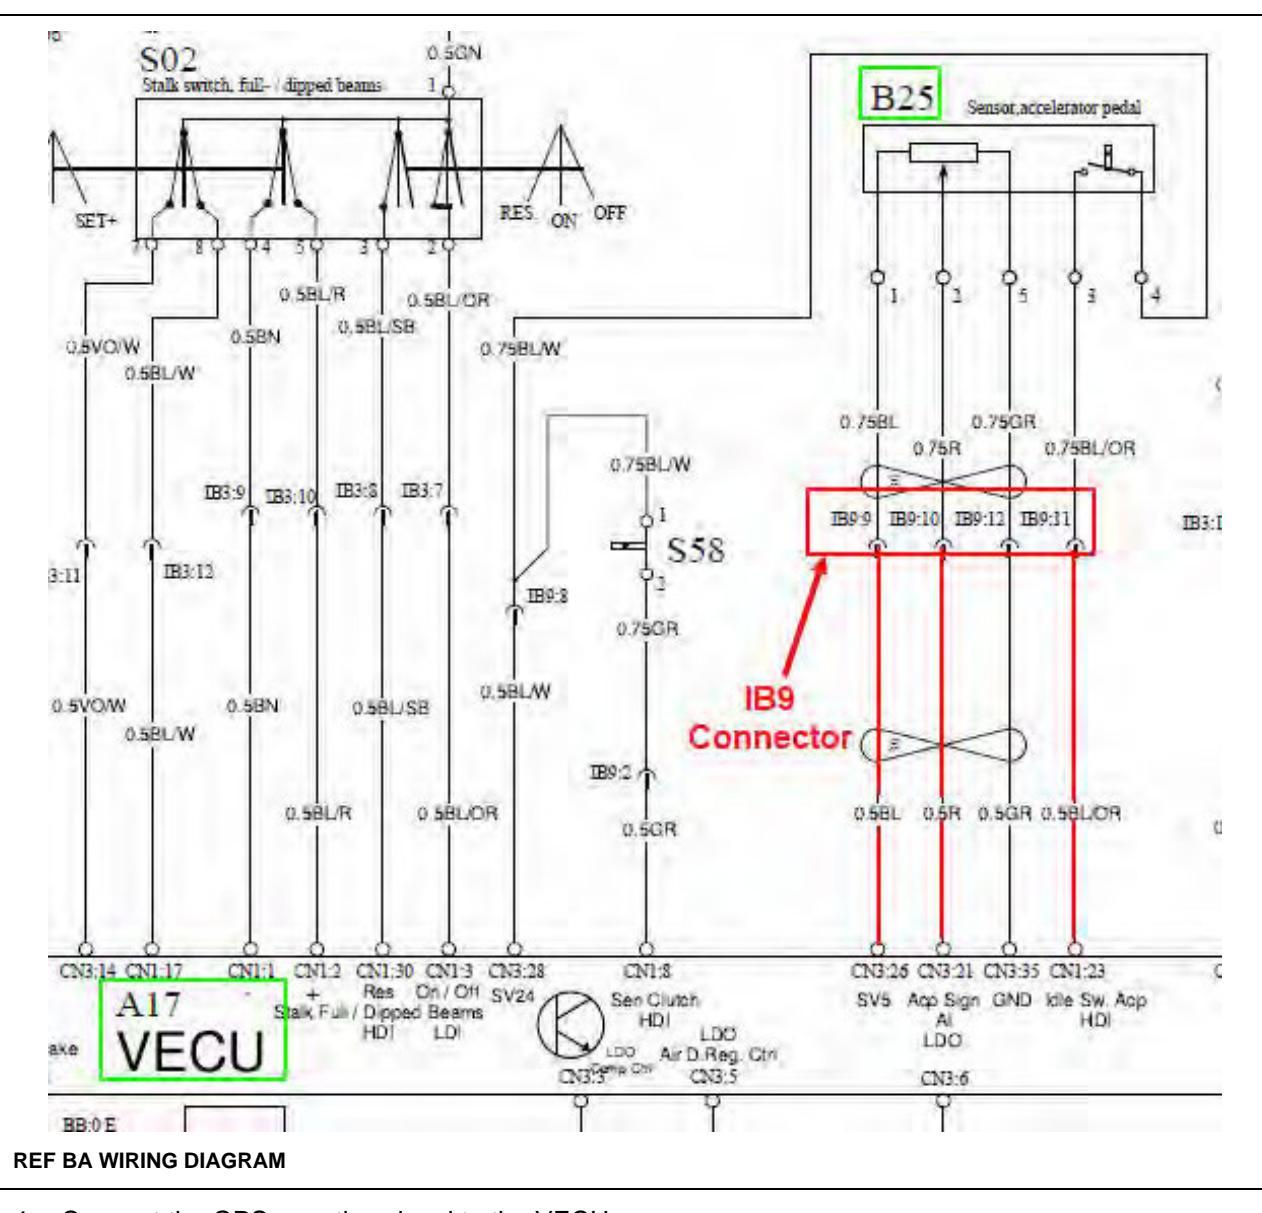
3. Remove the GPS component digital signal connection.		2.6	11	2	-12
• The bad digital signal connection of the GPS is located between VECU (A17) and the throttle position sensor (B25), therefore; look for spliced GPS wires near the IB9 connector of the power distribution center in the vehicle electrical center compartment.				5	4
NOTE			17	A	-
The digital signal of the GPS can be spliced to the wires located at PIN9, 10 or 11 of the IB9 connector as seen below.					1
<ul> <li>Once the GPS digital signal is located, remove it from the IB9 connector corresponding wire. This wire of the IB9 connector must be repaired to ensure proper "interference free" signal so the throttle response is back to normal operation. This will also resolve the VECU communication problem with the CAN network.</li> </ul>	No the second se

• Repair the wire using supplied butt splice connector and shrink tubing (solder the connection).		× Y			
NOTE	10	13-12	1.12	11	
Do not remove or modify other GPS connections. The problem only exist at the digital signal connection.		X	X

- 4. Connect the GPS negative signal to the VECU.
  - The GPS must send a negative LDI signal(-) from the power distribution center located in the vehicle electrical center compartment to the VECU vehicle control module.
  - To send the correct GPS signal, the GPS signal wire must be connected to PIN12 of the power distribution center BB13 connector (BB13:12). This connection will send the signal to PIN17 of the VECU control module CN3 connector (CN3:17 see wiring diag. BA).

Connect the GPS negative signal wire to the power distribution center using supplied wire and terminals (use shrink tubing and solder the terminals)
