Emissions Campaign Bulletin

Campaign No. 2022120013, January 2023

SUBJECT: Model 906 (Sprinter) Model Year 2010-2015 Check NOx Sensors

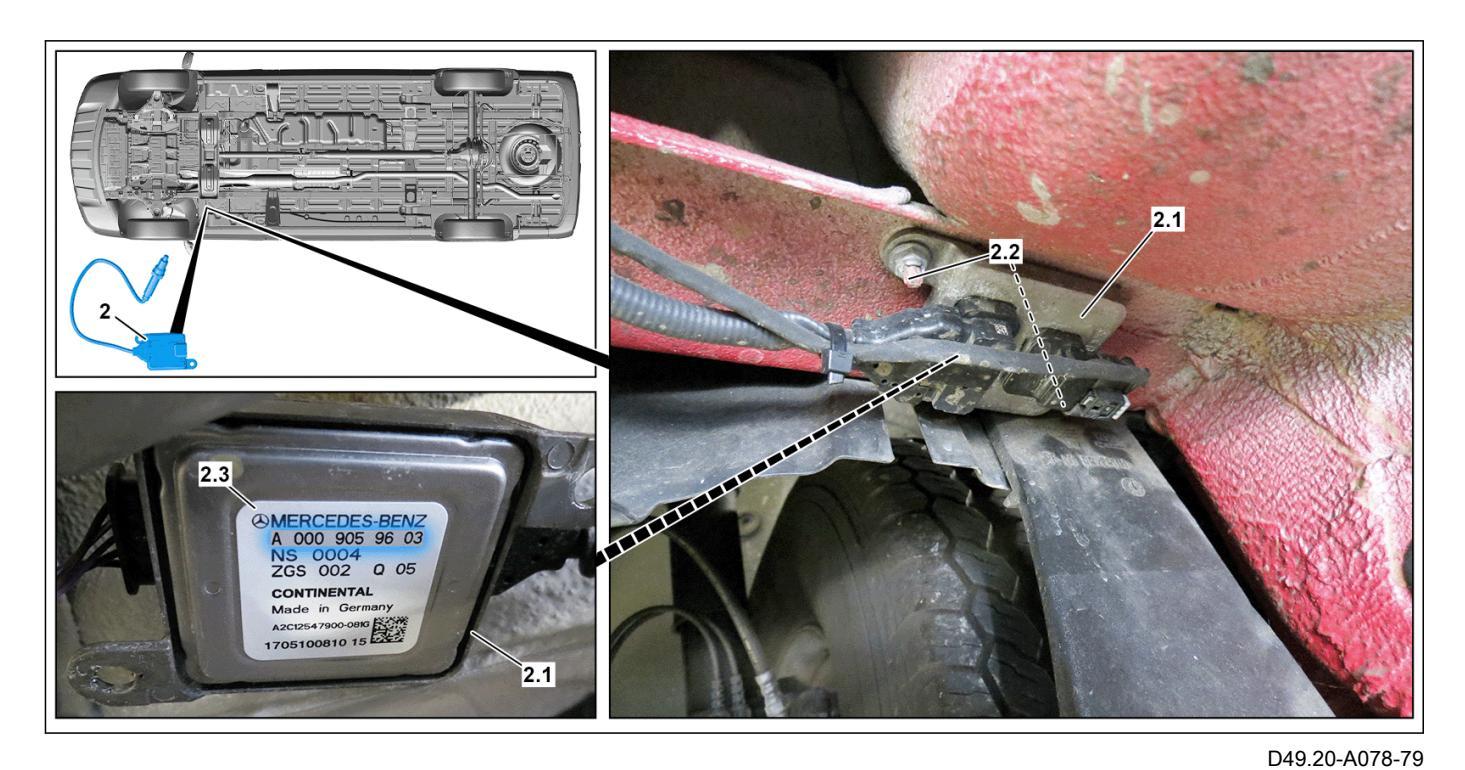
D00.00-A001-76

Shown on veh. with engine 642, NO_Xsensor (2.1) control unit upstream of SCR catalytic converter at wheel well crossmember, right side of vehicle

2	NO _x sensor upstream of	2.2	
	SCR catalytic converter		
2.1	NO _x sensor control unit

5	Remove NO _X sensor control unit (2.1) upstream of SCR catalytic converter at crossmember.	i For this, remove nuts (2.2).

4	Check		
6	Check part number of NO _X sensor	i	
	upstream of SCR catalytic converter (2).	For this, compare the part number on the information label (2.3) of the NO_X sensor control unit (2.1) with the part number shown in XENTRY Parts Information ("Main groups" 49).	
		i To compare the NO _X sensors installed upstream of the SCR catalytic converter (2), the vehicle must be selected using the FIN/VIN in XENTRY Parts Information.	
		If the part number of the installed NO _X sensor upstream of the SCR catalytic converter (2) is the same as the part number according to XENTRY Parts Information,	
		Attach NO _X sensor control unit (2.1) and proceed with operation step 7.	
		If the part number of the installed	BA00.10-Z-1002-01KOA
		NO _X sensor upstream of the SCR catalytic converter (2) is not the same as the part number according to XENTRY Parts Information,	
		Replace NO_X sensor upstream of SCR catalytic converter (2) and proceed with operation step 7.

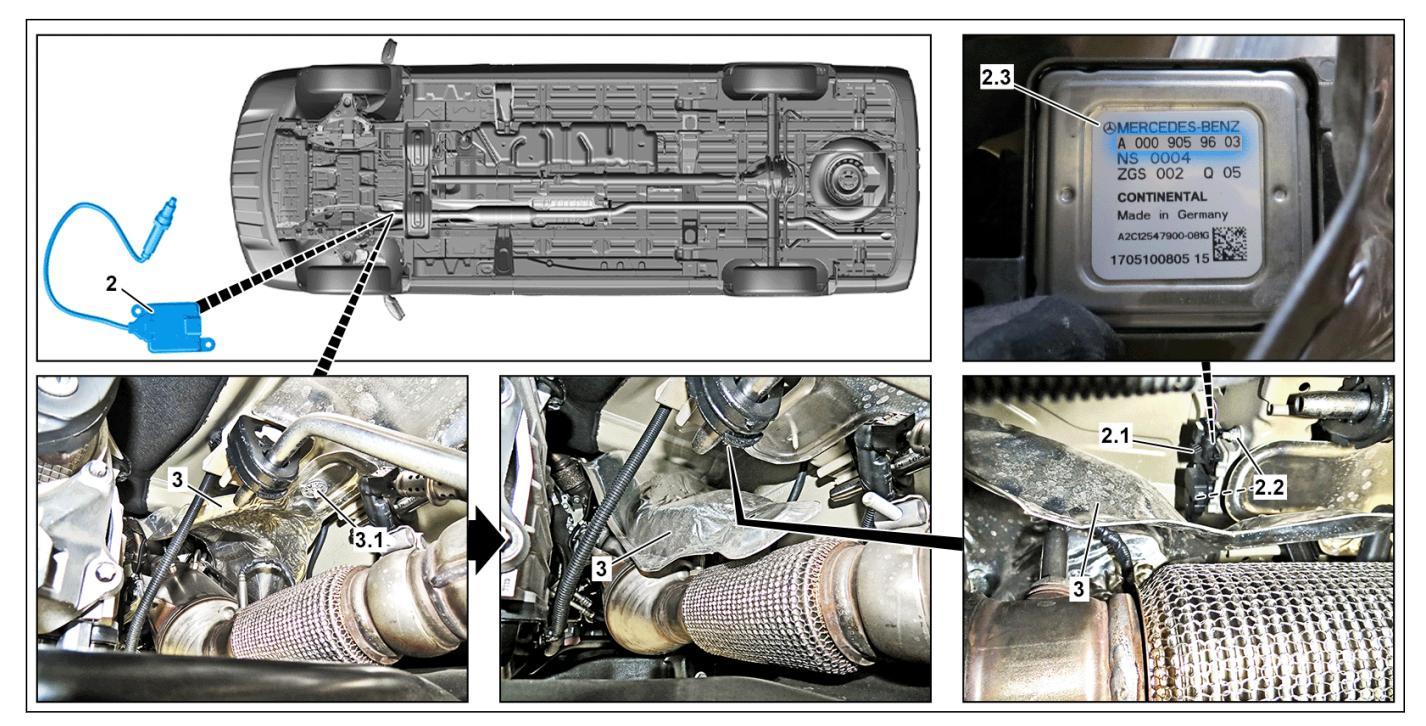
D49.20-A079-79

Shown on veh. with engine 642, NO_X sensor (2.1) control unit upstream of SCR catalytic converter at crossmember via exhaust system

2	NO _x sensor upstream of	2.2	Nuts	3	Heat shield
	SCR catalytic converter				
2.1	NO _x sensor control unit	2.3	Information label	3.1	Spring nut

7	Carefully bend heat shield (3) back and attach at crossmember.	If NO _X sensor control unit (2.1) upstream of SCR catalytic converter is installed at crossmember above exhaust system. i For this, attach spring lock nut (3.1).	
8	Carefully bend heat shield (4) to one side in area of NO _X sensor control unit (5.1) downstream of SCR catalytic converter.		
9	Remove NO _X sensor control unit (5.1) from longitudinal member.	i For this, remove nuts (5.2).

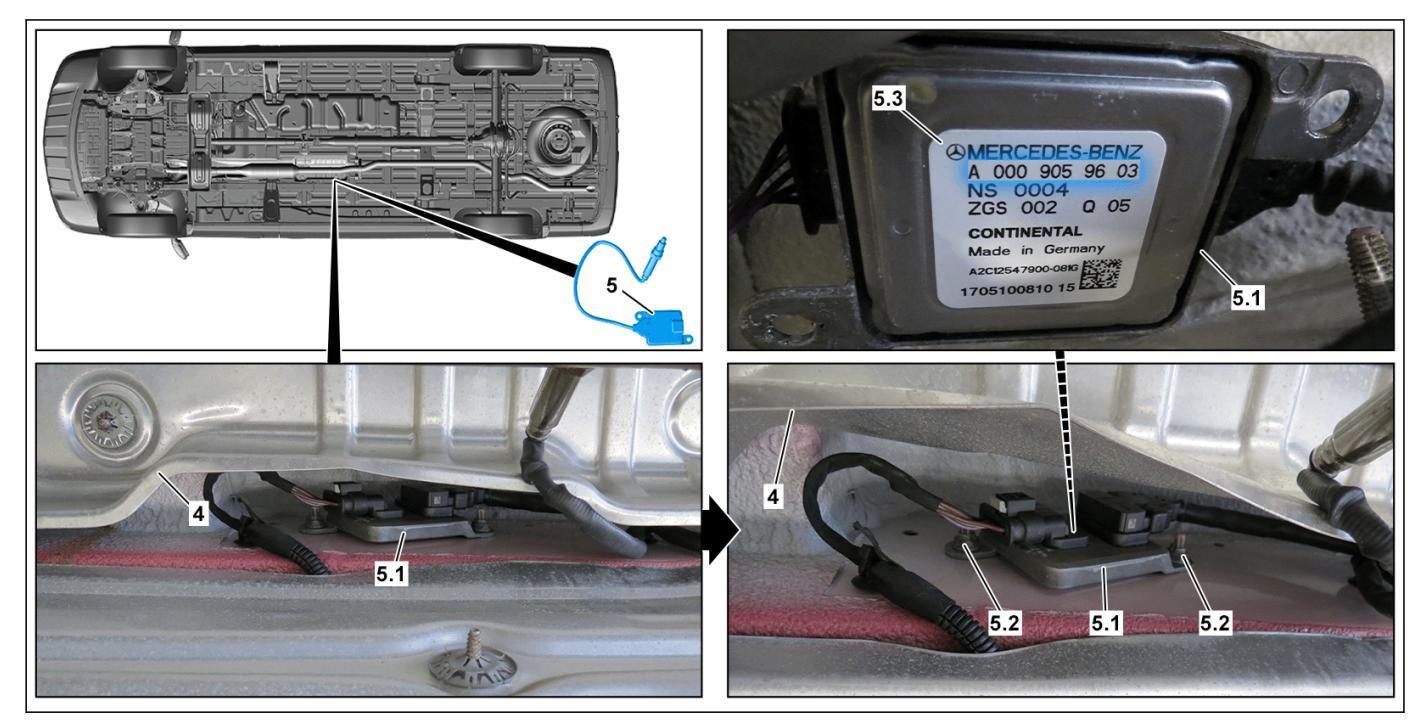
D49.20-A080-79

NO_xsensor control unit (5.1) downstream of SCR catalytic converter at longitudinal member

Heat shield	5.1	NO _X sensor control unit	5.3	Information label
NO _x sensor downstream of	5.2	Nuts

Check		
10	Check part number of NO _X sensor	i	
	downstream of SCR catalytic converter (5).	For this, compare the part number on the information label (5.3) of the NO_X sensor control unit (5.1) with the part number shown in XENTRY Parts Information ("Main groups" 49).	
		i To compare the NO _X sensor installed downstream of the SCR catalytic converter (5), the vehicle must be selected using the FIN/VIN in XENTRY Parts Information.	
		If the part number of the installed NO _X sensor downstream of the SCR catalytic converter (5) is the same as the part number according to XENTRY Parts Information,	
		Attach NO _X sensor control unit (5.1) and proceed with operation step 11. Mm M6	BA00.10-Z-1002-01KOA
		If the part number of the installed NO _X sensor downstream of the SCR catalytic converter (5) is not the same as the part number according to XENTRY Parts Information,	
₩ ^{SE} AR		Replace NO_X sensor downstream of SCR catalytic converter (5) and proceed with operation step 11. Remove/install NOx sensor downstream of SCR catalytic converter Engine 642 in model 906 with code XM0 (Facelift), engine 642.898 in model 906 except code XM0 (Facelift), engine 651 in model 906 with code XM0 (Facelift) i Do not yet perform commissioning of the NO _X sensor downstream of the SCR catalytic converter (5).	AR14.40-D-2060M
