TECHNICAL INSTRUCTIONS

SAFETY RECALL JOY

REAR AXLE HUB BEARING BOLT INSPECTION

CERTAIN 2019 C-HR

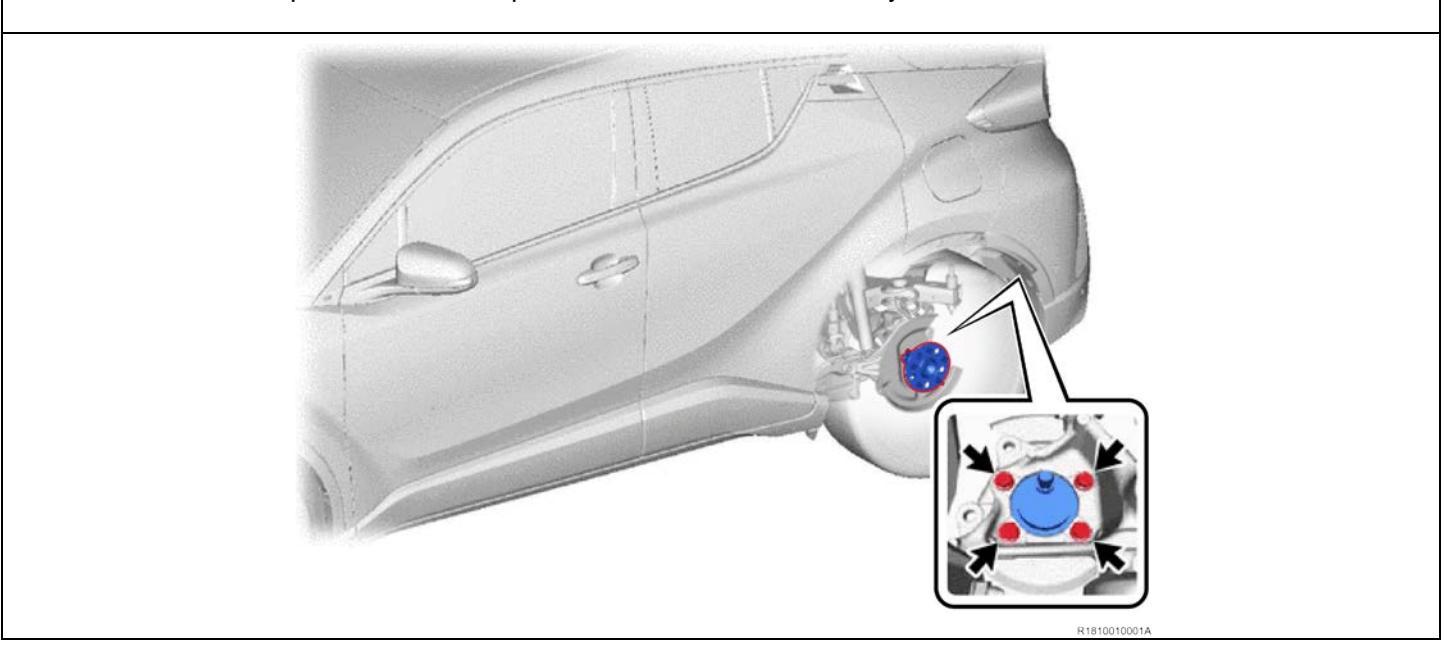
There is a possibility that one or more rear axle bearing bolts on some vehicles may not have been tightened sufficiently during the manufacturing process. If one or more bolts become loose or detach during vehicle operation, they could damage the rear brake components or could cause the rear wheels to detach, resulting in reduced brake performance or a potential loss of vehicle stability. This could increase the risk of a crash.

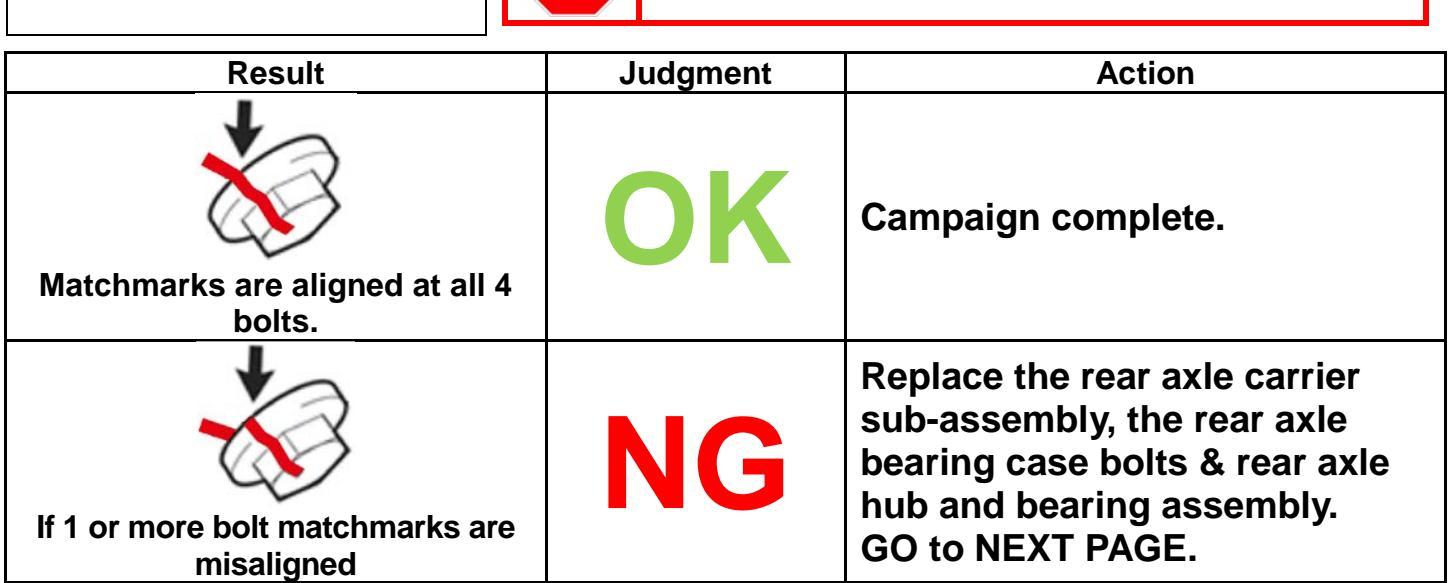
c. Check to see if the matchmarks are aligned or not

- 2. INSPECT THE TORQUE OF THE REAR AXLE BEARING CASE BOLT
 - a. Put a matchmark on each bolt
 - b. Tighten each bolt to 58 ft.lbs (79 N*m) using a torque wrench

VI. REPLACE THE REAR AXLE CARRIER SUB-ASSEMBLY & REAR AXLE HUB AND BEARING ASSEMBLY (ONLY PERFORM IF YOU FOUND ONE OF THE BOLTS TO BE <u>NG</u> IN THE PREVIOUS STEP)

a. Replace the rear axle carrier sub-assembly, the rear axle hub and bearing assembly, and the rear bearing case bolts with *NEW* ones.
