Stacy L. Balzer Operating Director Service Engineering Operations Ford Customer Service Division Ford Motor Company P. O. Box 1904 Dearborn, Michigan 48121

November 22, 2022

SUBJECT: Customer Satisfaction Program 21M05 - Supplement # 3 Certain 2017-2022 Model Year Super Duty Vehicles Equipped with a Power Release Tailgate - Unintended Tailgate Opening

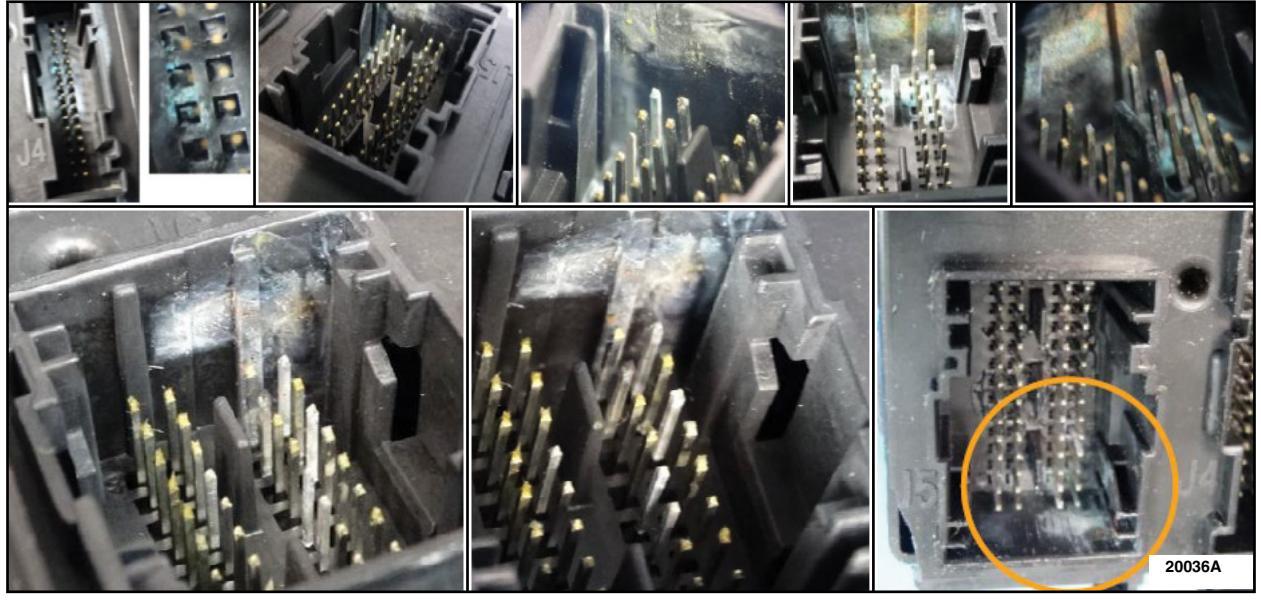
- 5. Remove the Body Control Module (BCM). Please follow the WSM procedures in Section 419-10.
- 6. Inspect the BCM for any sign(s) of moisture and/or corrosion. See Figure 1 for examples of corrosion. - Was any sign(s) moisture and/or corrosion present?

- Yes Photo(s) of BCM water contamination MUST be submitted to the Special Service Support Center (SSSC) prior to continuing with water leak diagnostics. Then proceed to Step 8.

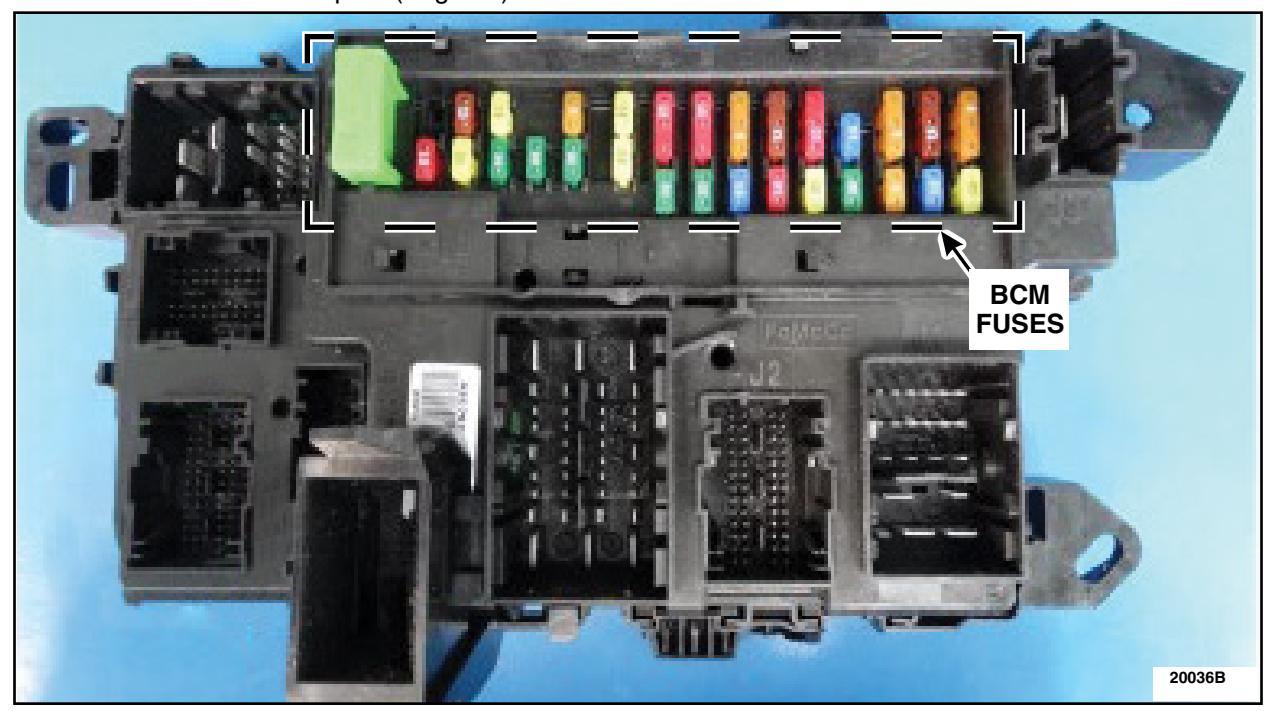
7. Remove each BCM fuse, one at a time, and inspect for any sign(s) of moisture and/or corrosion. See Figure 2.

Yes - Photo(s) of BCM water contamination MUST be submitted to the SSSC prior to continuing with water leak diagnostics. Then proceed to Step 8.
 No - Proceed to Step 36 (Page 12).

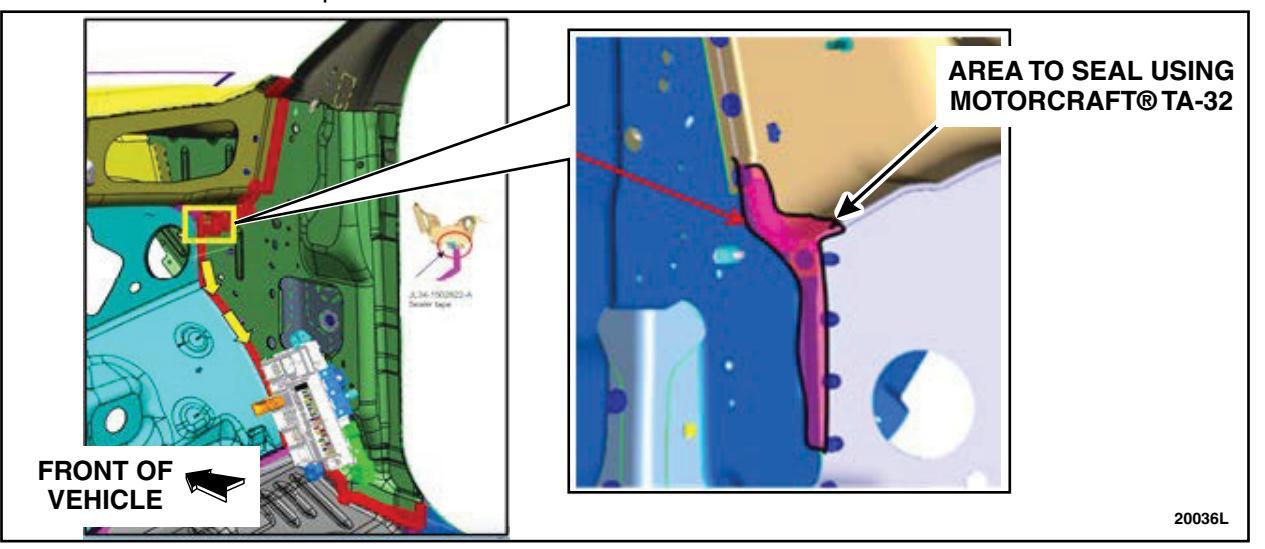
FIGURE 12

- 21. Remove the Instrument Panel. Please follow the WSM procedures in Section 501-12.
- 22. Verify the location of the water leak by repeating Step 19.
- 23. Using Motorcraft® TA-32 Clear Silicone Rubber Sealer or equivalent, apply a bead along the body patch and allow it to dry. See Figure 12. Retest by performing Step 19 once the Clear Silicone Rubber is dry.

Yes - Apply more sealant by performing Step 23. No - Proceed to Step 24.
