BECHNICAL Service Bulletin		GROUP	NUMBER			
		RECALL	17-01-011			
		DATE	MODEL(S)			
		JANUARY 2017	SONATA (LFa) ELANTRA (AD/ADa)			
SUBJECT:	DRIVER AIR BAG (DAB) INSPECTION / REPLACEMENT (RECALL CAMPAIGN 156)

## SUBJECT: DRIVER AIR BAG (DAB) INSPECTION / REPLACEMENT (RECALL CAMPAIGN 156)

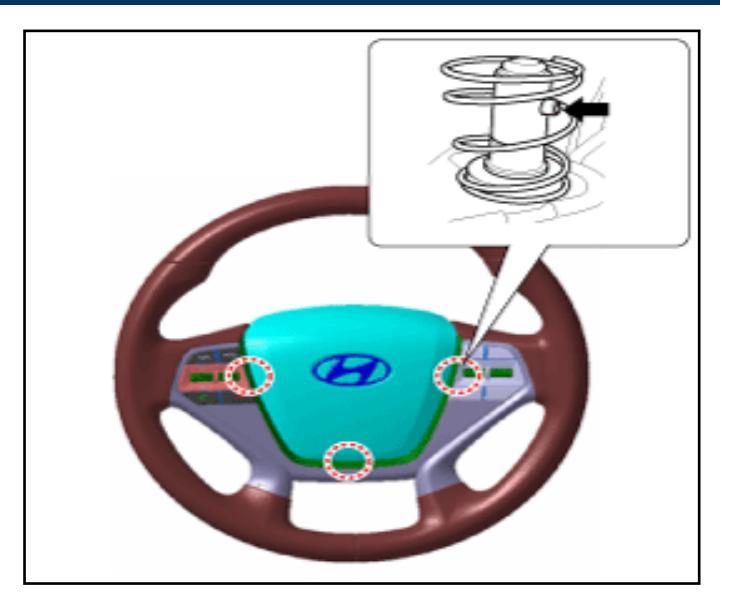
4. Locate the 3 locking points of the Driver Air Bag (DAB).

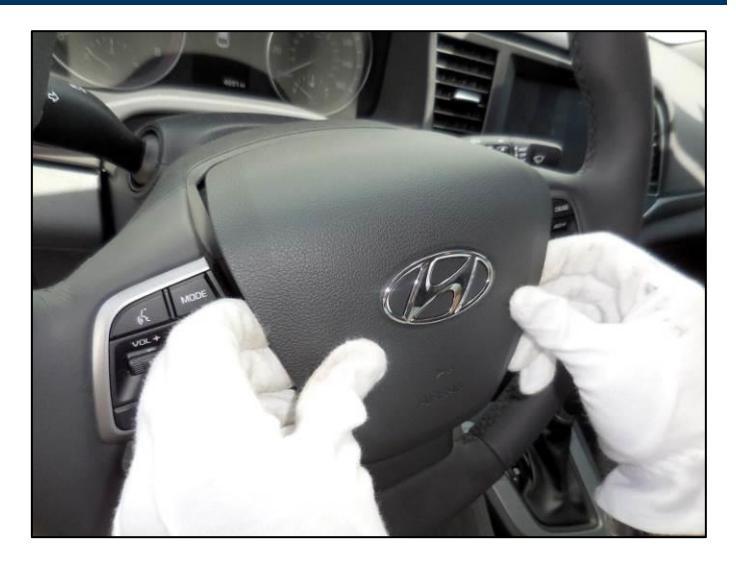
Be careful not to damage the clock spring connections.

Gently remove the Driver Air Bag (DAB) module from the steering wheel after depressing the snap fit pin stopper.

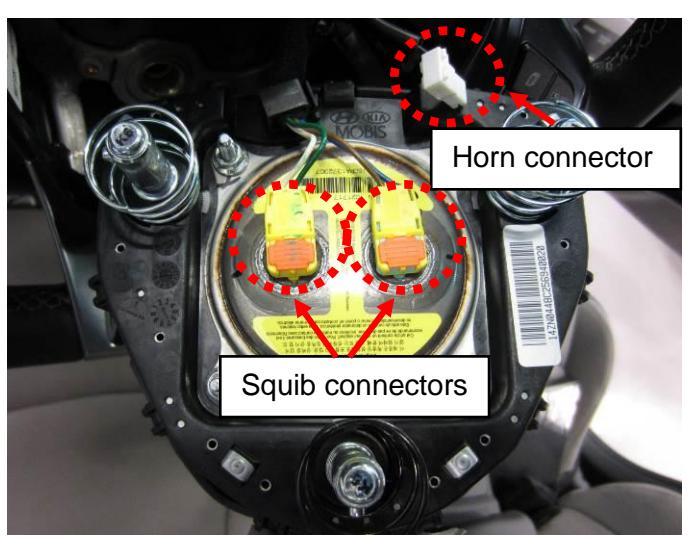
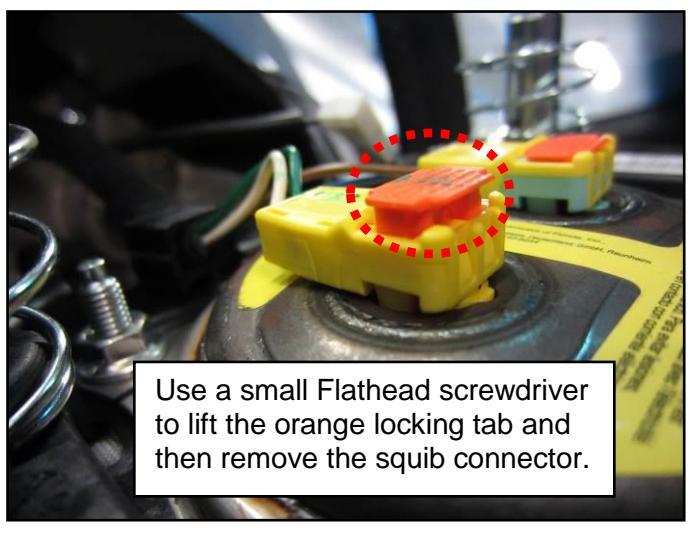
#### <u>Sonata</u>

Sonata squib connectors have an orange locking tab at the top that can be released using a small flathead screwdriver.

The removed air bag module should be stored in a clean, dry place with the pad cover facing up.

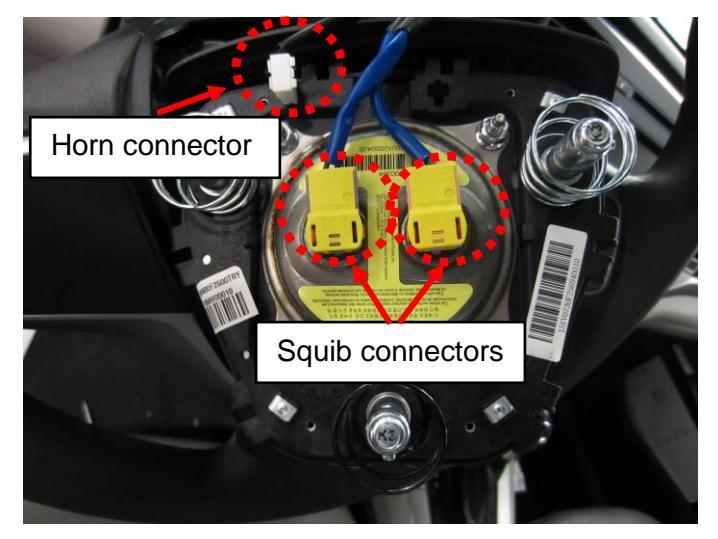
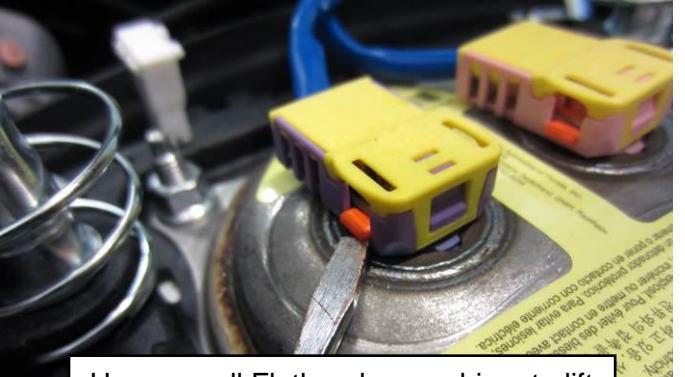
#### **Elantra**

Elantra squib connectors have an orange locking mechanism on either side of the connector that needs to be pulled up (away from DAB assembly) to release the connector.

Use a small Flathead screwdriver to lift the orange locking tab from both sides and then remove the squib connector.
