Updates from Warranty Operations

WK Shifter Bezel Collateral Damage

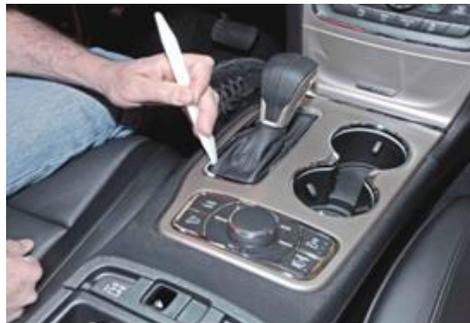
Figure 1

1. Removal of the gear selector boot: If a plastic trim stick is not used, damage to the plastic can occur. The boot must be pried off at the attachment points (see Figure 1). There is high retention on the boot to the bezel and if not carefully performed, may cause the technician to think that the boot is part of the chrome ring, hence the technician trying to pry the chrome ring from the bezel. This may be caused by technicians not familiar with the design/vehicle.

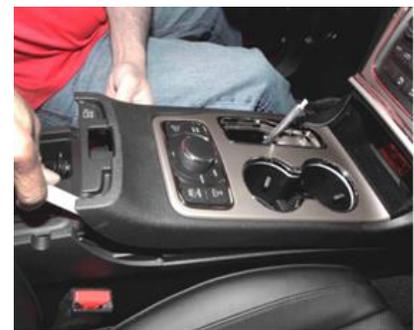
Figure 2

2. Removal of the shift bezel:
 - Detaching the bezel from the center console: A trim stick must be used to prevent damage and it must be used to pry the attachment points. The technician must work the trim stick around the bezel, not pry on one side and pull off. To do so will fracture or will break the attachment anchors from the bezel (see Figure 2).

- Damage to the bezel in each of the steps can be caused by removing these parts using a screw driver or other sharp instrument. You will most likely find scratches or cracking of the outer ring on the bezel. Additionally, in some cases, you will also find the attachment anchors broken because of high retention of the anchors to the center console and improper removal of the bezel.

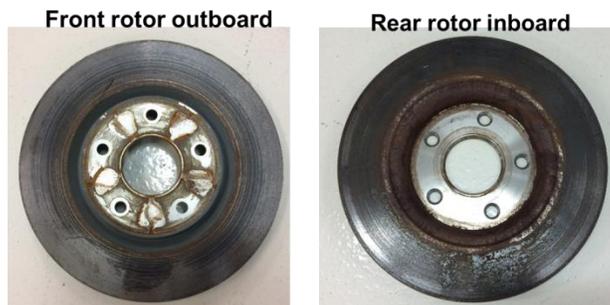
Below are brake rotor examples for vehicles that remained stationary too long, which cause corrosion between the caliper and rotor from moisture. The effects of this will result in a noise and/or vibration complaint.

1. Perform several brake applies, from 50-30 mph, to clean off the rotors.
2. Take the vehicle on a smooth highway, and at 60 mph apply the brake lightly such as you're slowing down to exit the highway. Do this several times, noting any vibration either felt through the seat/body or through the steering wheel.
3. If steering wheel nibble or oscillation exists, that indicates the front rotors are likely the issue. If vibration is only felt through the seat/body, the rear rotors are likely the issue and less likely the front. A combination might indicate both front and rear rotors are an issue. Smooth braking indicates no issue.
4. Reface or replace front and/or rear rotors as necessary, per test drive, to resolve the vibration/pulsation (judder) issue.

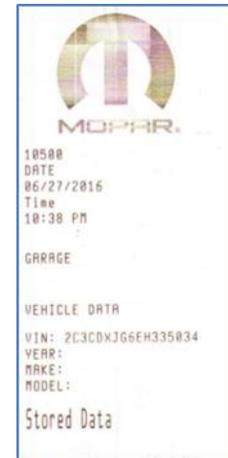
If by some chance the slip to support the repair is not printed at the time of the repair the machine has the ability to reprint store data. The slip will show the statement "stored data" as shown here.

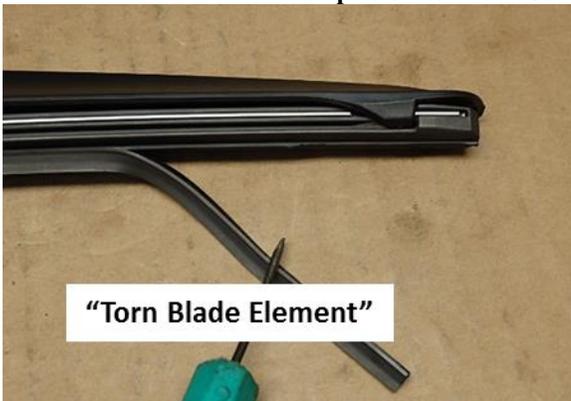
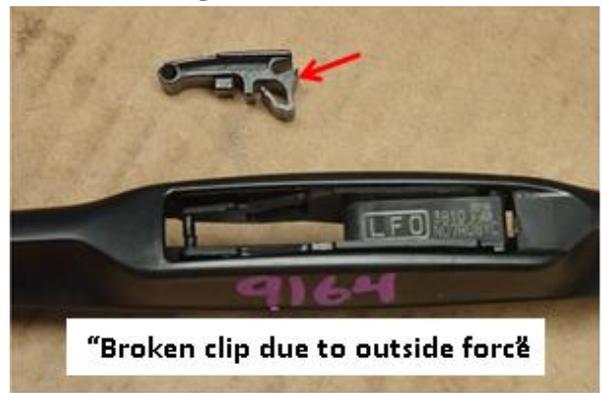
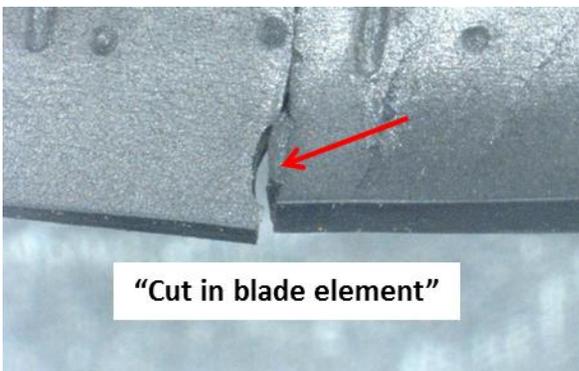
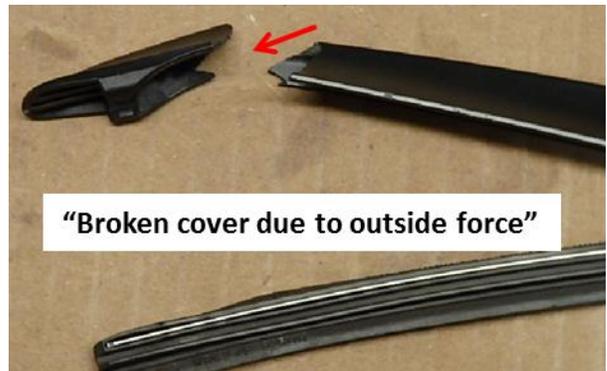
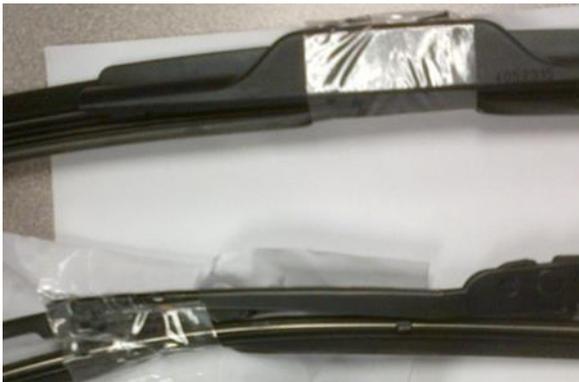
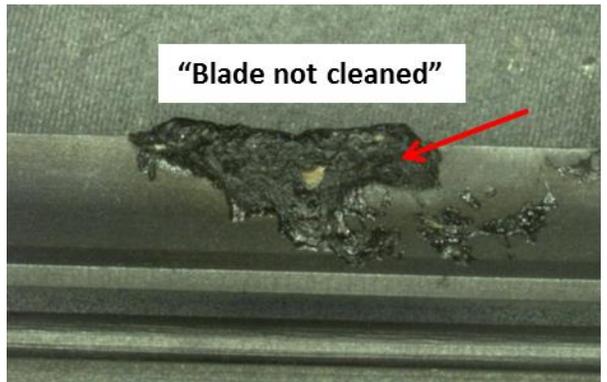
Examples of Potential Customer Abuse / Chargeback Conditions:

must be tested prior to replacement. In many cases, cleaning will correct performance issues. Blades that are torn or have obvious damage from ice scrapers or other outside forces are not warrantable. When blades are returned to FCA, ensure that packing tape does not come into contact with the wiper element.
