SERVICE BULLETIN

APPLICABILITY: 2013-14MY Legacy and Outback Models with 2.5L FB Engines 2011-14MY Forester Models with 2.5L FB Engines 2015 MY Forester (Manual Transmissions Only) with 2.5L FB Engines 2012-13 MY Impreza and XV Crosstrek Models with 2.0 FB Engines 2014-15 MY Impreza and XV Crosstrek Models (Manual Transmissions Only) with 2.0 FB Engines

SUBJECT: Engine Oil Consumption

NUMBER: 02-157-14R **DATE:** 08/28/14 **REVISED:** 01/26/21

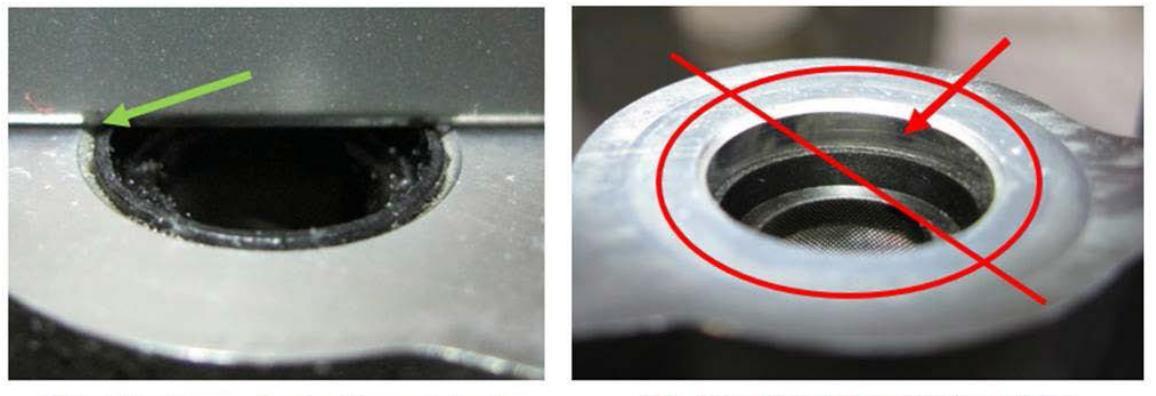
<u>OK</u>- Filter Screen <u>flush</u> with machined surface of camshaft carrier.

<u>NG</u>- Filter Screen installed <u>too deep</u> into the camshaft carrier bore.

• IMPORTANT: The one-time use AVCS filter screens in the cam carriers are available separately (p.n. 14451AA050). NOTE: Although the filter screens are not directional, they must be installed flush with the machined surface of the cam carrier as shown in the OK photo below. The NG photo shows the screen installed too deep into the camshaft carrier. Engines with AVCS on both intake and exhaust will have 2 filters in each carrier as opposed to just one (intake only AVCS).

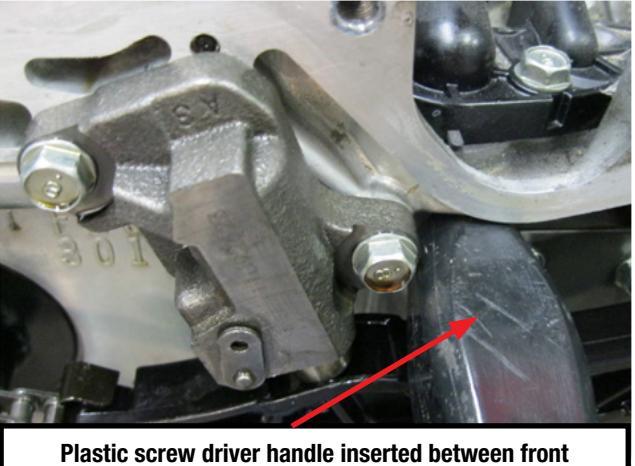
Plastic screw driver handle inserted between front lip of the block and the B2 upper chain guide VERY CAREFULLY pushing downward on the upper guide.

• If necessary, insert a plastic screwdriver handle between the lip of the block and the left side (B2) guide. Then, **VERY CAREFULLY** push down on the guide just enough to get the extra tensioner notch / "click". When using this method, always make sure you are using plastic on plastic and NOT metal on plastic to avoid damaging the chain guides.

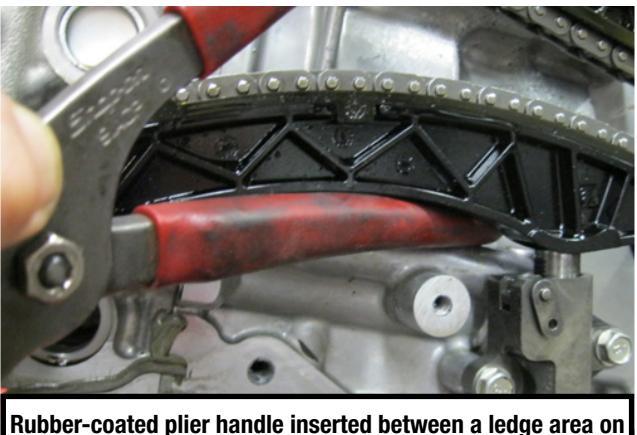
Rubber-coated plier handle inserted between a ledge area on the front of the block and the B1 lower chain guide VERY CAREFULLY lifting upward on the lower guide.

• Same as the left side, align the indicator links to the timing marks found on the cam sprocket assemblies. Install the chain guides and tensioner. Once proper positioning has been confirmed, pull the pin to release the tensioner. With your hand, grab and squeeze the upper and lower left side chain / guides together to allow the plunger in the tensioner to extend fully and click into its furthest notch as shown in the previous (right side) photo. If necessary, insert a rubber-coated plier handle between the ledge area on the front of the block and the right side (B1) lower chain guide. Then, **VERY CAREFULLY** lift up on the guide just enough to get the extra "click" on the tensioner as shown in the photo below.
