Service Bulletin

Subject: Poor Engine Performance in Extremely Cold Weather Conditions for LE2 Engines, Charge Air Cooler Icing - Malfunction Indicator Lamp (MIL) Illuminated, DTC P0299, P0234, P2227, P00C7 Set

Brandi	Model:	Model Year:		VIN:		Engino	Tronomiccion
Brand:		from	to	from	to	Engine:	Transmission:
Duiek	Encore	2016	2019	_	_	1.4L (RPO LE2)	_
BUICK		2021	2022				
Chevrolet	Trax	2021	2022

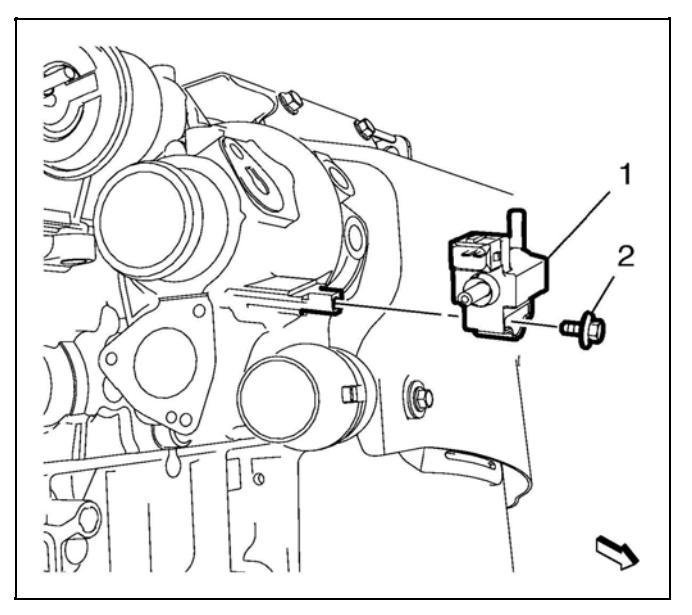
3686945

Turbocharger Wastegate Regulator Solenoid Valve (TCV) Thermo-Wrap

- Remove the turbocharger wastegate regulator solenoid valve (1). Refer to *Turbocharger Wastegate Regulator Solenoid Valve Replacement* in the Service Manual.
- Drain the turbocharger wastegate regulator solenoid valve (TCV) by turning the valve upside down.

Note: Check port #2 to assure the spring gets lifted off the seat. This will be determined by the compressed air not dead heading when applied to port #2. When applying air to this port a small amount of air should be observed at port #3 and even less air will be noticed at port #1. If this does not happen, the TCV plunger may have hardened deposits from hot operating conditions which will impede TCV plunger movement, and the turbocharger wastegate regulator solenoid valve should be replaced.

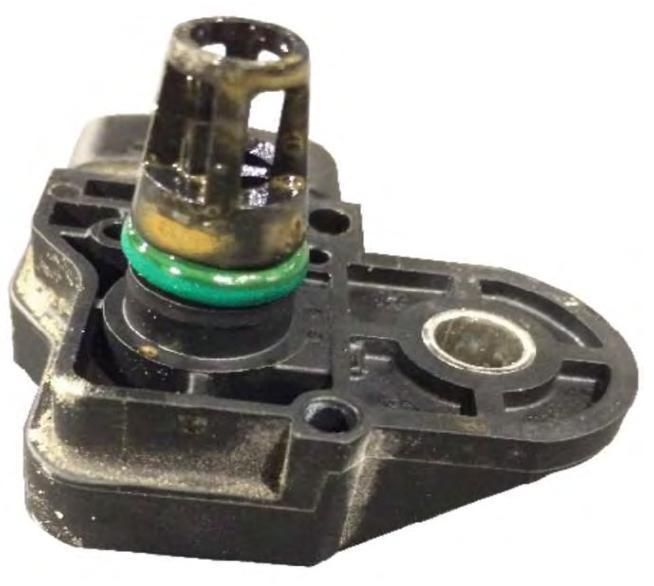
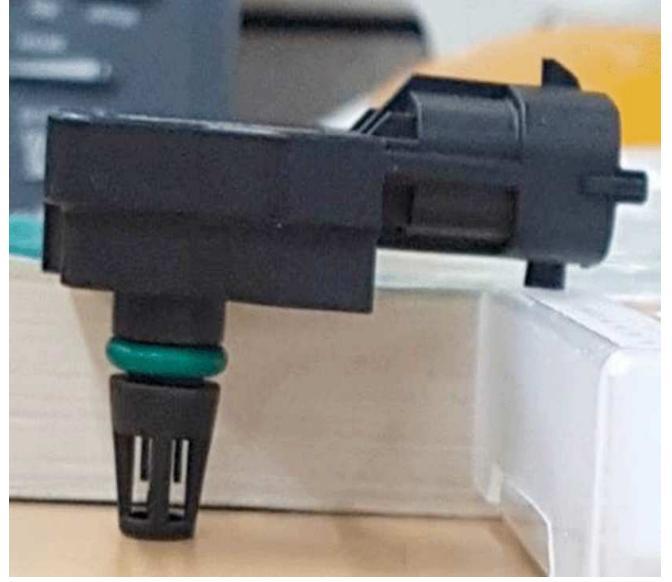
2. Inspect the sensor for any contaminates.

- 3. Allow time for any ice build-up to melt by placing the sensor port down.
- 4. Clean the sensor with a clean towel.
- 5. Install the sensor.

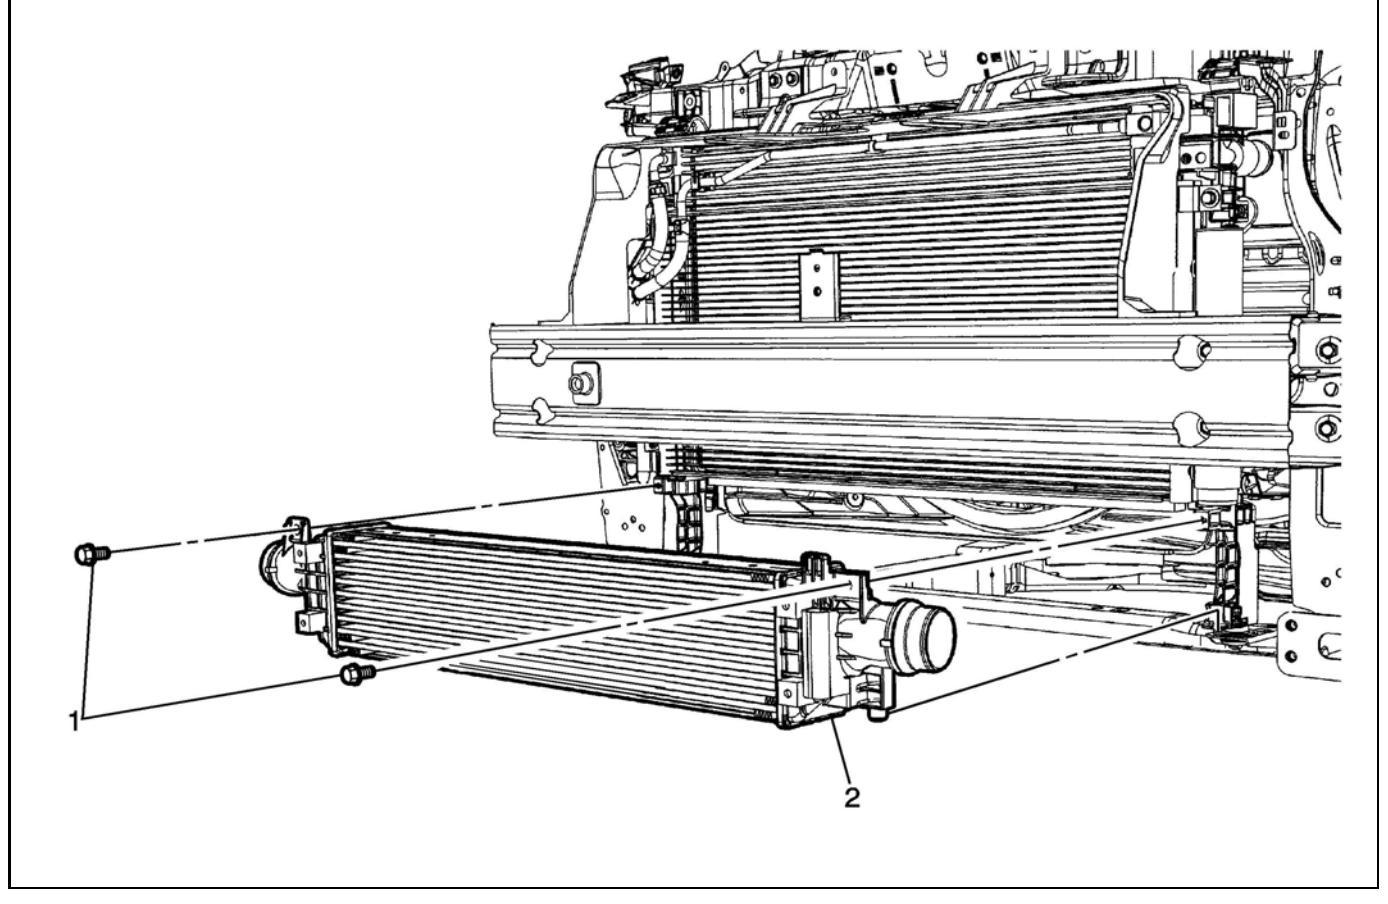
2851444

• P0234
	• P0299
	• P2227
	• P00C7
Cause	This condition may be caused by ice accumulation in the charge air cooler (CAC), restricting air flow to the throttle body.

1. Install the CAC (2). Refer to Charge Air Cooler Replacement in SI.
