SERVICE BULLETIN

- APPLICABILITY:2012MY Forester, Impreza and WRX Models
Equipped with Fujitsu Ten Audio / Navigation
SystemsNUMBER:15-155-12R
DATE:08/14/12REVISED:11/09/12
 - **SUBJECT:** Fujitsu Ten (F10) Audio/Navigation Unit SD Card Exchange Information Including Diagnosis and Troubleshooting for Specific Software-Related Conditions Which May Be Corrected Through A Programming Update

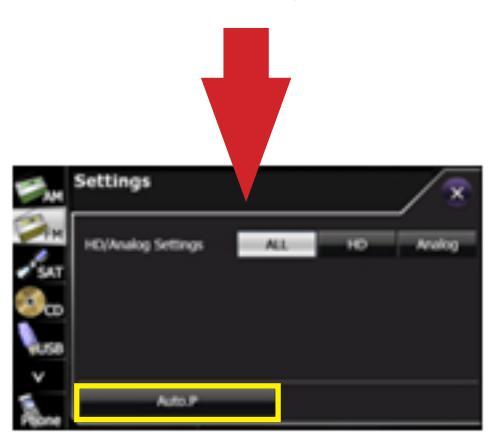
Condition 1:

When the "Auto. P" button is pressed on the "Settings" screen in AM or FM mode, a small "pop" noise is heard through the speakers. This condition may occur when the same radio station preset is saved twice in the "Preset" memory.

Speakers make a small "pop" noise

If the same FM preset is saved twice, change one to a different station

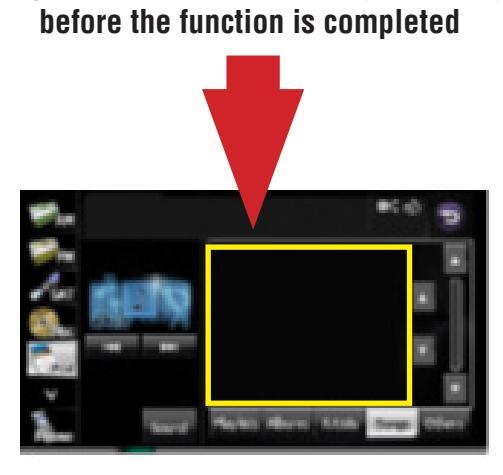
Condition 2:

Song titles are not shown in iPod mode. This condition may occur when the "Search" button on the "iPod Main" screen is pressed while the "Searching iPod Please wait..." message is displayed.

No song titles are shown

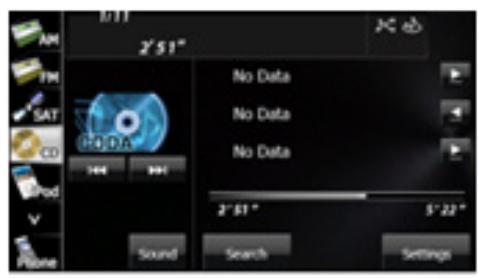
Condition 3:

CD playback is delayed for approximately 10 seconds after loading a CD or the CD mode is selected.

CD playback takes about 10 seconds to start

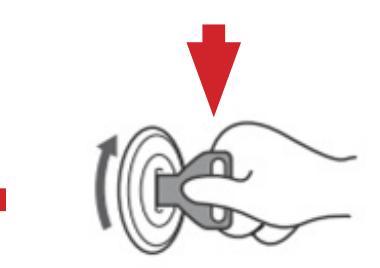
Condition 4:

FM radio can still be heard even if the audio unit is in "Audio Off" mode. This condition happens after "Delete Personal Data" button is pressed and cycling the ignition key off and back on again.

FM audio output continues in

"Audio Off" mode

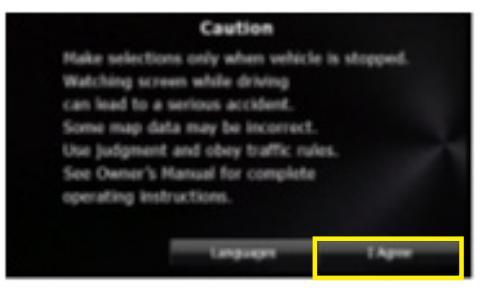
Condition 5:

"I Agree" button cannot be selected on the Caution screen.

"I Agree" button does not work

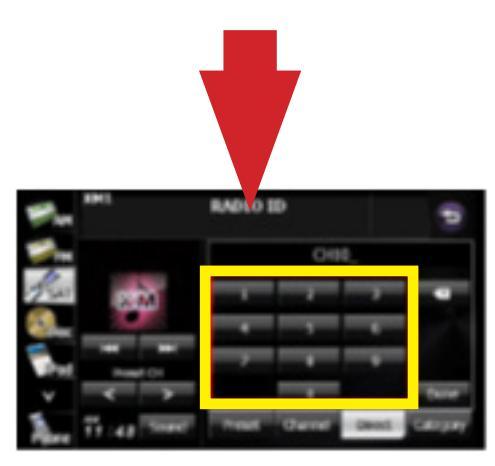
Condition 6:

In XM mode, the keypad appears normal but is inoperative while the vehicle is in motion. Once the vehicle is stopped, the keypad operates normally.

Although the keypad appears to be functional (not grayed-out), it does not operate unless the vehicle is stopped.

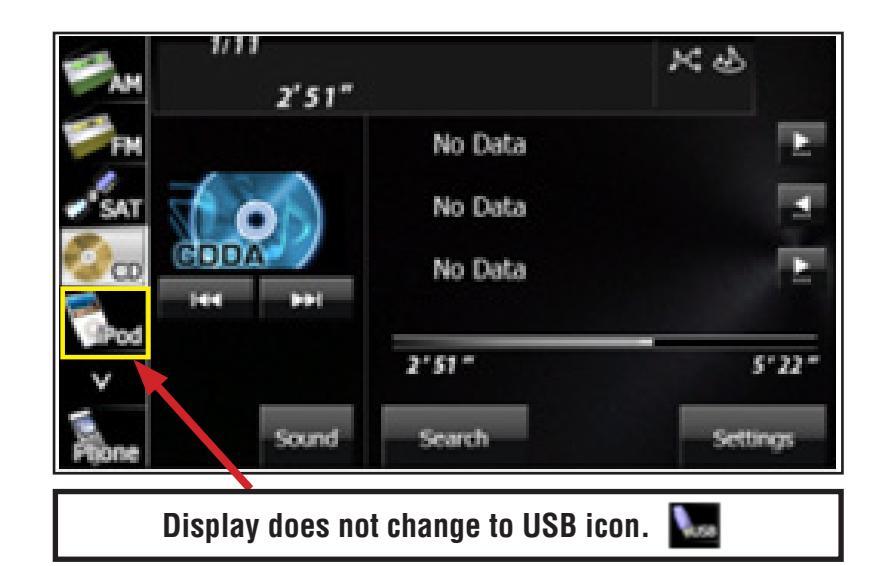
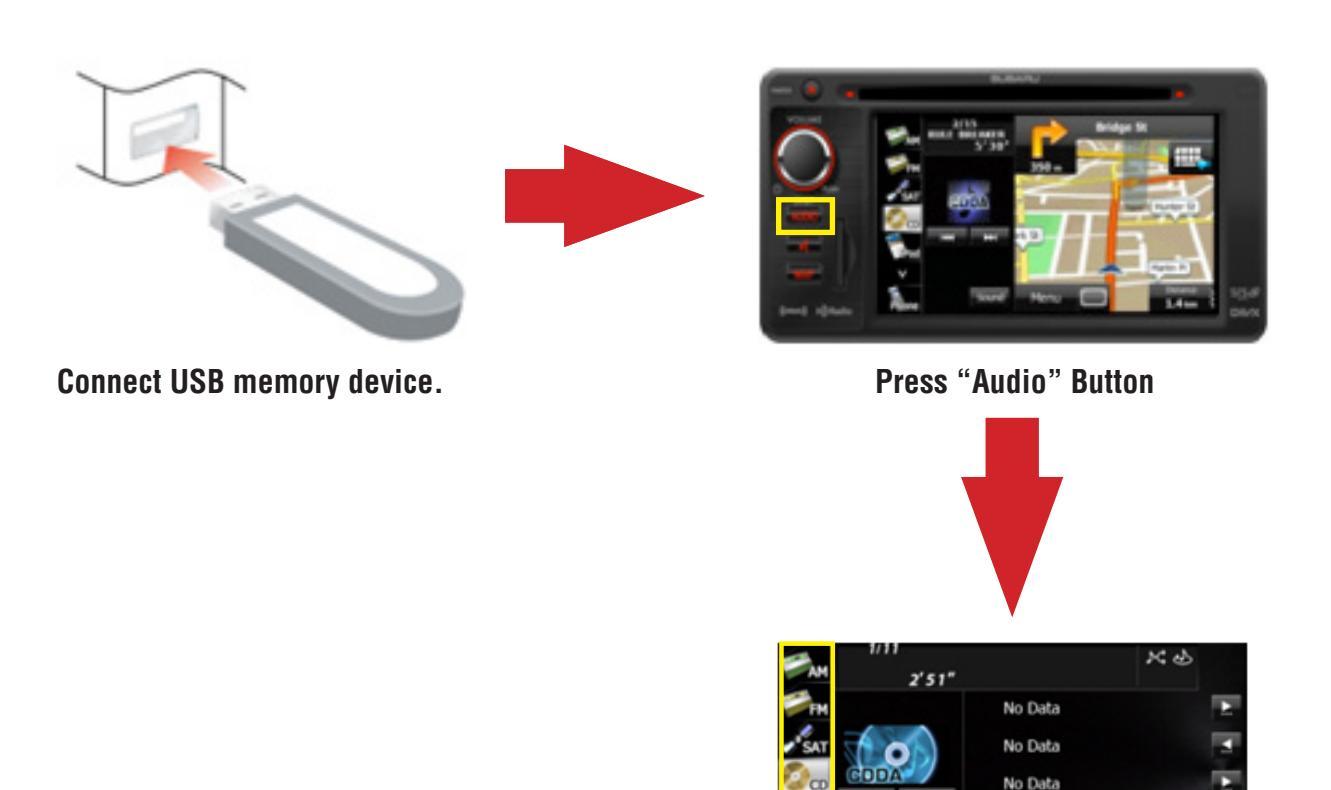
Condition 7:

USB Flash Memory device is not recognized.

USB memory is not recognized.
