Techline News

Contents

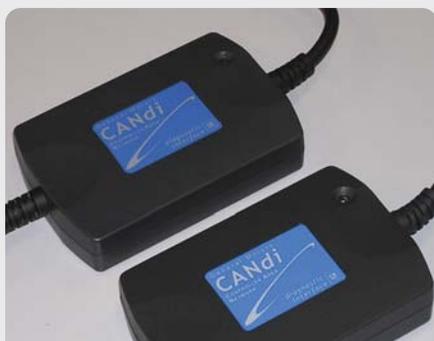
GM and Bosch Diagnostics have discovered counterfeit Tech 2 scan tools and GM Control Area Network diagnostic interface (CANdi) modules available to the aftermarket through online auction websites and other retail websites.

Everything is copied to closely resemble the real thing – from the cables and plastic cases to the brand logos and serial numbers. However, some of these counterfeit tools acquired by GM and Bosch Diagnostics have been found to be built with lower grade components and electronics or with used equipment from other diagnostic tools. As a result, some of the counterfeit tools will not work right from the start, may fail quickly or will run extremely slowly.

Can you tell the difference?
The top CANdi module is counterfeit.

Scan tools and diagnostic tools such as the Tech 2 and CANdi module are large investments for many service departments. For buyers to ensure that they are getting the real tool, and the tech support and warranty protection (authentic Tech 2 scan tools and CANdi modules include a two-year warranty) that comes with it, purchases should only be made from approved retail channels such as GM Dealer Equipment or Bosch Diagnostics.

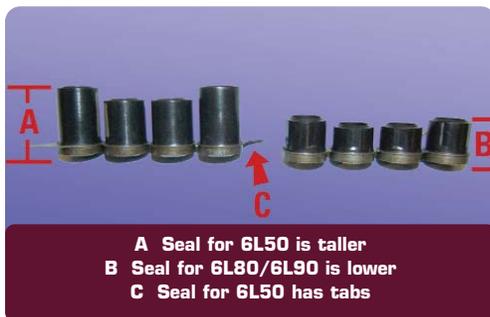
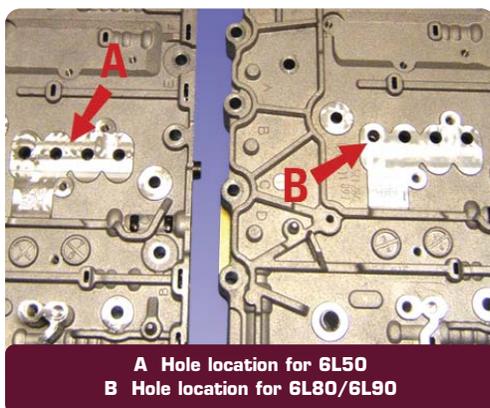
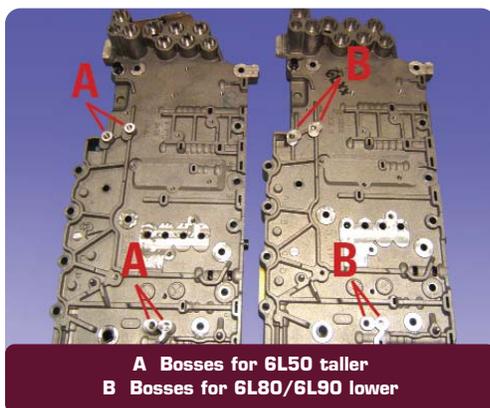
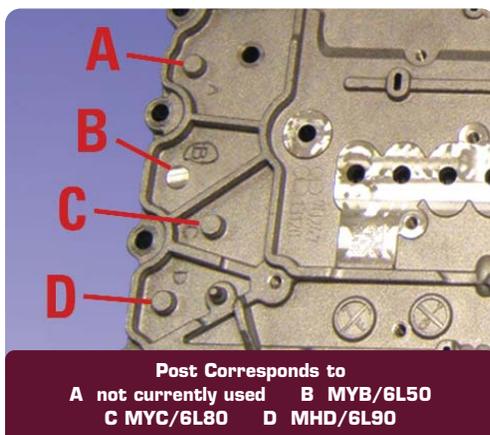
A 2007-08 SRX, STS, 2008 CTS equipped with 6L50 (RPO MYB) automatic transmission may have no forward or reverse or no input or output speed signal after valve body installation or replacement.

According to bulletin 09-07-30-005, this may be caused by the installation of the incorrect center support fluid passage seal or upper valve body assembly. The

center support fluid passage seal for the 6L50 is approximately 5/16 inch (8 mm) taller than the seal used on the 6L80/6L90. The 6L50 seal can also be identified by the metal tabs or wings extending from the ends of the seal. The shorter 6L80/6L90 part will not seal the valve body to the center support resulting in an internal fluid leak.

Also, the 6L50 upper valve body center support oil transfer holes are in a different location than on the 6L80/6L90 valve body. Installation of the 6L80/6L90 upper valve body may result in an internal fluid leak with no forward or reverse.

Finally, installation of a 6L80/6L90 upper valve body will not place the input and output speed sensors close enough to their respective drums to generate a speed signal.

Upper valve bodies can be identified by observing the machining of the small posts in the illustration. The post is milled to indicate A, B, C or D.

If these conditions are encountered, check the P/Ns used in the repair to verify that they are the appropriate parts for the 6L50 (MYB).

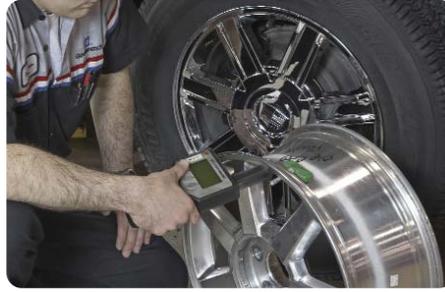
How To Position The Antenna Of The J-46079 Tester

TIP: When activating a sensor, placement of the antenna of the J-46079 Tester

is critical, especially with the latest software update.

When activating a sensor, the antenna tip of the J-46079 Tester must be placed on the sidewall, perpendicular to the tire, and close to the valve stem. This assures proper activation of the sensor. If the antenna is placed either on the valve stem or on the wheel itself, the tool may not properly activate the sensor, causing improper diagnosis.
