SPECIAL EDITION

TROUBLESHOOTING AND IDENTIFYING USB TYPES WITH TECHLINE RECOMMENDATIONS

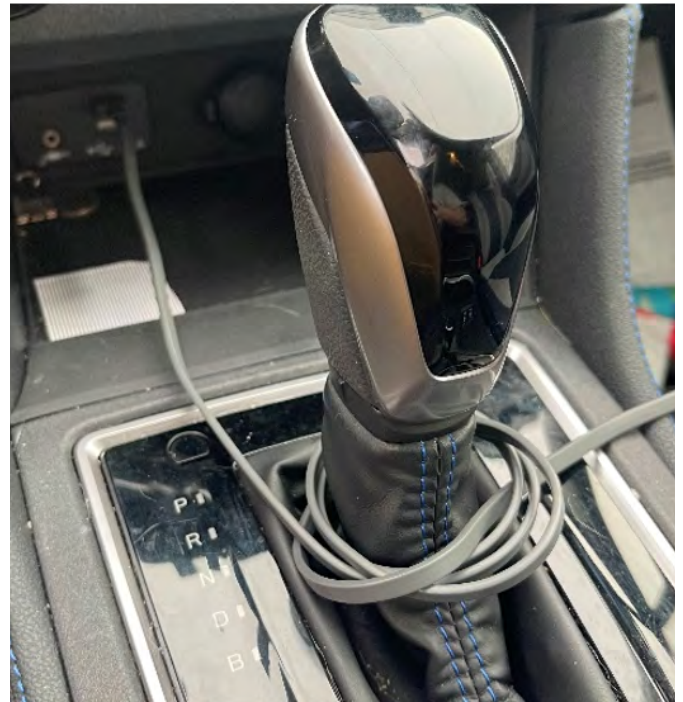
The first two levels of USB cables are USB 1.0 and USB 2.0. Techline has determined that the colors are interchangeable depending on the manufacturer of the cable, but USB 2.0 is typically white. A cable that uses a black insert USB 1.0 should only be used for low power charging, they are not recommended for projection apps (Apple CarPlay or Android Auto).

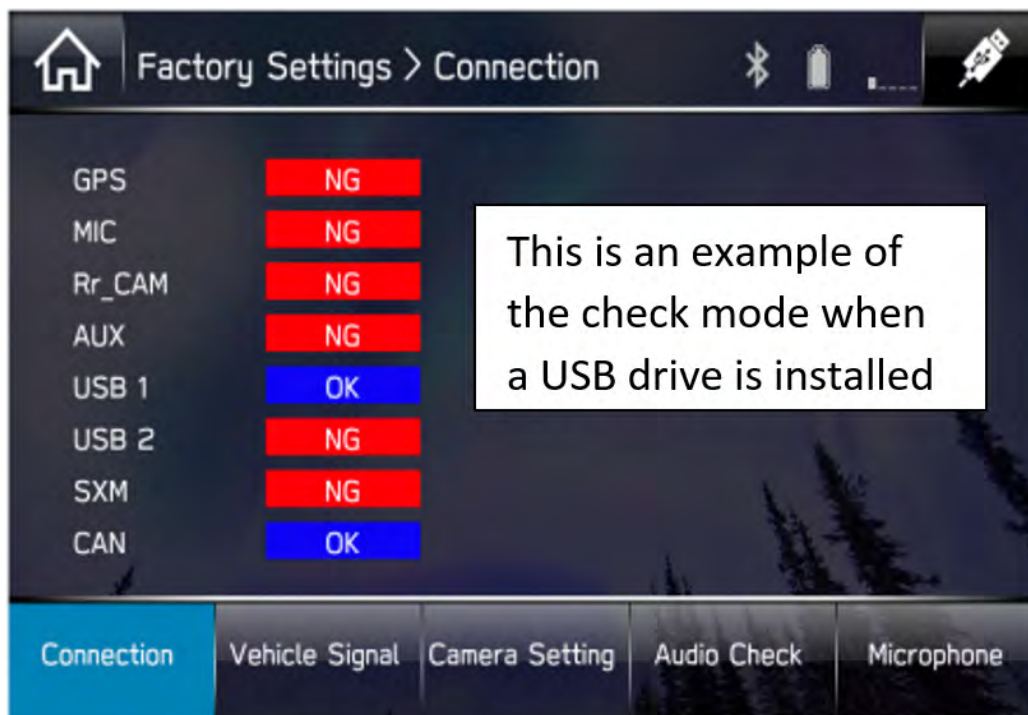
- View the list of possible connections, they may take a minute to populate.
- Observe “USB 1/2” at the start of this test, it should say “**NG**”. Plug the USB drive into the USB hub, it should change to “**OK**”.
- Remove the USB drive.
- On Denso CP 1.0/1.5 vehicles it is necessary to back out of the “**Connection**” screen and go back to it for the “USB” status to shift from “**OK**” back to “**NG**”.
- Move the USB drive to the other USB hub port.
- “USB 1/2” should say “**OK**” with the device plugged in again.
- This is an acknowledgement of the device being plugged in and connecting. **It is not recommended to perform this test with a cellular phone or similar device.**

If “USB 1” in the “**Connection**” menu always shows “**NG**” during the test, switch to a different USB drive and test again. If this makes no change to the “**OK**” or “**NG**” status the next step should be a visual inspection of the back of the head unit for a missing or damaged connector. Techline often finds a craftsmanship error and the USB hub connector is trapped near the floor pan area. If no missing or damaged connector are found, use STIS to refer to the “Body Electrical > Wiring system > Audio System” to verify power and ground at the USB hub connector. Images of the Infotainment connector layout can also be found in STIS, Diagnostics > Infotainment > Control Module I/O Signal. Generally, there should be no empty plugs on the back of the head unit.

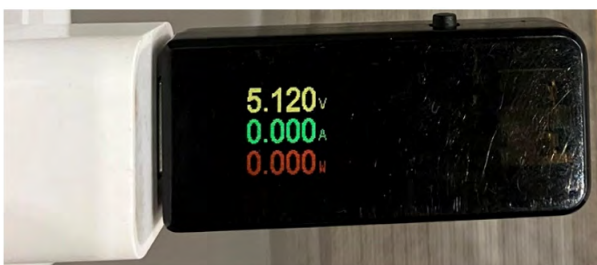
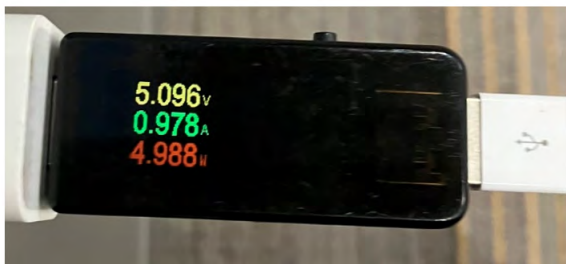
Below is an example of a USB tester in use. The photo on the left indicates a normally operating connection. The photo on the right shows a phone plugged in with the tester set to pass thru mode, showing the charging Amps and Watts.
