General Service Bulletin (GSB):	Bumper Warrantable / Non-Warrantable Conditions
GSB Overview:	Use this GSB to help determine (Warrantable / Non-Warrantable) Bumper defects vs. damage
NOTE: This information is not intended to replace or supersede any warranty, parts and service policy, Work Shop Manual (WSM) procedures or technical training or wiring diagram information.

# Bumper GSB

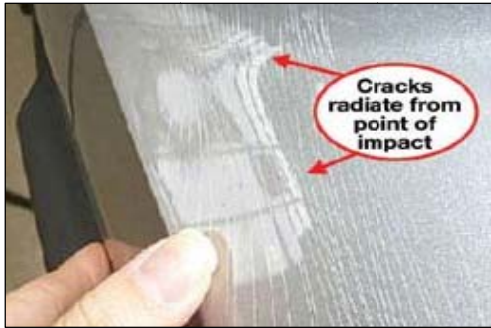
Flexible Bumper – Impact Damage / Paint Cracking

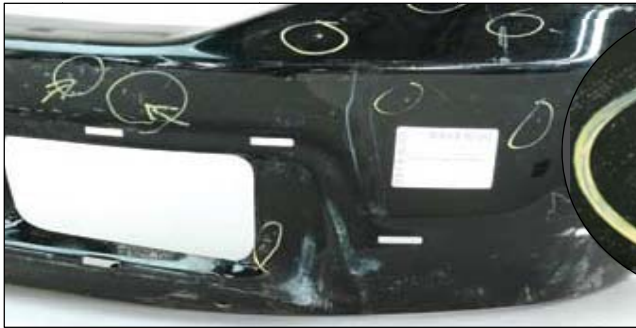
Painted Bumper – Stone Pecking

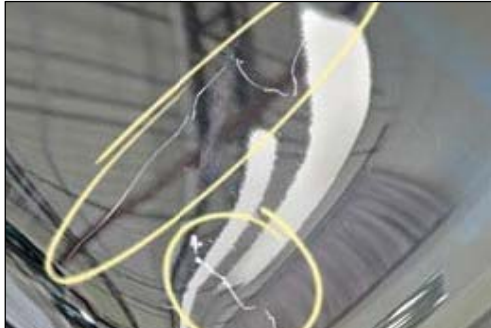
Chrome Bumper – Damaged Scratched / Dented

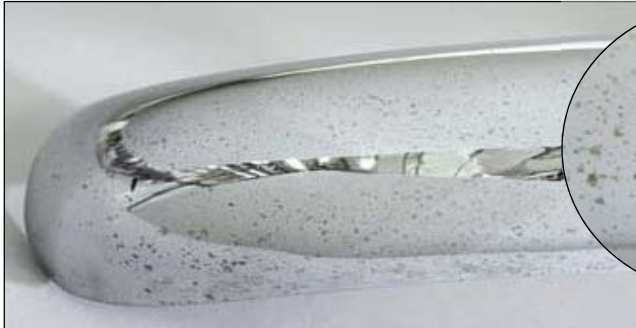
Chrome Bumper or Running Board – Stone Pecking

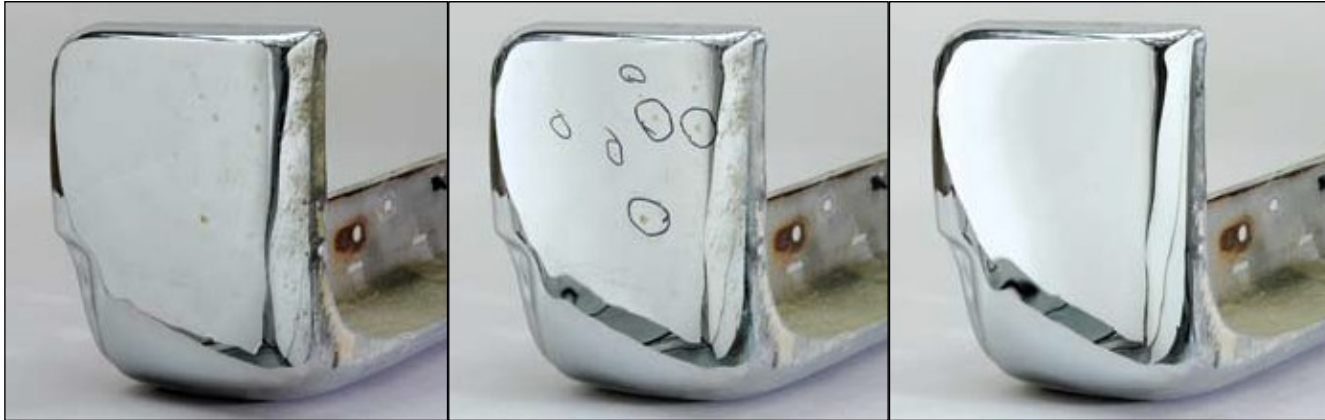
Chrome Bumper – Lack of Maintenance (before / after cleaning)

**Maintenance:**  
Owners are expected to wash and wax their vehicles, including chrome parts, to remove harmful deposits from the vehicle's surfaces to help protect the finishes.

**Exterior Chrome Cleaning Procedure:**  
Refer to the vehicle Owner's Guide for cleaning recommendations.

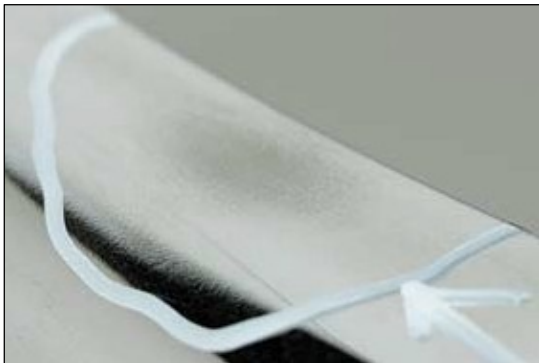
Chrome Bumper – Abrasive Cleaning

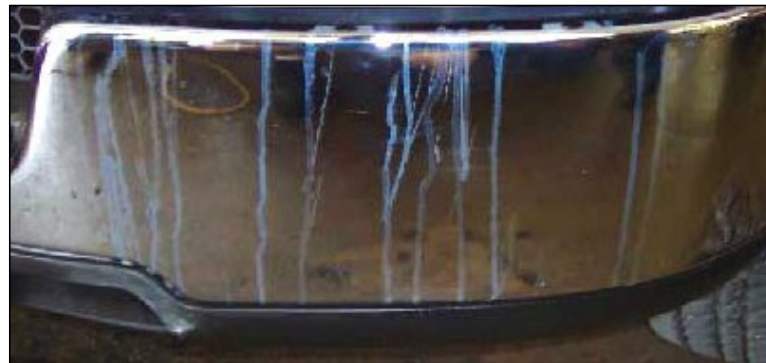
\*Chrome Bumper – Chemical Damage

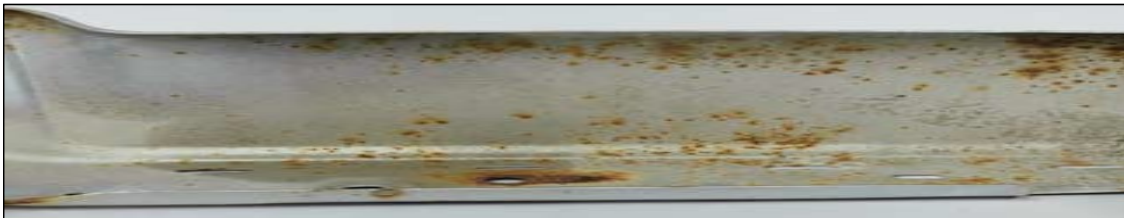
**Corrosion:**  
Corrosion due to lack of maintenance or from impact is not covered under warranty. The backside of the bumper is lightly chrome plated. It also has a protective coating that reduces, but does not eliminate environmental exposure. Corrosion on the backside of the bumper is not warrantable.

Chrome Bumper – Corrosion on Backside of Bumper

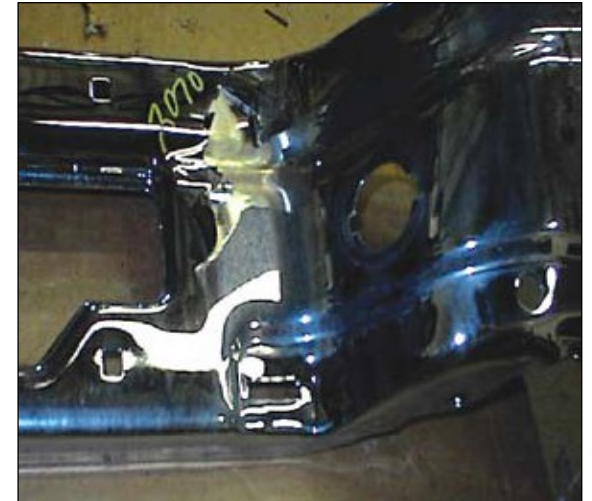
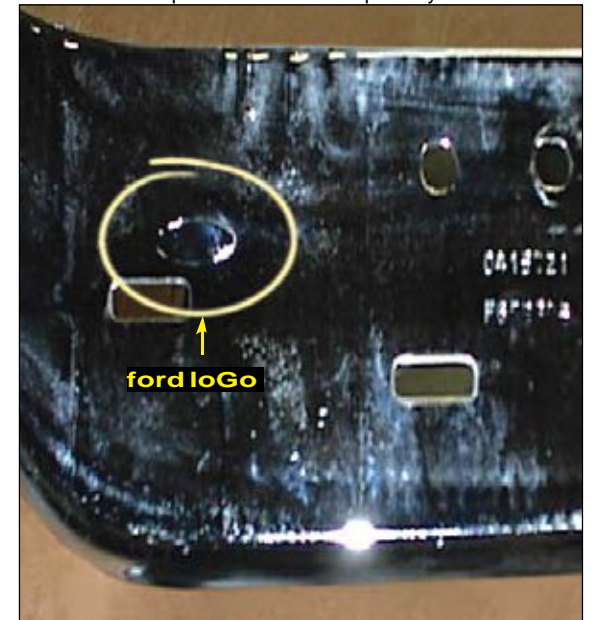
**Aftermarket Remanufactured/ Re-chromed Bumper**  
To help identify re-chromed bumpers: the backside of Ford bumpers are only lightly chrome plated; also, the Ford logo is usually partially removed during the re-chroming procedure.

Aftermarket Remanufactured / Rechromed Bumpers with Poor Replate and Ford oval partially removed
