General Service Bulletin (GSB):	Box Side Step Defect / Damage (Warrantable / Non-Warrantable)
GSB Overview:	Use this GSB to help determine (Warrantable / Non-Warrantable Box Step Defect vs. Damage)
NOTE: This information is not intended to replace or supersede any warranty, parts and service policy, Work Shop Manual (WSM) procedures or technical training or wiring diagram information.

This GSB is designed to provide pictorial examples of box step defects / damage to assist in the warrantable / non-warrantable determination. Refer to the latest version of the Warranty and Policy Manual for warranty coverage.

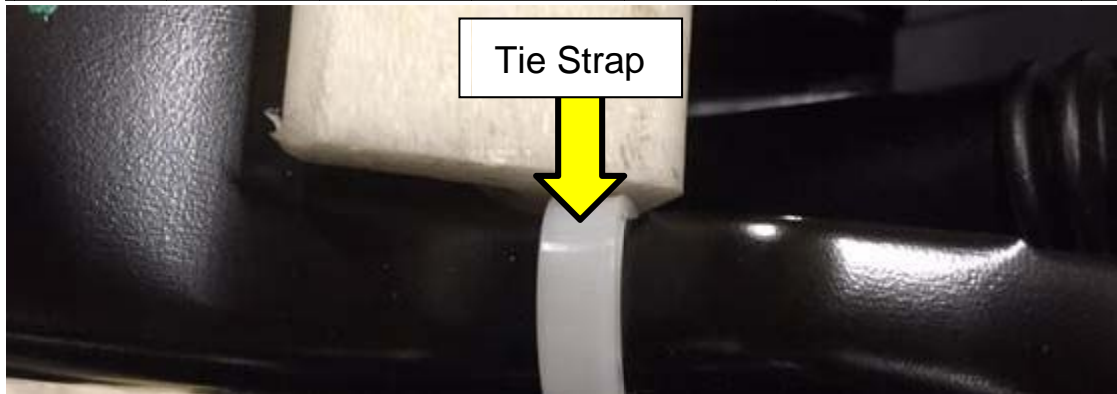
NON-WARRANTABLE

Shipping tie straps on the step preventing deployment

Note: This tie strap is installed during manufacturing to prevent deployment during shipping. This should be removed during Pre-delivery Inspection (PDI).

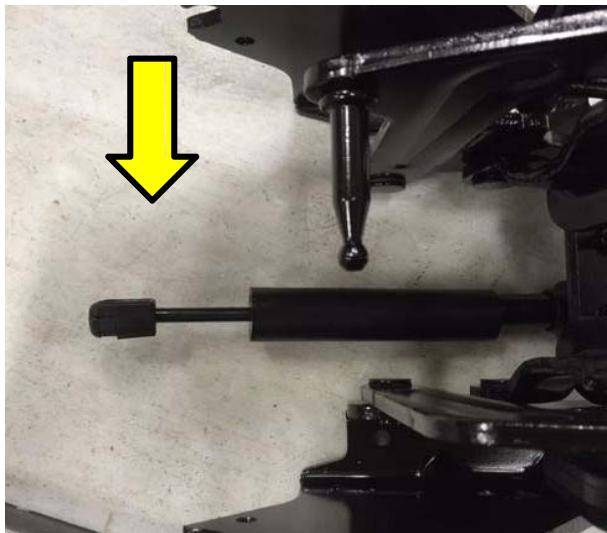
Gas strut detached.

Note: Step replacement not required, reattach strut.

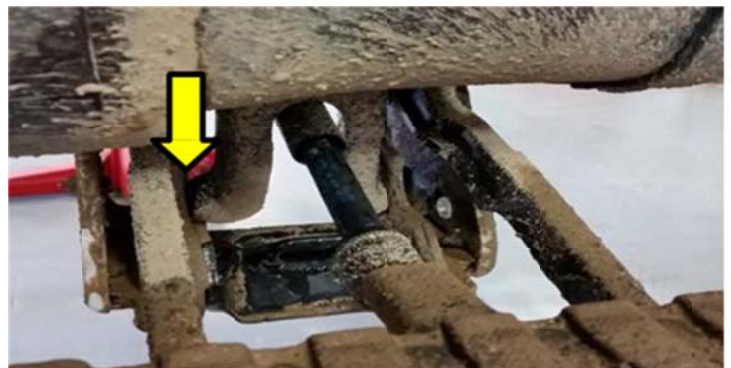
Dirt and debris preventing the function of the step

Note: Refer to the vehicle Owner's Manual for maintenance and operation instructions.

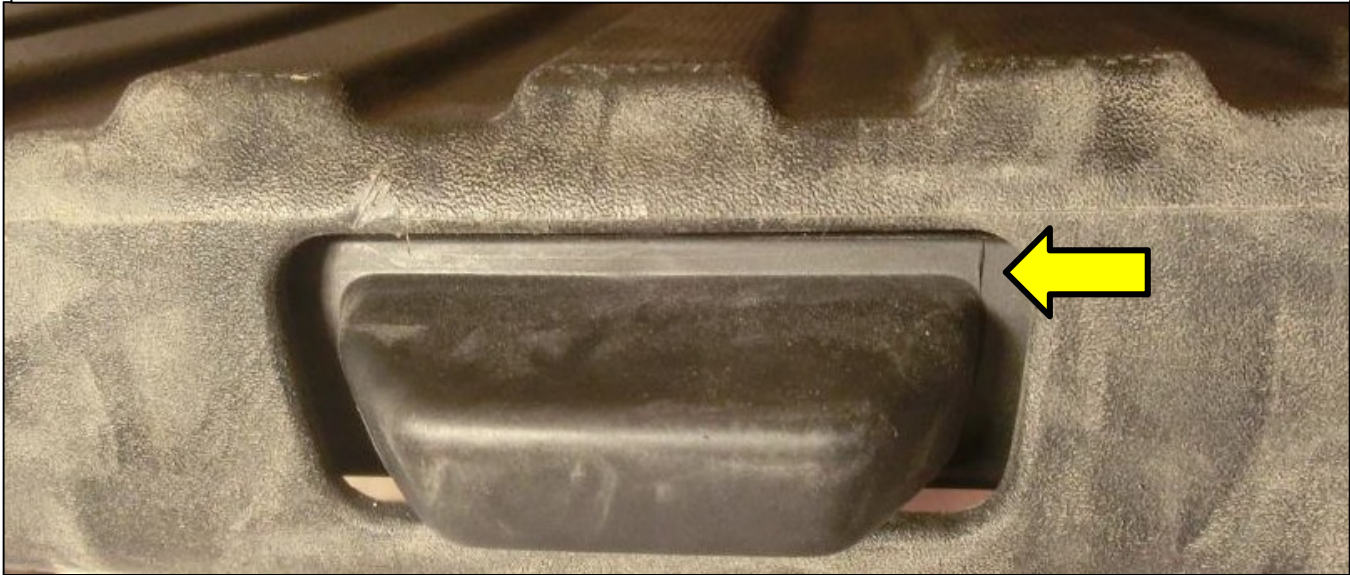
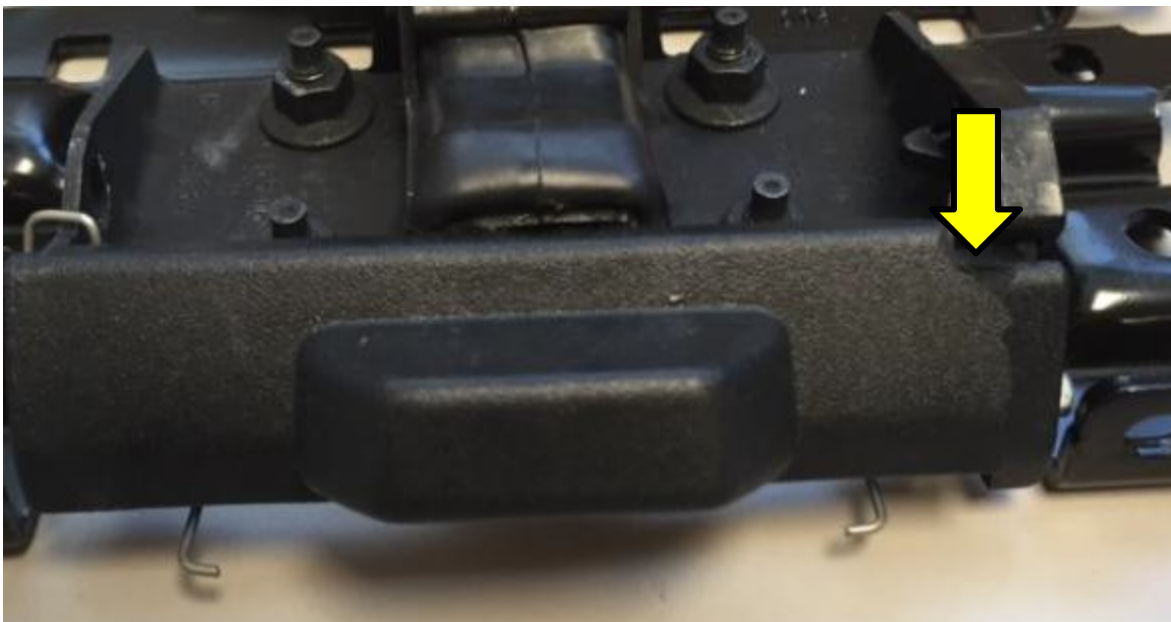
WARRANTABLE

Cracked buttons are often due to attempting to deploy / stow the step repeatedly without succeeding.

Note: Replacing the entire step assembly would be considered an over repair. Replace only the defective part (Latch).

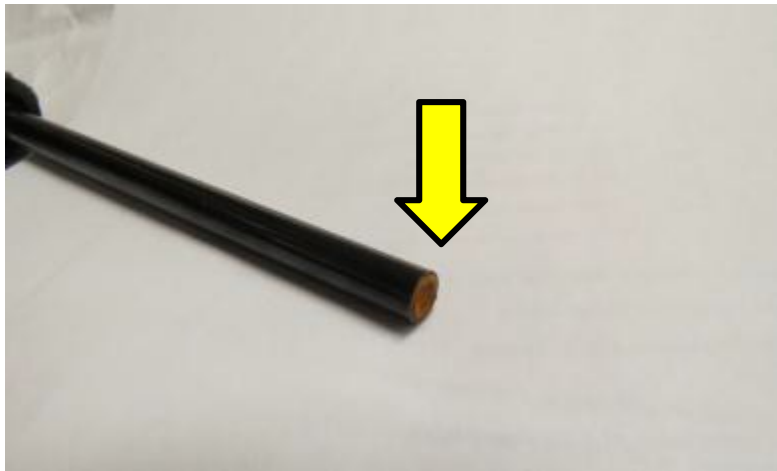
WARRANTABLE

Broken strut due to rust / corrosion

Note: Replacing the entire step assembly would be considered an over repair. Replace only the defective part (strut).

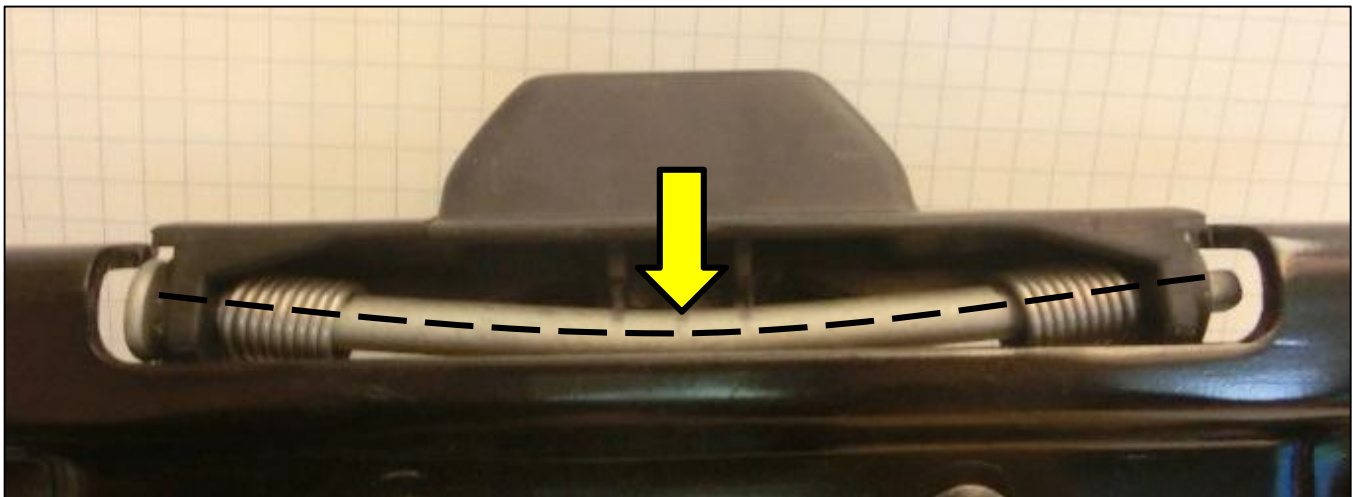
Bent latch assembly without impact damage

Note: Replacing the entire step assembly would be considered an over repair. Replace only the defective part (Latch).
