General Service Bulletin (GSB):	Automatic Transmission Main Control Inspection
GSB Overview:	This bulletin will assist technicians in determining inspection and analysis of hydraulic valves found in the Valve Body, Solenoid Body and Pump.
NOTE: This information is not intended to replace or supersede any warranty, parts and service policy, Work Shop Manual (WSM) procedures or technical training or wiring diagram information.

# Automatic Transmission Main Control Inspection

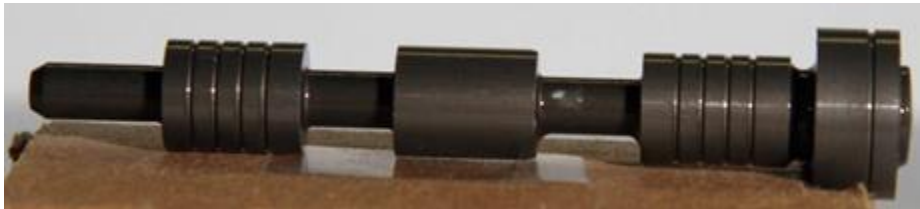
## Anodized Valves

**Note:** Have a dull, somewhat dark color. Anodized coating should not have bright, polished areas which would indicate the valve has worn through the anodized coating. Normal appearing valves will not show significant scratching in areas which contact the bore. Refer to Inspection Criteria in this document.

- Separator plates should have only slight witness marks from check balls.
- **Anodized Valves Only:** Inspect the valves for scratches and worn through coating on the face of the valve lands (surface that touches the bore).

- A scratch is any measurable depth or raised area which runs across the **entire length** of the valve land.
  - **For anodized valves, a scratch or worn valve land requires part replacement.**

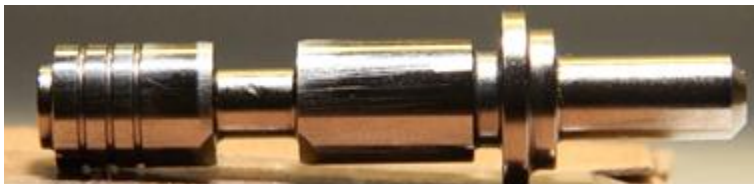
## Nickel Plated Valves

**Note:** Nickel plated valves have a somewhat reflective or shiny appearance.

Visible scratching on nickel plated valves is normally cosmetic and **does not** indicate part replacement is required. Follow Inspection Criteria in this document.

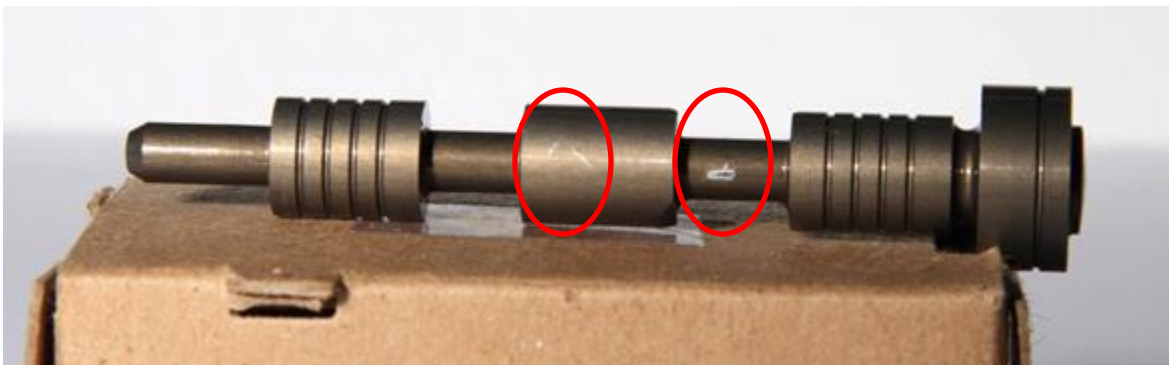
- **Part Description-** Control Pressure Regulator valve
- **Engineering Analysis/Comments-** This part passed engineering performance tests. The photo indicates cosmetic issues only. Area in left circle is very light, not measurable or felt with a fingernail, and doesn't extend across entire length of surface so it would not result in a leak. Valley area in right circle is not a sealing surface. This valve should not have been replaced.
