General Service Bulletin (GSB):	Grille Defect vs. Damage GSB
GSB Overview:	Use this GSB to help determine warrantable / non-warrantable grille defect vs. damage
NOTE: This information is not intended to replace or supersede any warranty, parts and service policy, Work Shop Manual (WSM) procedures or technical training or wiring diagram information.

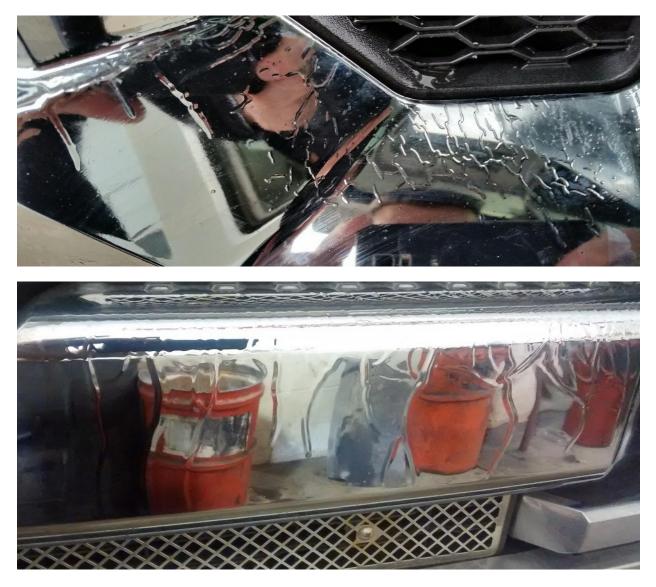
TOPIC: Worm Tracks

DESCRIPTION: Worm tracks are raised portions of chrome that form in lines as if a worm or snake had burrowed under the chrome.

WARRANTY STATUS: Warrantable

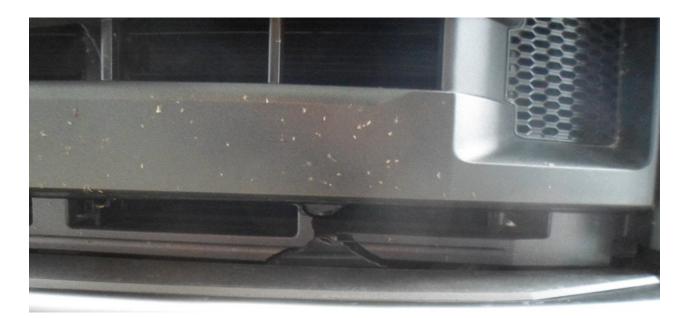
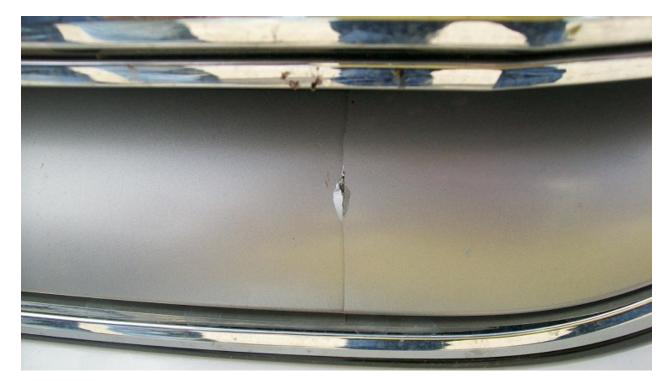
TOPIC: Cracks / Parts of the Grill Missing / Holes

DESCRIPTION: This type of damage is caused by over-flexing of the grille or impact with an outside object. There will be obvious cracks that may be associated with missing portions of the grille. There also may or may not be associated witness marks and/or paint transfer to the grille. Cracks and breaks in the grille may also not be seen on the front of the grille, but present on the grille's backside.

WARRANTY STATUS: Not Warrantable

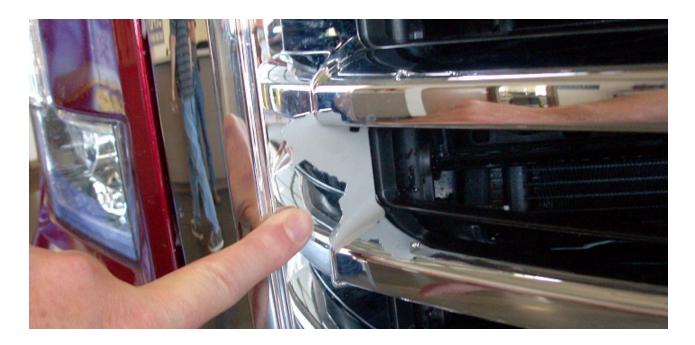
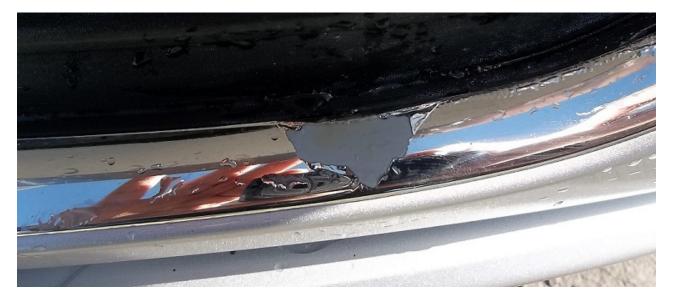
TOPIC: Peeling Chrome

DESCRIPTION: Chrome finish of grille peeling away from the grille substrate with lifting edges and no damage to the grille surface and substrate.

WARRANTY STATUS: Warrantable

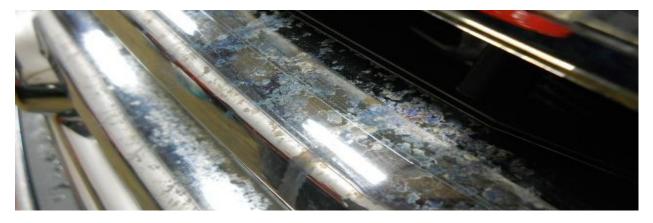
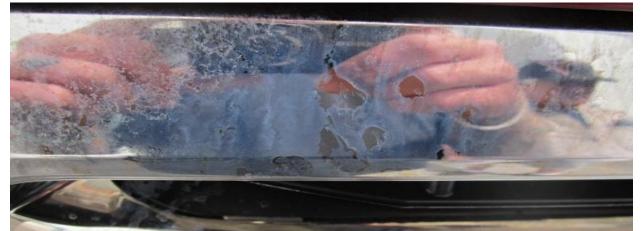
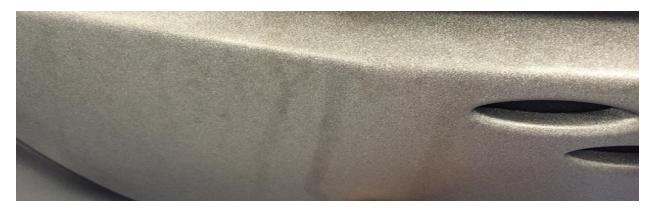
TOPIC: Discoloration/Staining

DESCRIPTION: The surface of the grille has been etched and/or stained from an outside influence, such as a harsh chemical or cleaner. The grille will have a discolored and uneven appearance and there may or may be liquid drip patterns on the surface of the grille.

NOTE: The discoloration may be removed by properly cleaning the grille but if the discoloration cannot be cleaned using the procedures found in the Vehicle's Owners Guide, then the grille will be considered stained and damaged from an outside source.

WARRANTY STATUS: Not Warrantable

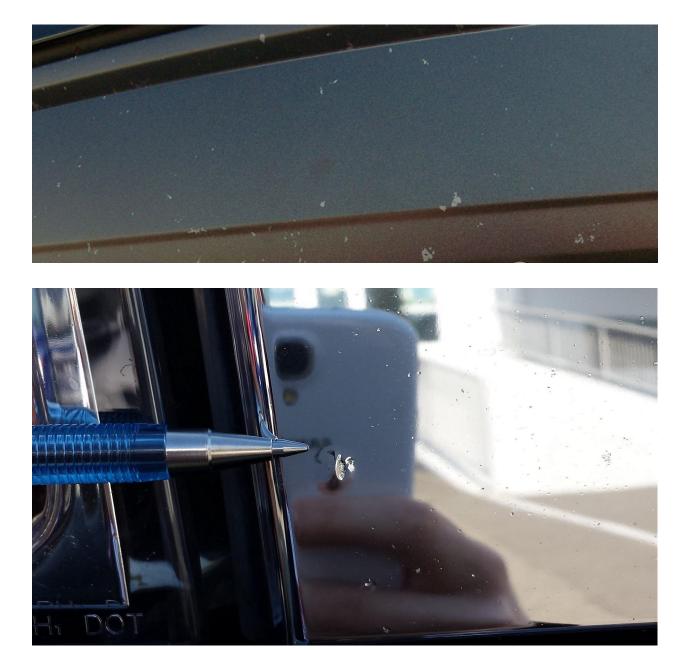
Examples of Stone Pecking

TOPIC: Stone Chipping/Impacts

DESCRIPTION: Chips or abrasions in the chrome surface. Can appear as a small pecking in the surface of the grille or as larger chips with pieces of the surface gouged and removed.

WARRANTY STATUS: Not Warrantable

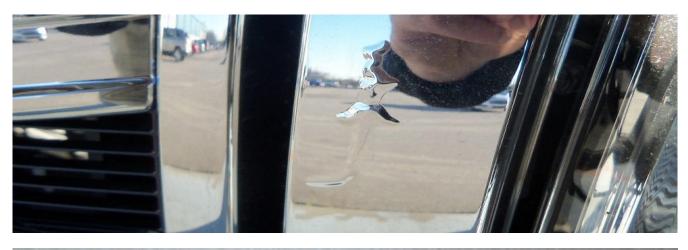
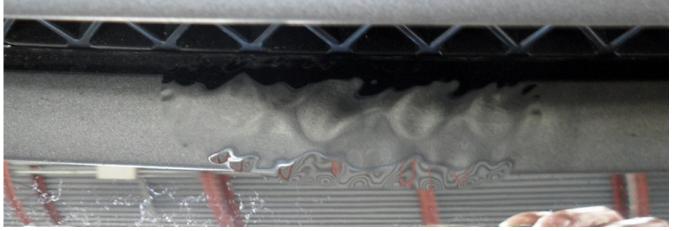
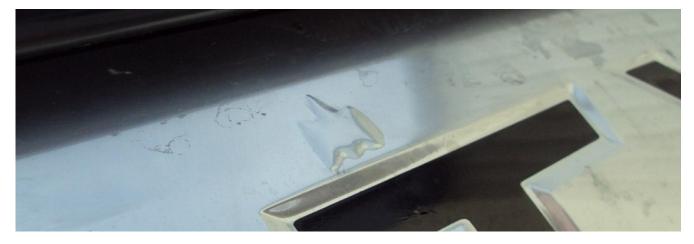
TOPIC: Bubbled Chrome

DESCRIPTION: These are portions of the grille where the chrome finish will bubble due to an adhesion issue with the chrome to the grille's substrate. The chrome will have a raised dome effect and can be seen in various random patterns.

WARRANTY STATUS: Warrantable

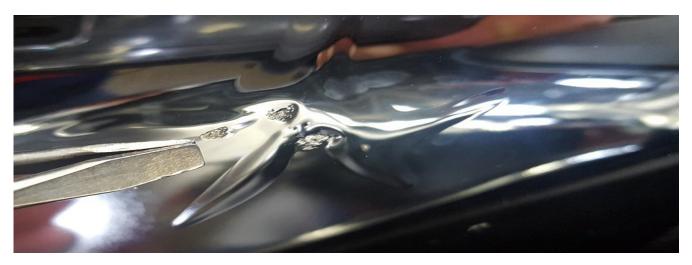
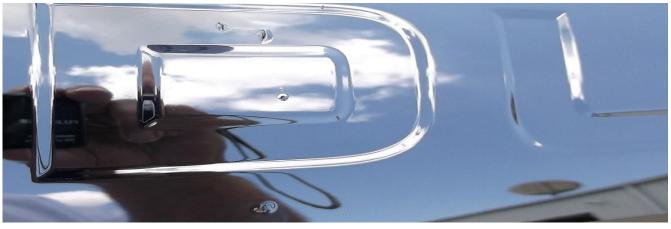
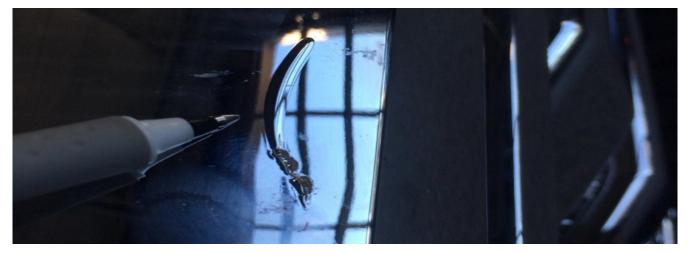
TOPIC: Bubbled Chrome with Impact Damage

DESCRIPTION: Bubbled Chrome caused by impact to the grille. There will be bubbled-up chrome but with impingement of the surface with impact points, identified by indents in the chrome with feathered-in edges.

WARRANTY STATUS: Not Warrantable
